Ref/Project number Contract No. HY/2012/07
Tuen Mun – Chek Lap Kok Link – Southern
Connection Viaduct Section

Subject Notification of Exceedance for Air Quality Impact
Monitoring

Notification of Exceedance

**ANNEX A - PHOTO AT SEAFRONT REINSTATEMENT WORKS AREA ON
25 JUNE 2019**

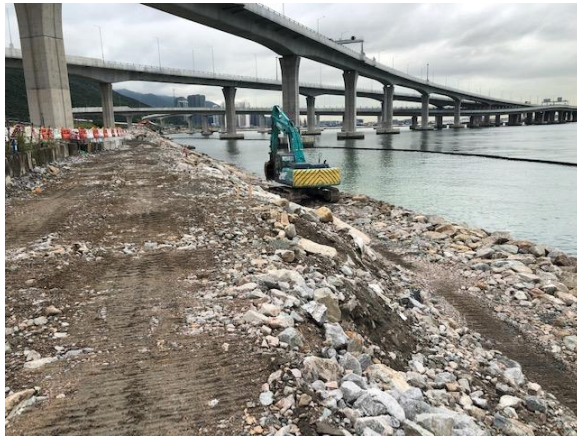
Photo 1 - Seafront on 25 June 2019

Log No.	<p><u>Limit Level Exceedance</u> 0215660_25 June 2019_1hrTSP_Station ASR9</p> <p>[Total No. of Exceedances = 1]</p>	
Date	<p>25 June 2019 (Measured) 11 July 2019 (Results received by ERM)</p>	
Monitoring Station	ASR8A, ASR9	
Parameter(s) with Exceedance(s)	1-hr TSP	
Action Levels	1-hr TSP ($\mu\text{g}/\text{m}^3$)	ASR8A = 394 ASR9 = 393
Limit Levels	1-hr TSP ($\mu\text{g}/\text{m}^3$)	ASR8A and ASR9 = 500
Measured Levels	<p><u>Limit Level Exceedance</u> 1. 1-hr TSP at ASR9 ($752 \mu\text{g}/\text{m}^3$) during 8:30a.m.-9:30 a.m.</p>	
Works Undertaken (at the time of monitoring event)	<p>Works undertaken under this Contract on 25 June 2019 included:</p> <ul style="list-style-type: none"> • Reinstatement of seawall at Seafront, and • At-Grade Works at Southern Landfall. 	
Possible Reason for Action or Limit Level Exceedance(s)	<p>The exceedance is unlikely to be due to the Contract, in view of the following:</p> <ul style="list-style-type: none"> • According to the record provided by the Contractor, works under this Contract conducted on 25 June 2019 included reinstatement of seawall at seafront and at-grade works at southern landfall (see <i>Figure 1</i>). According to the recorded wind direction (ranged between 227° and 238°, blowing from a southwesterly direction), the works area at seafront is located upstream of Station ASR9. However, the reinstatement works at the seafront were at the marine and intertidal zones where exposed surfaces are kept wet. In addition, with reference to the low wind speed (ranged from 0.13 to 0.45 m/s) during the period of the observed 1-hr TSP exceedance and the distance between the works area and ASR9 of approximately 400 m, it is considered that the observed exceedance should not be due to the dust, if any, generated by the construction activities under this Contract. • Apart from one 1hr-TSP (08:30a.m.-9:30a.m.) at ASR9, other 1-hr TSP levels and all 24-hr TSP at ASR8A and ASR9 were in compliance with the Action and Limit Levels on the same day. • According to ET inspection of the seafront, no particular observation was observed at the works area (see <i>Annex A</i>). <p>Based on the above, the exceedance is unlikely to be due to the Contract.</p>

Actions Taken/ To Be Taken	<p>No immediate action is considered necessary. The Contractor has been reminded to ensure all dust suppression measures are implemented at the site area including water spraying at unpaved road/stockpiles and use of tarpaulin for stockpiles covering (if any). The ET will monitor for future trends in exceedances.</p>	
Remarks	<p>The monitoring results and meteorological information on 25 June 2019 and locations of air quality monitoring stations are attached.</p>
