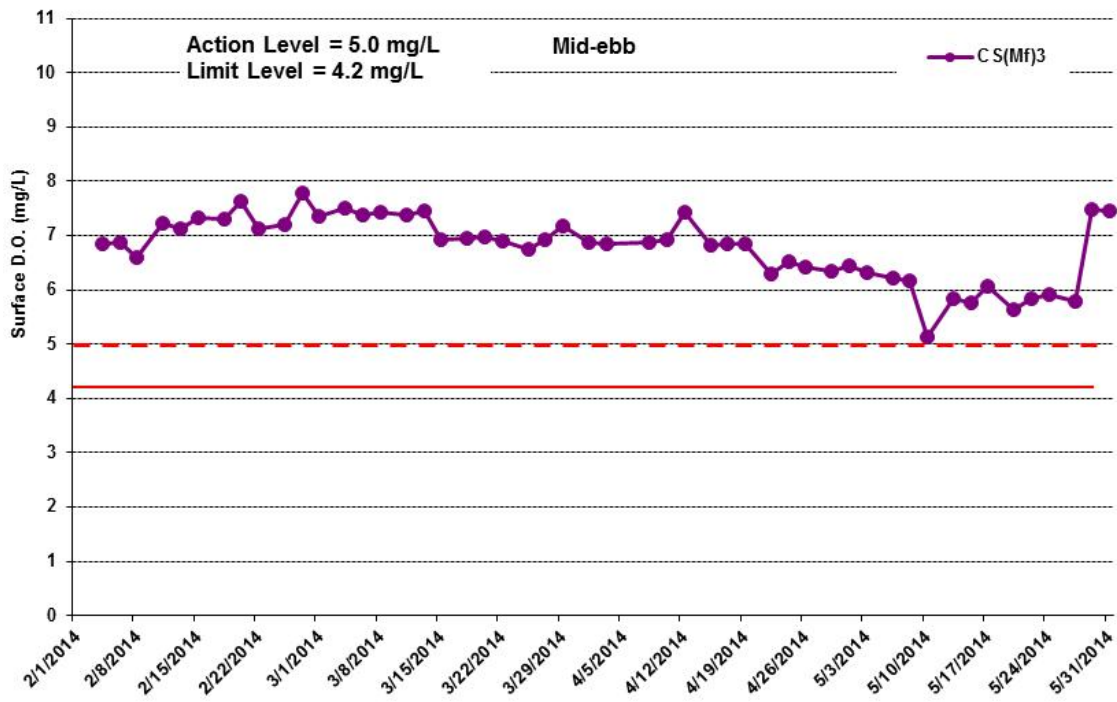
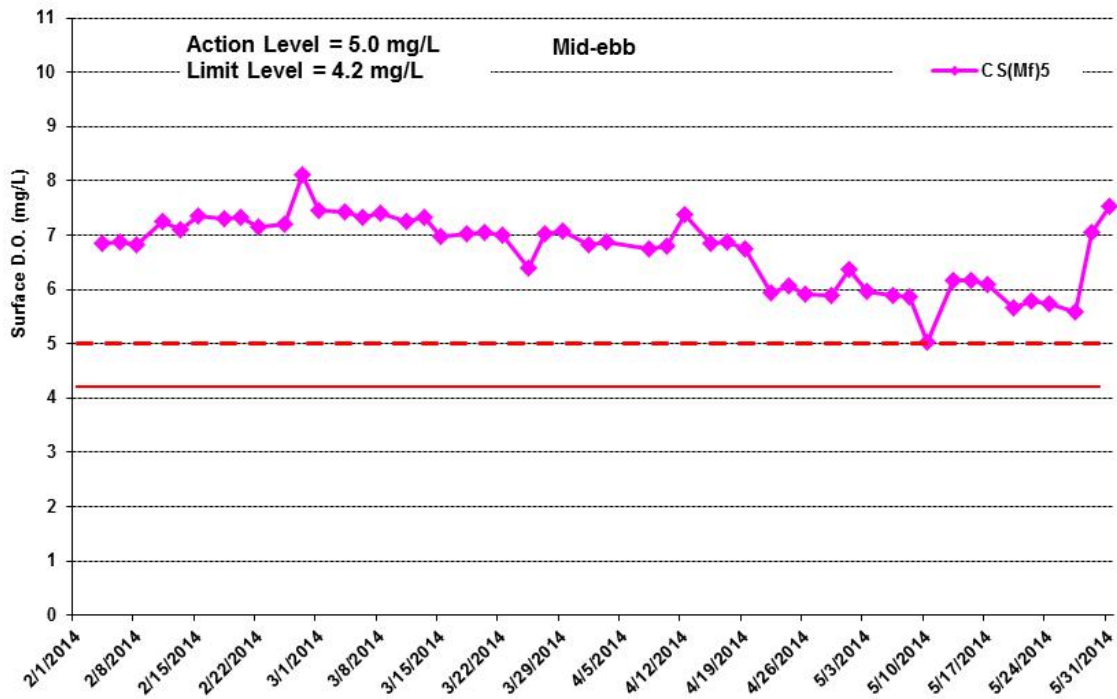
Figure H1 Impact Monitoring - Mean Level of Dissolved Oxygen (mg/L) in surface waters during mid-ebb tide between 1 February to 31 May 2014 at CS(Mf)3 and CS(Mf)5.

(Weather condition varied between sunny to rainy within the reporting period. Marine works within the reporting period include rockfill platform construction, marine piling platform installation and survey tower erection.)

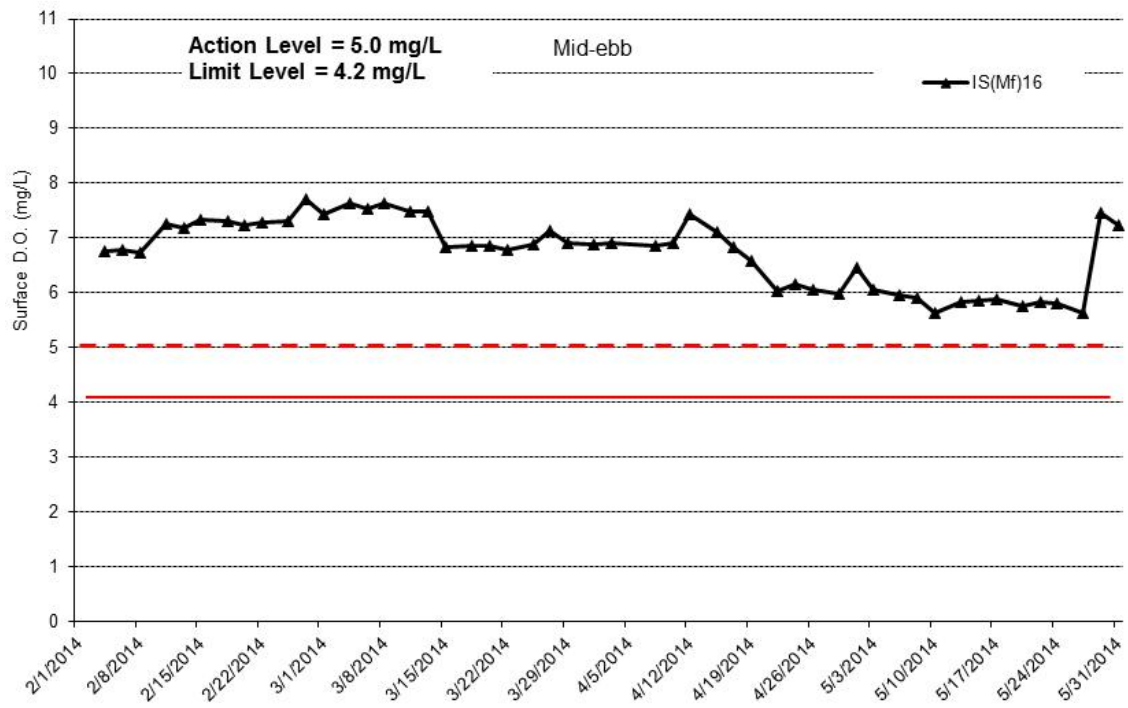
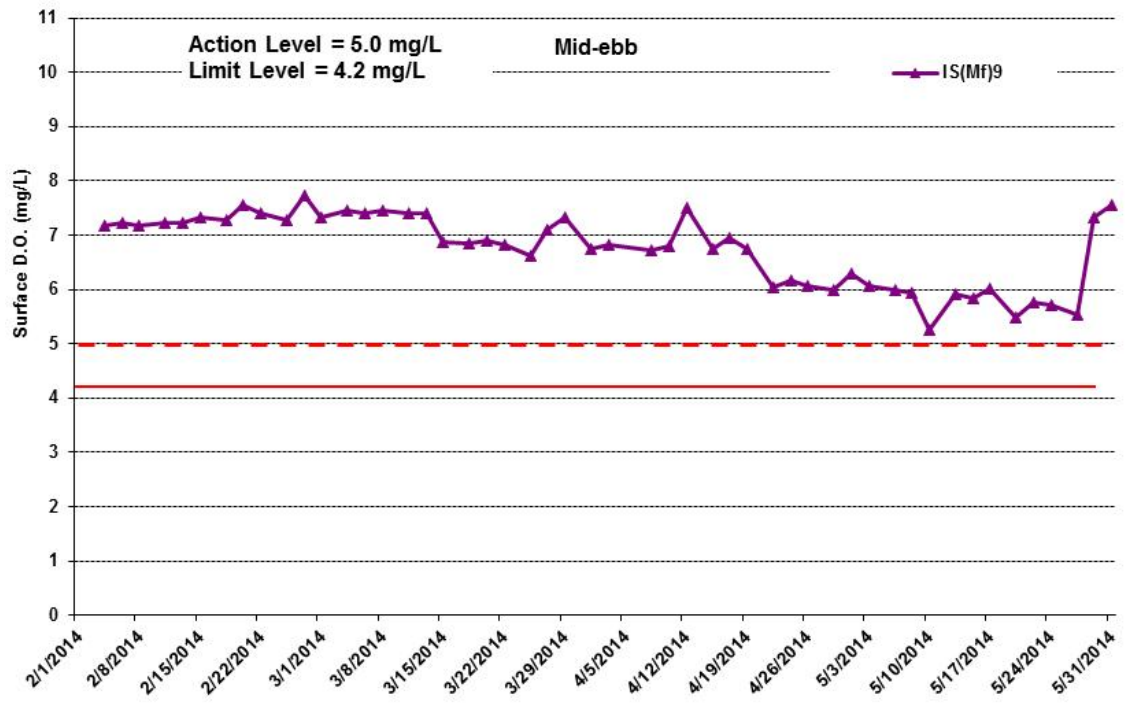
Figure H2 Impact Monitoring - Mean Level of Dissolved Oxygen (mg/L) in surface waters during mid-ebb tide between 1 February to 31 May 2014 at IS(Mf)16 and IS(Mf)9.

(Weather condition varied between sunny to rainy within the reporting period. Marine works within the reporting period include rockfill platform construction, marine piling platform installation and survey tower erection.)

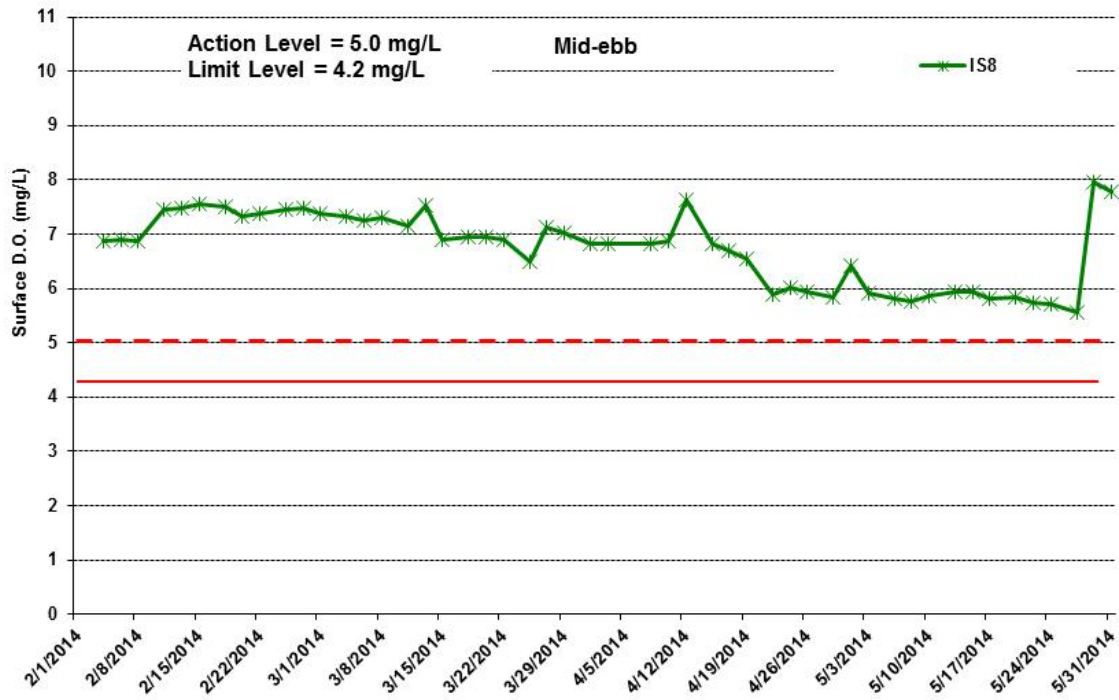
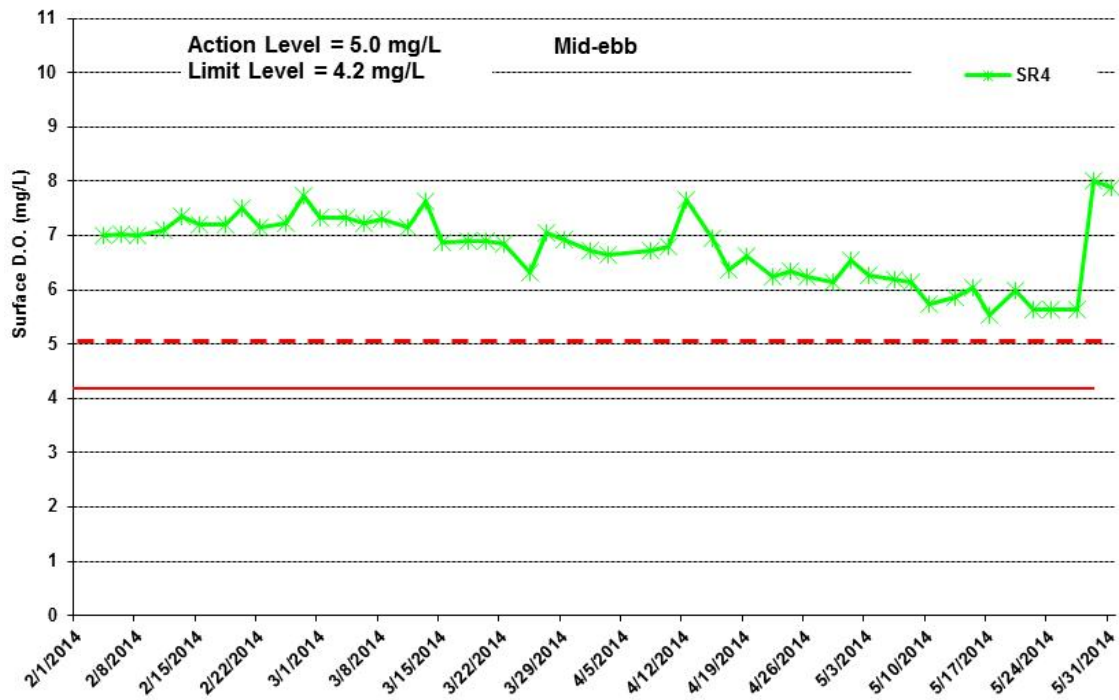
Figure H3 Impact Monitoring - Mean Level of Dissolved Oxygen (mg/L) in surface waters during mid-ebb tide between 1 February to 31 May 2014 at IS8 and SR4.

(Weather condition varied between sunny to rainy within the reporting period. Marine works within the reporting period include rockfill platform construction, marine piling platform installation and survey tower erection.)

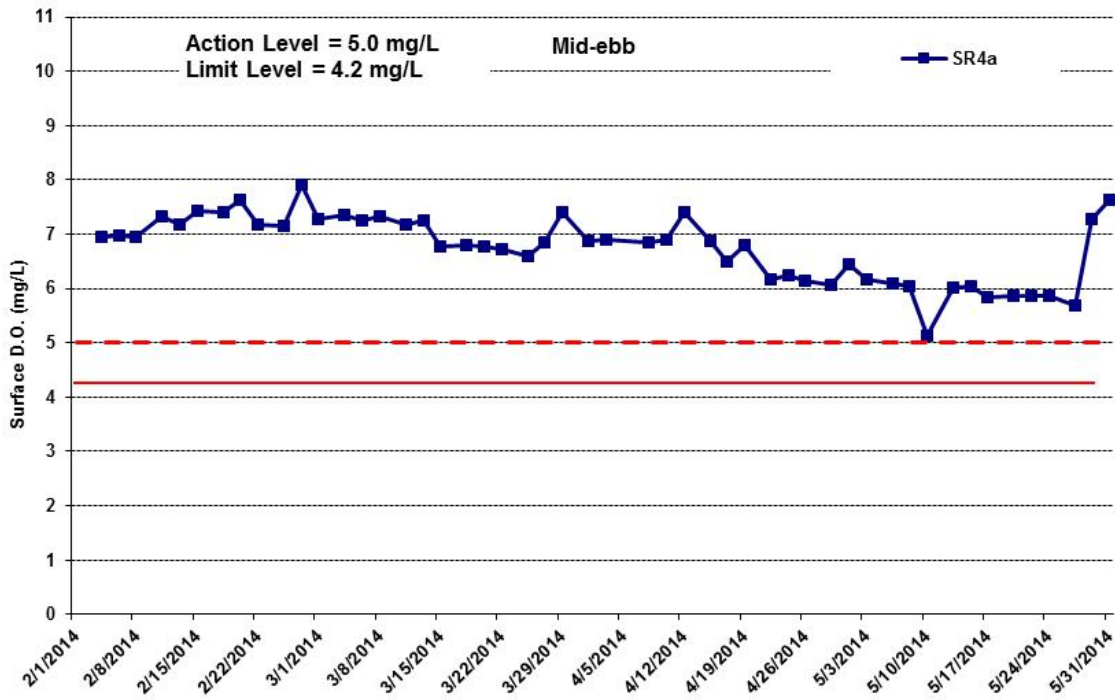
Figure H4 Impact Monitoring - Mean Level of Dissolved Oxygen (mg/L) in surface waters during mid-ebb tide between 1 February to 31 May 2014 at SR4a.

(Weather condition varied between sunny to rainy within the reporting period. Marine works within the reporting period include rockfill platform construction, marine piling platform installation and survey tower erection.)

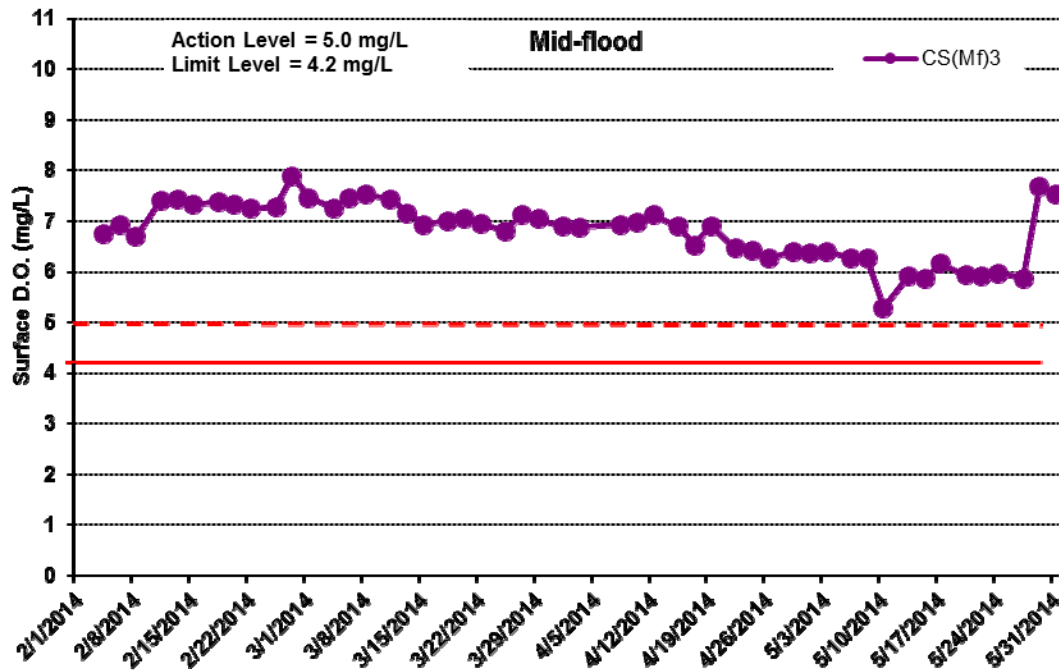
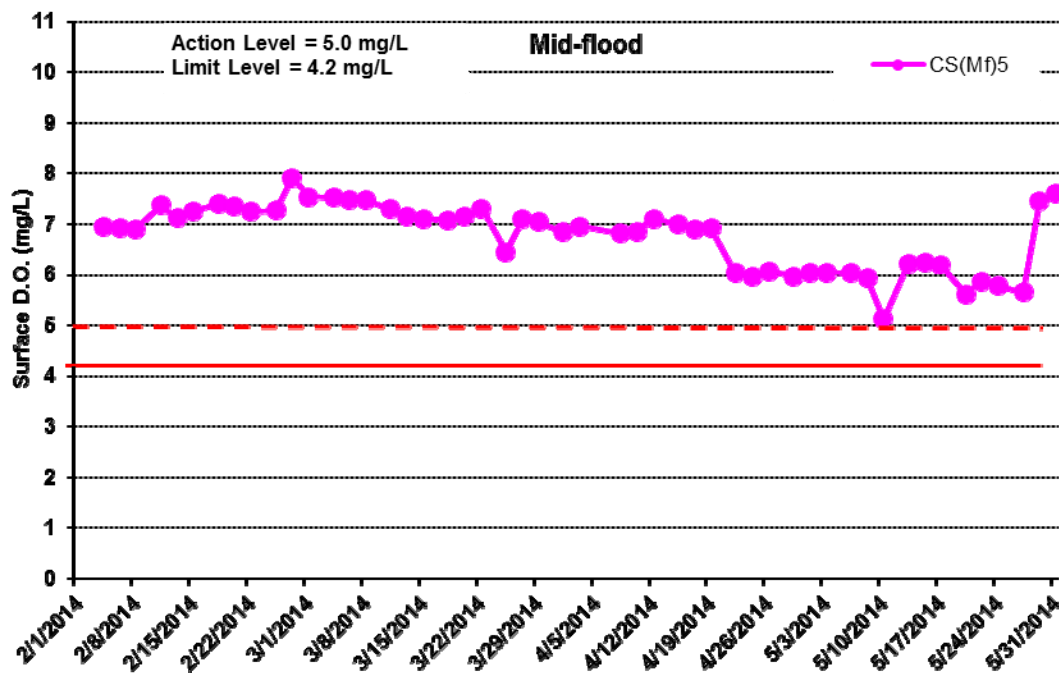
Figure H5 Impact Monitoring - Mean Level of Dissolved Oxygen (mg/L) in surface waters during mid-flood tide between 1 February to 31 May 2014 at CS(Mf)3 and CS(Mf)5.

(Weather condition varied between sunny to rainy within the reporting period. Marine works within the reporting period include rockfill platform construction, marine piling platform installation and survey tower erection.)

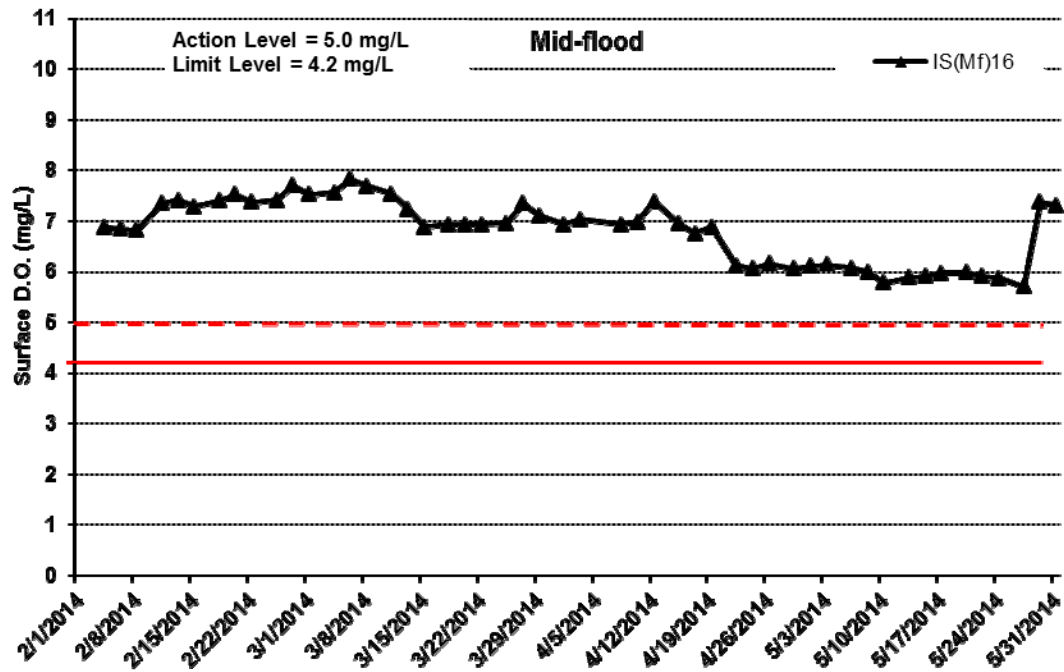
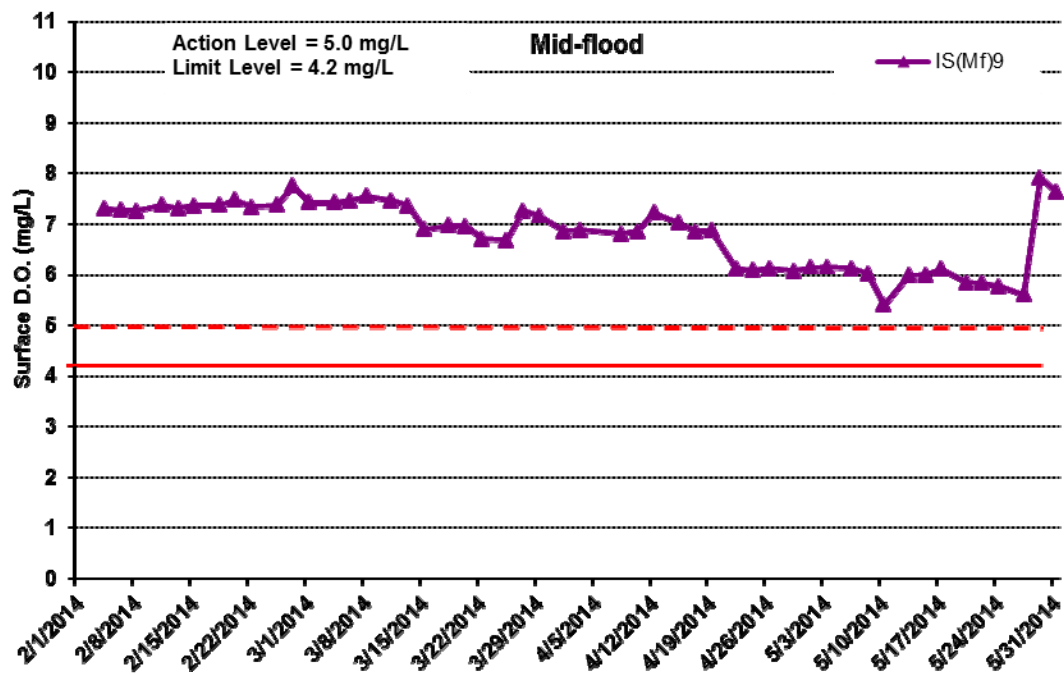
Figure H6 Impact Monitoring – Mean Level of Dissolved Oxygen (mg/L) in surface waters during mid-flood tide between 1 February to 31 May 2014 at IS(Mf)16 and IS(Mf)9.

(Weather condition varied between sunny to rainy within the reporting period. Marine works within the reporting period include rockfill platform construction, marine piling platform installation and survey tower erection.)

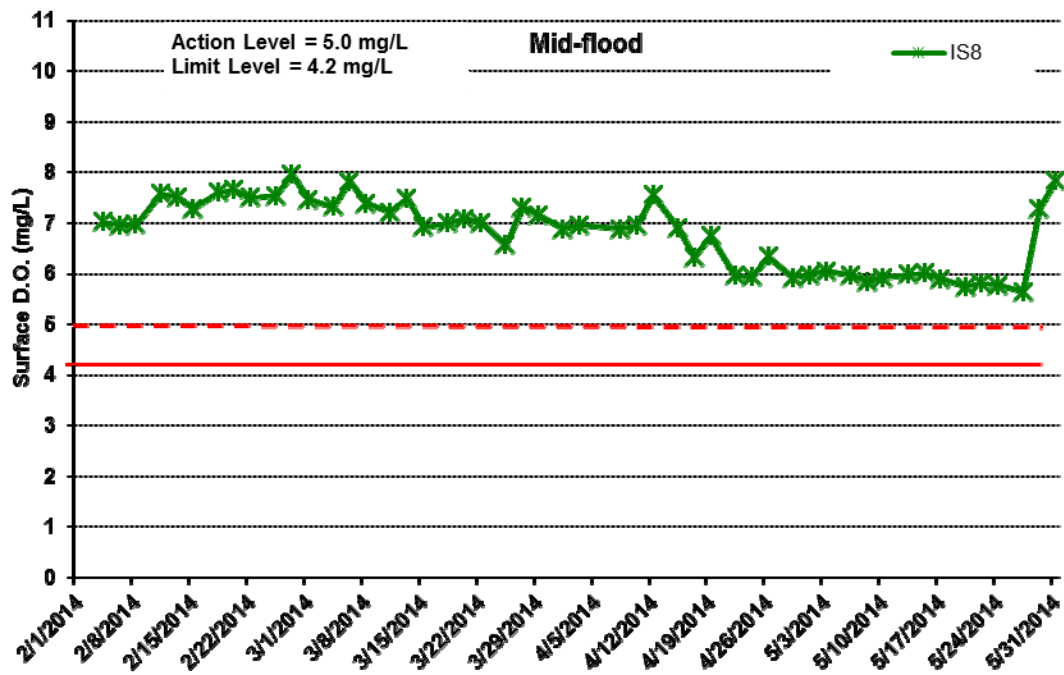
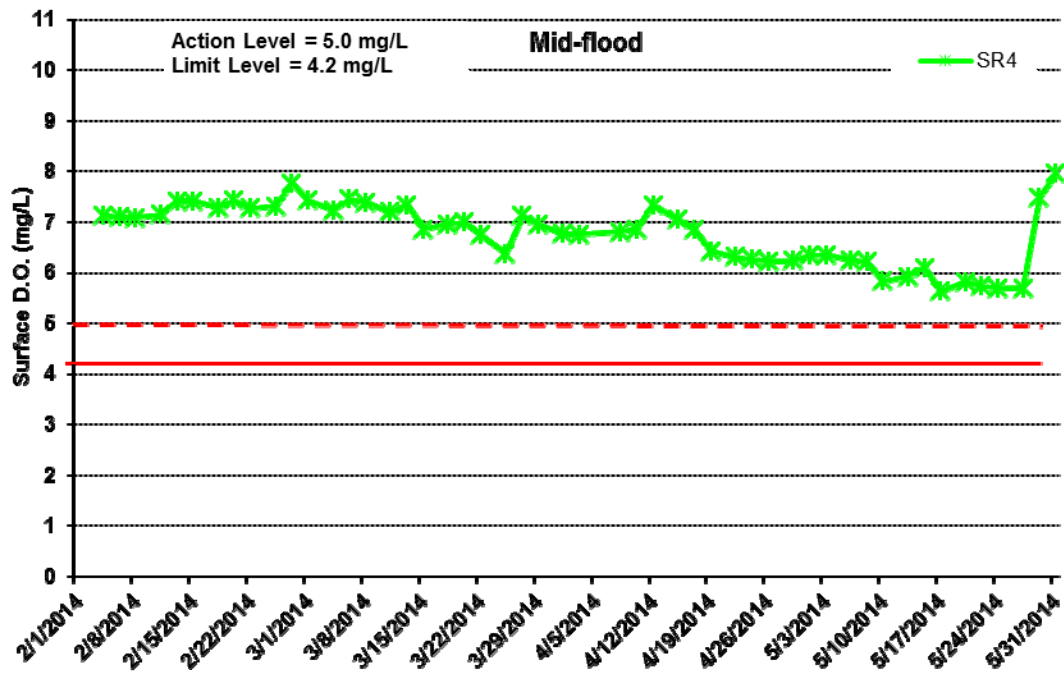
Figure H7 Impact Monitoring – Mean Level of Dissolved Oxygen (mg/L) in surface waters during mid-flood tide between 1 February to 31 May 2014 at IS8 and SR4.

(Weather condition varied between sunny to rainy within the reporting period. Marine works within the reporting period include rockfill platform construction, marine piling platform installation and survey tower erection.)

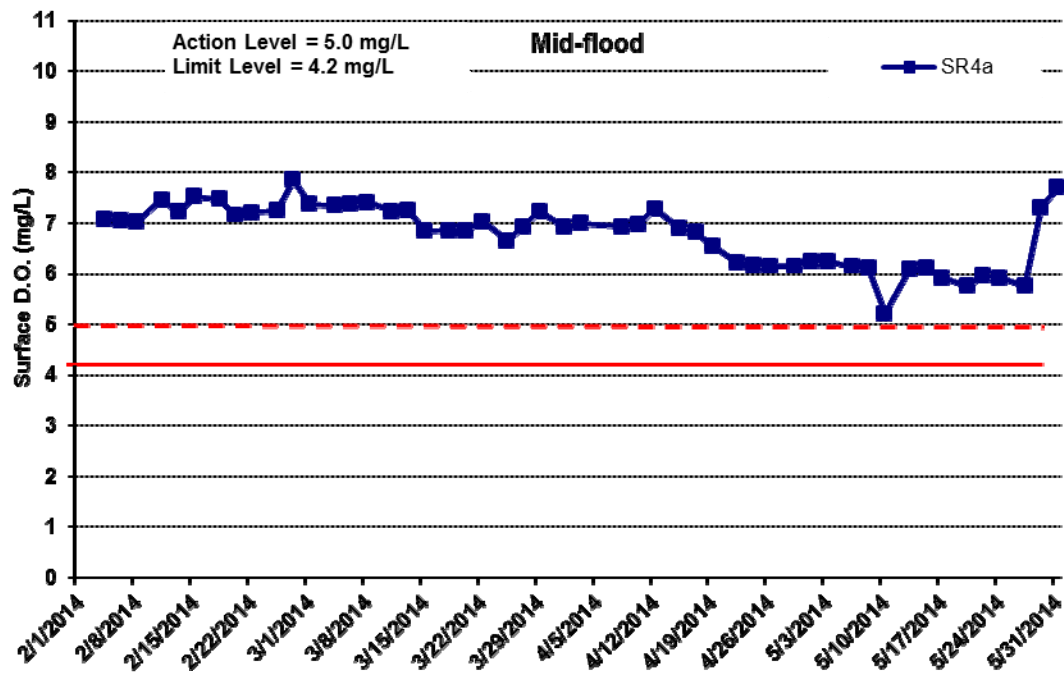
Figure H8 Impact Monitoring – Mean Level of Dissolved Oxygen (mg/L) in surface waters during mid-flood tide between 1 February to 31 May 2014 at SR4a.

(Weather condition varied between sunny to rainy within the reporting period. Marine works within the reporting period include rockfill platform construction, marine piling platform installation and survey tower erection.)

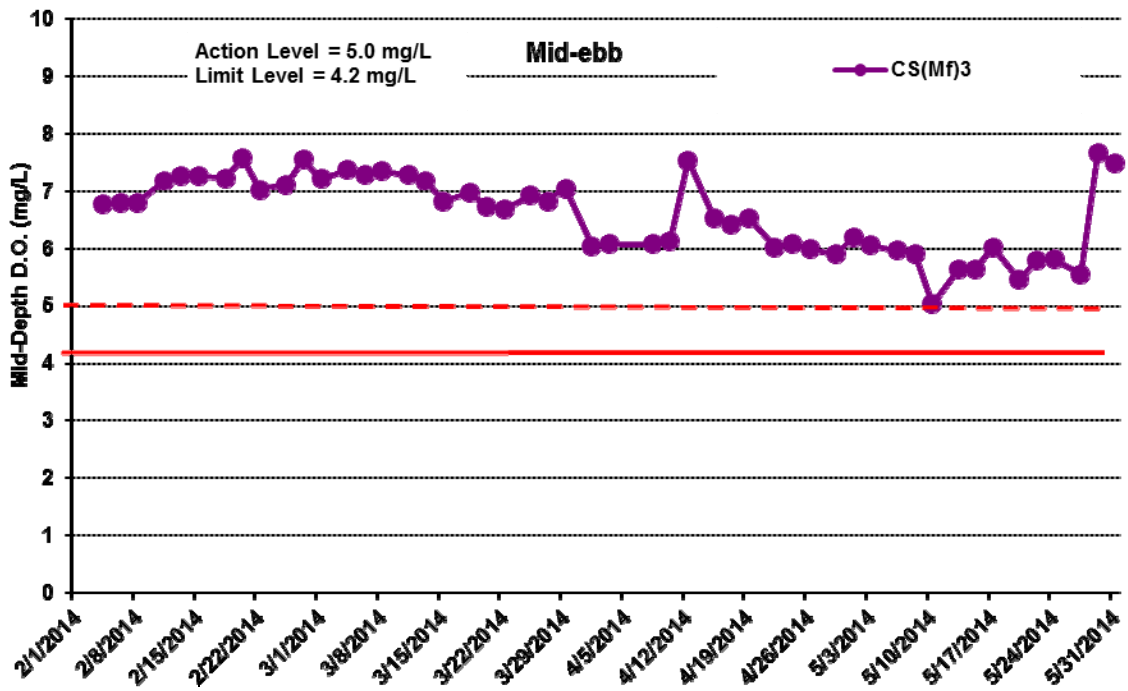
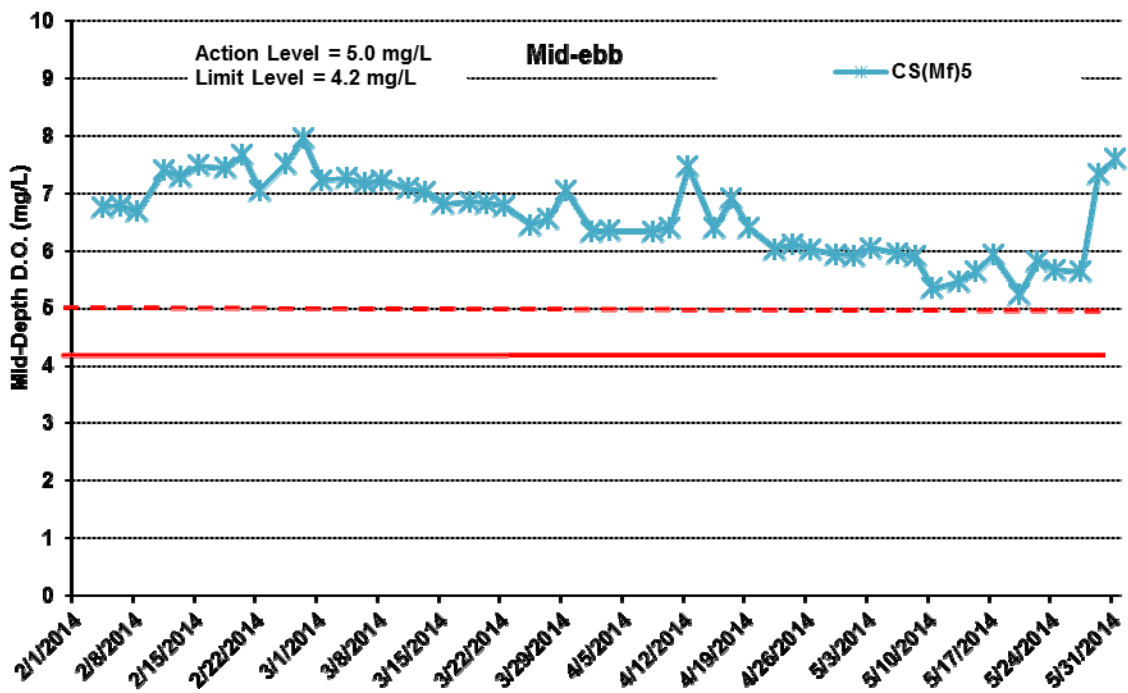
Figure H9 Impact Monitoring - Mean Level of Dissolved Oxygen (mg/L) in mid-depth waters during mid-ebb tide between 1 February to 31 May 2014 at CS(Mf)3 and IS(Mf)5.

(Weather condition varied between sunny to rainy within the reporting period. Marine works within the reporting period include rockfill platform construction, marine piling platform installation and survey tower erection.)

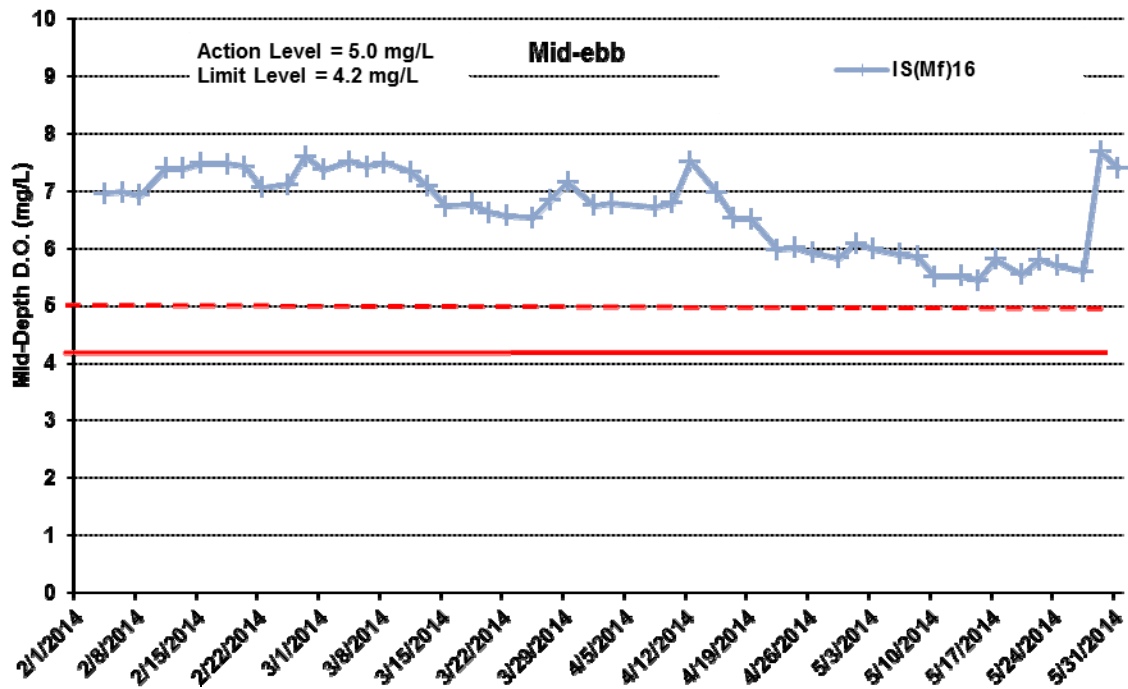
Figure H10 Impact Monitoring - Mean Level of Dissolved Oxygen (mg/L) in mid-depth waters during mid-ebb tide between 1 February to 31 May 2014 at IS(Mf)16.

(Weather condition varied between sunny to rainy within the reporting period. Marine works within the reporting period include rockfill platform construction, marine piling platform installation and survey tower erection.)

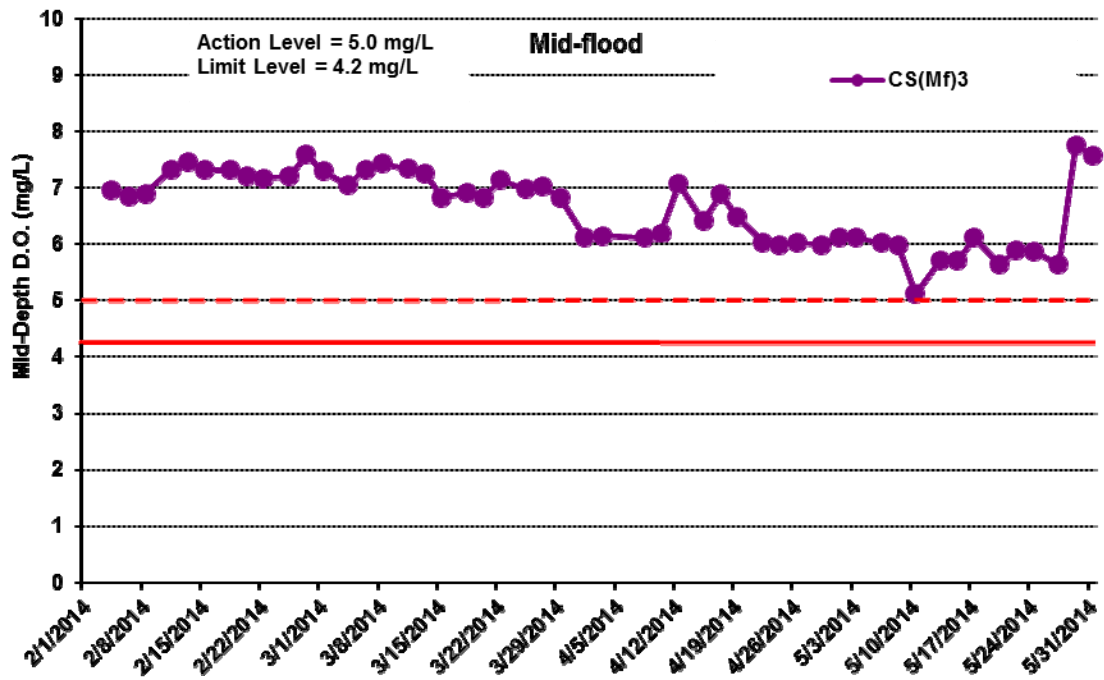
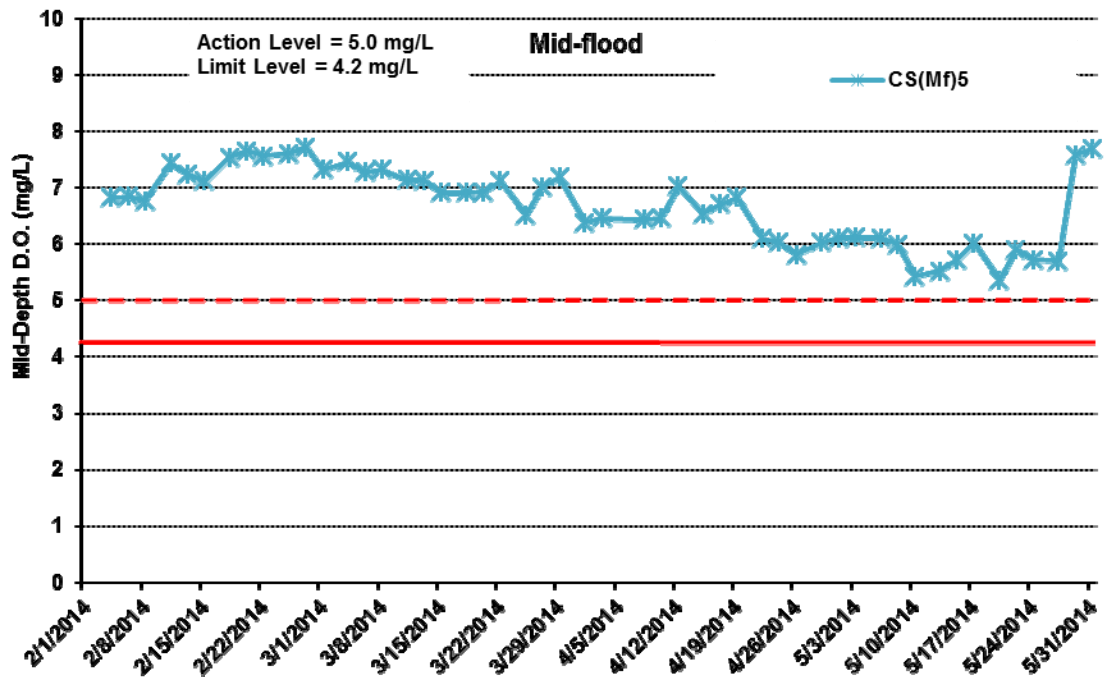
Figure H11 Impact Monitoring - Mean Level of Dissolved Oxygen (mg/L) in mid-depth waters during mid-flood tide between 1 February to 31 May 2014 at CS(Mf)3 and IS(Mf)5.

(Weather condition varied between sunny to rainy within the reporting period. Marine works within the reporting period include rockfill platform construction, marine piling platform installation and survey tower erection.)

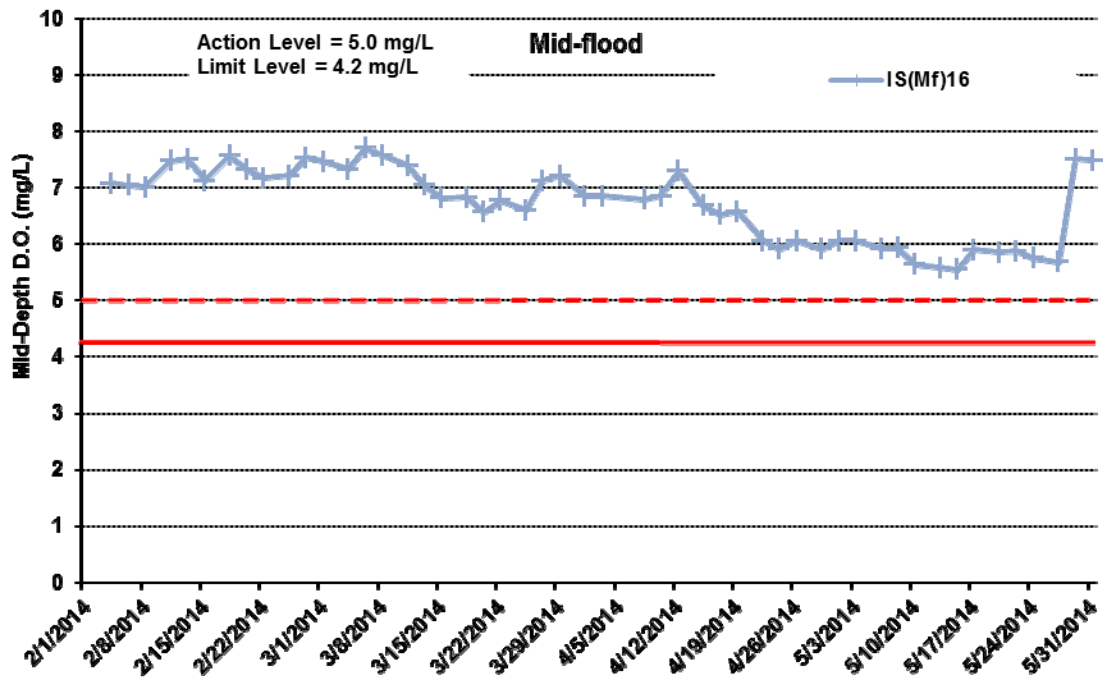
Figure H12 Impact Monitoring – Mean Level of Dissolved Oxygen (mg/L) in mid-depth waters during mid-flood tide between 1 February to 31 May 2014 at IS(Mf)16.

(Weather condition varied between sunny to rainy within the reporting period. Marine works within the reporting period include rockfill platform construction, marine piling platform installation and survey tower erection.)

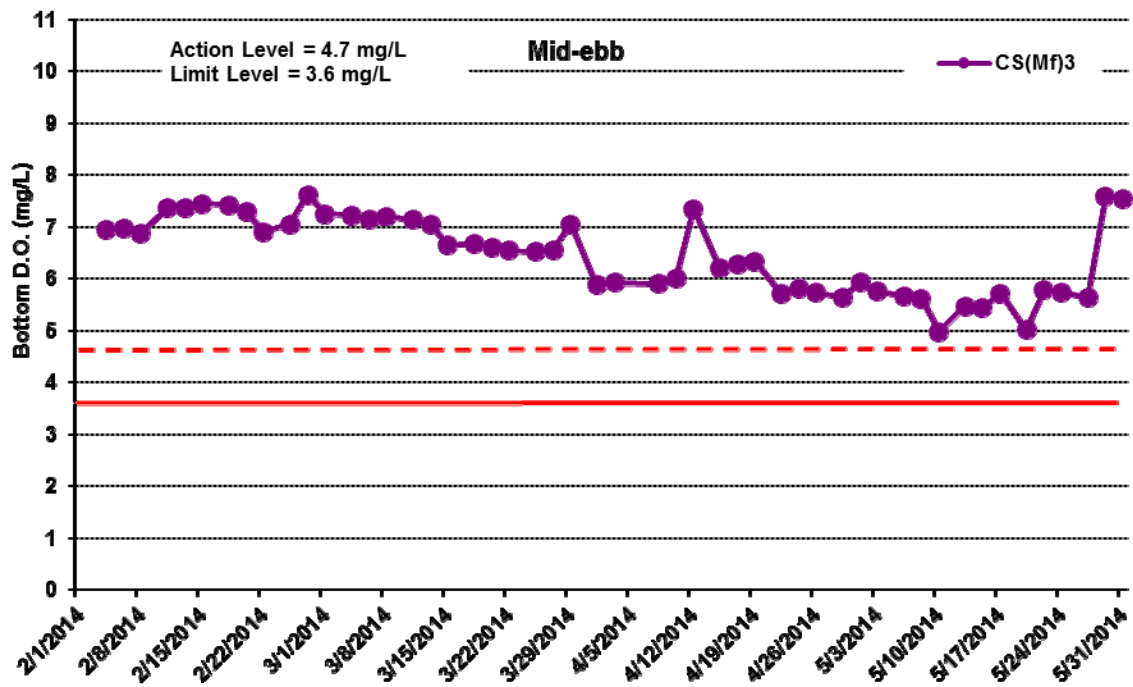
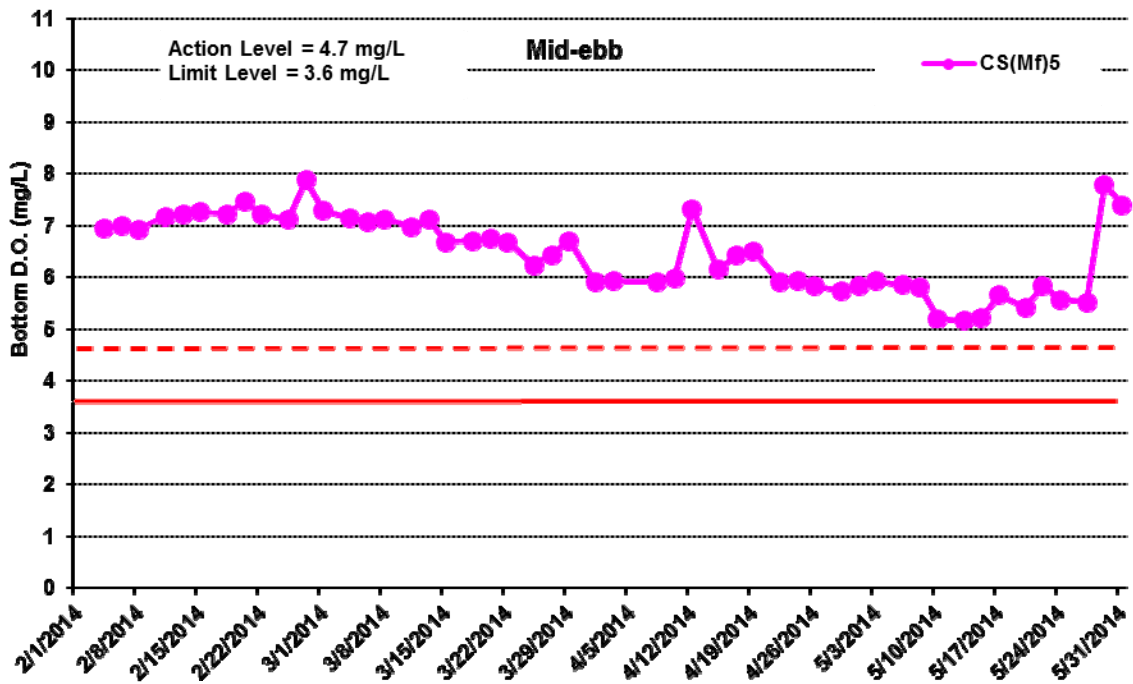
Figure H13 Impact Monitoring - Mean Level of Dissolved Oxygen (mg/L) in bottom waters during mid-ebb tide between 1 February to 31 May 2014 at CS(Mf)3 and CS(Mf)5.

(Weather condition varied between sunny to rainy within the reporting period. Marine works within the reporting period include rockfill platform construction, marine piling platform installation and survey tower erection.)

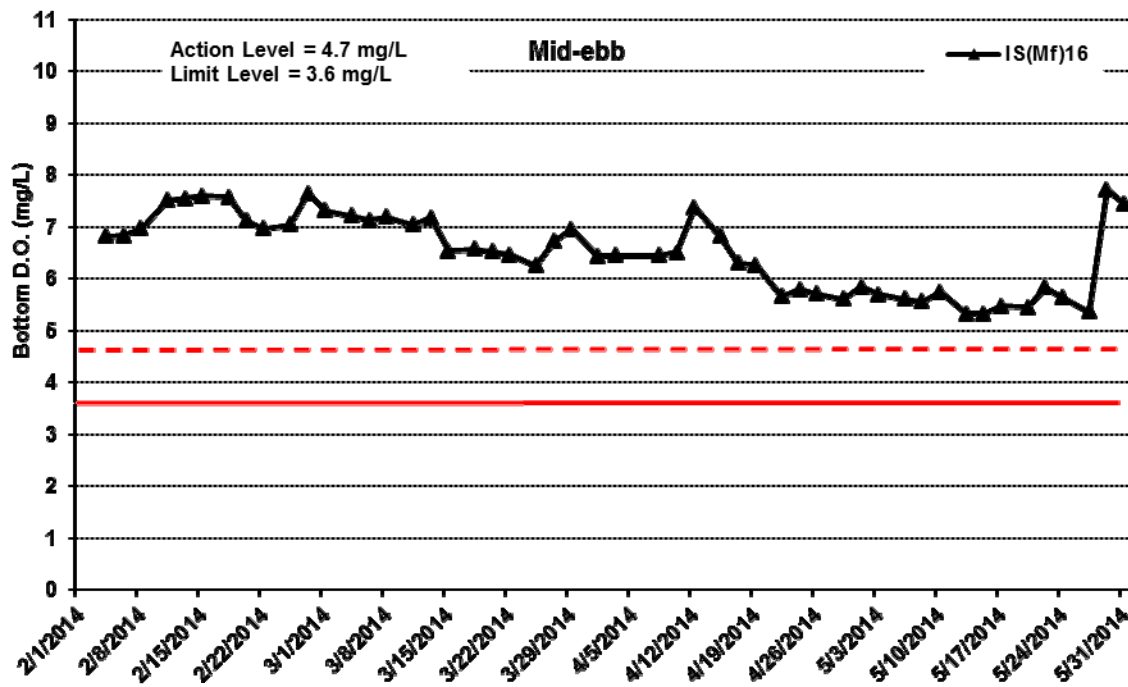
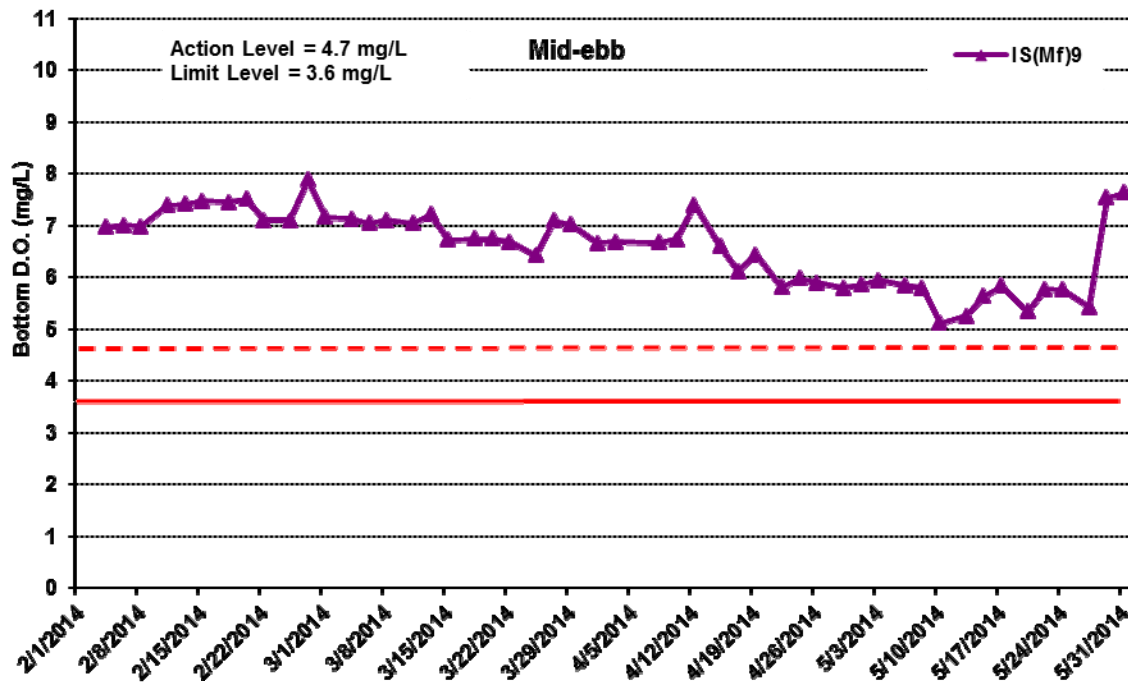
Figure H14 Impact Monitoring - Mean Level of Dissolved Oxygen (mg/L) in bottom waters during mid-ebb tide between 1 to 28 February 2014 at IS(Mf)16 and IS(Mf)9.

(Weather condition varied between sunny to rainy within the reporting period. Marine works within the reporting period include rockfill platform construction, marine piling platform installation and survey tower erection.)

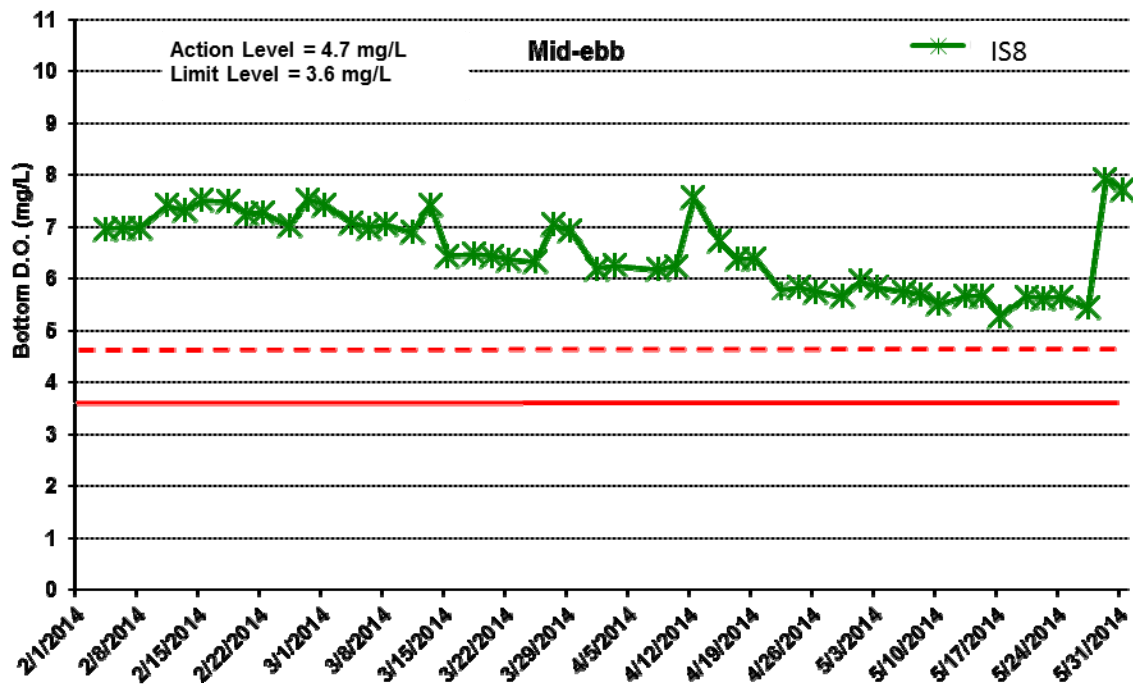
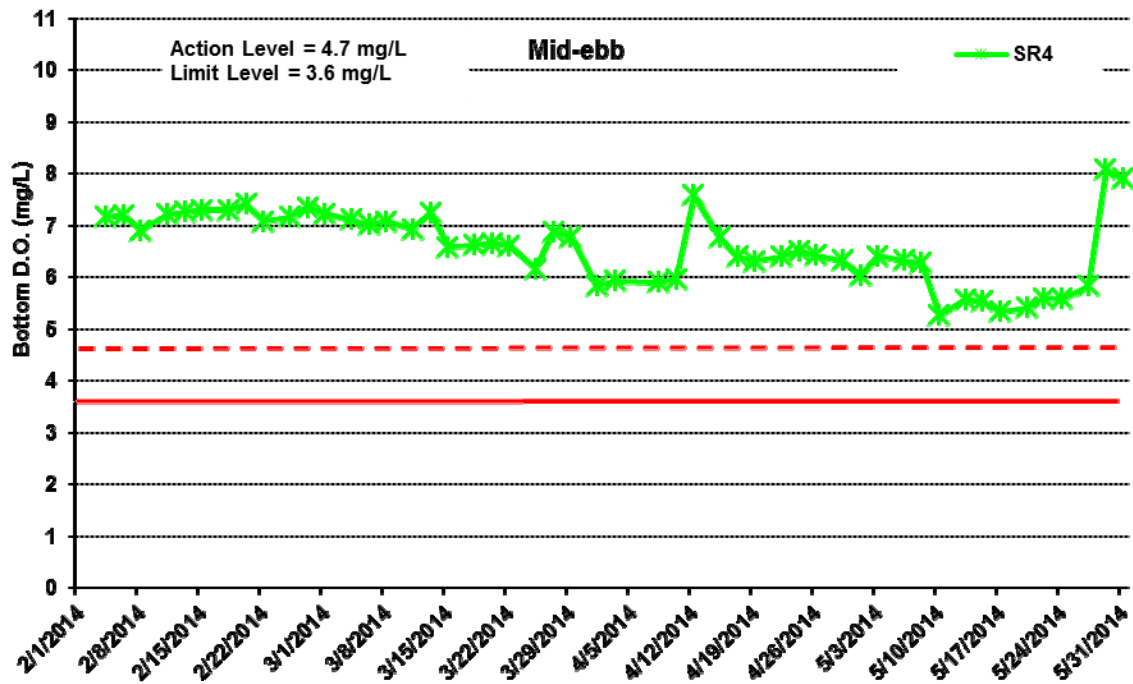
Figure H15 Impact Monitoring - Mean Level of Dissolved Oxygen (mg/L) in bottom waters during mid-ebb tide between 1 February to 31 May 2014 at IS8 and SR4.

(Weather condition varied between sunny to rainy within the reporting period. Marine works within the reporting period include rockfill platform construction, marine piling platform installation and survey tower erection.)

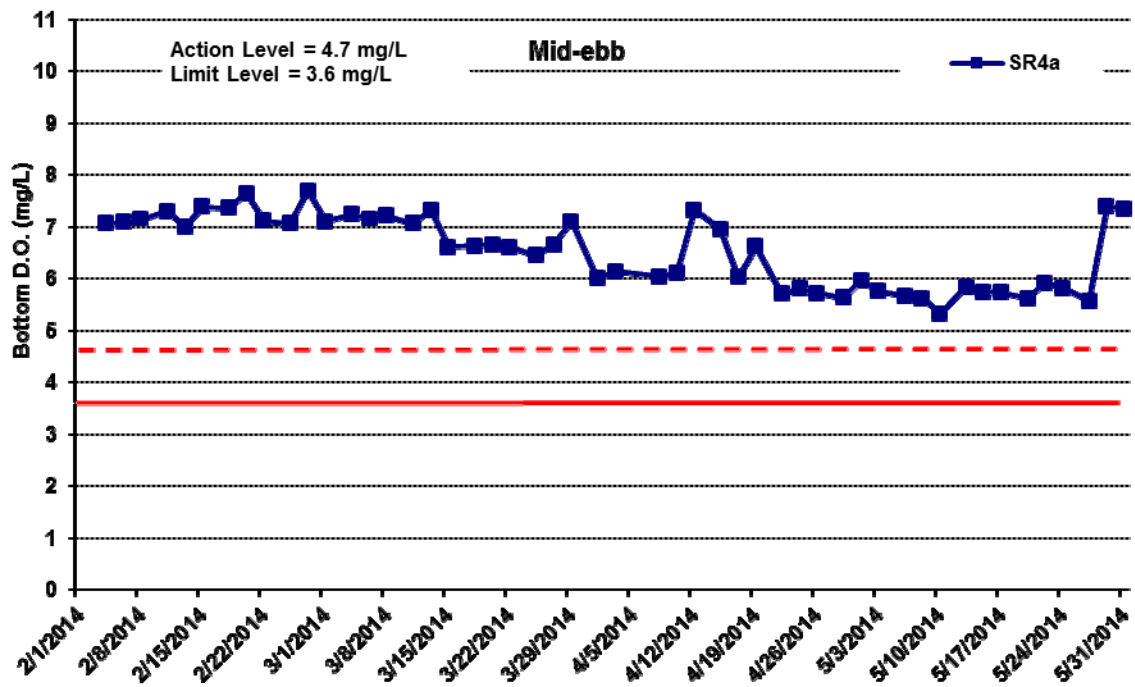
Figure H16 Impact Monitoring - Mean Level of Dissolved Oxygen (mg/L) in bottom waters during mid-ebb tide between 1 February to 31 May 2014 at SR4a.

(Weather condition varied between sunny to rainy within the reporting period. Marine works within the reporting period include rockfill platform construction, marine piling platform installation and survey tower erection.)
