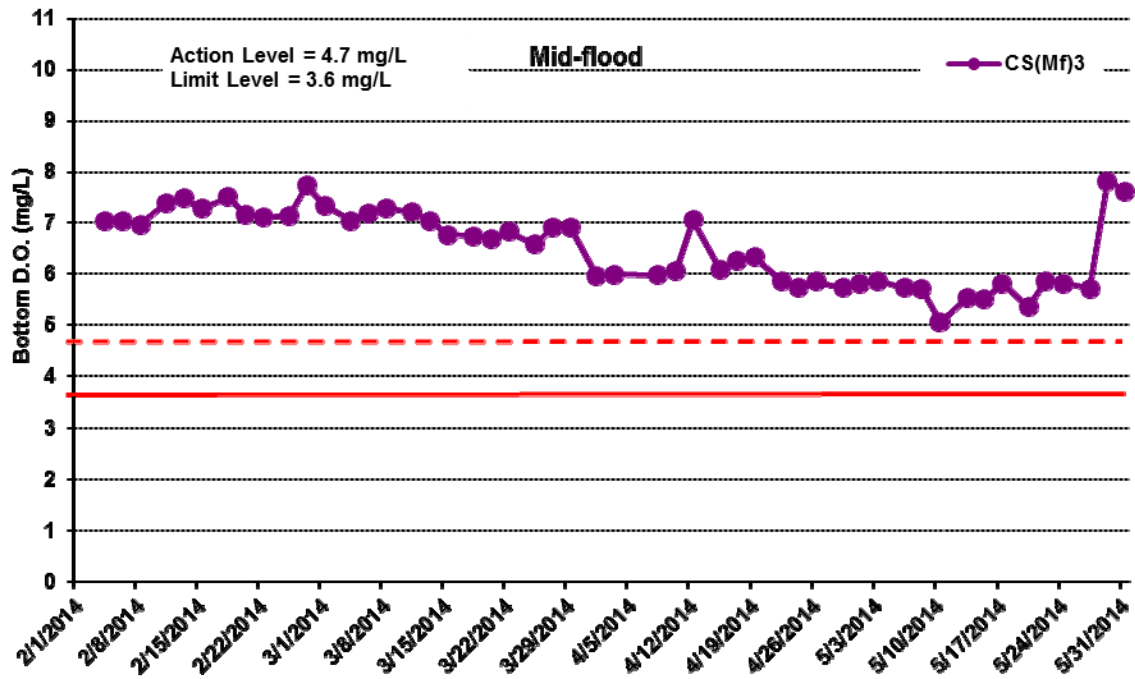
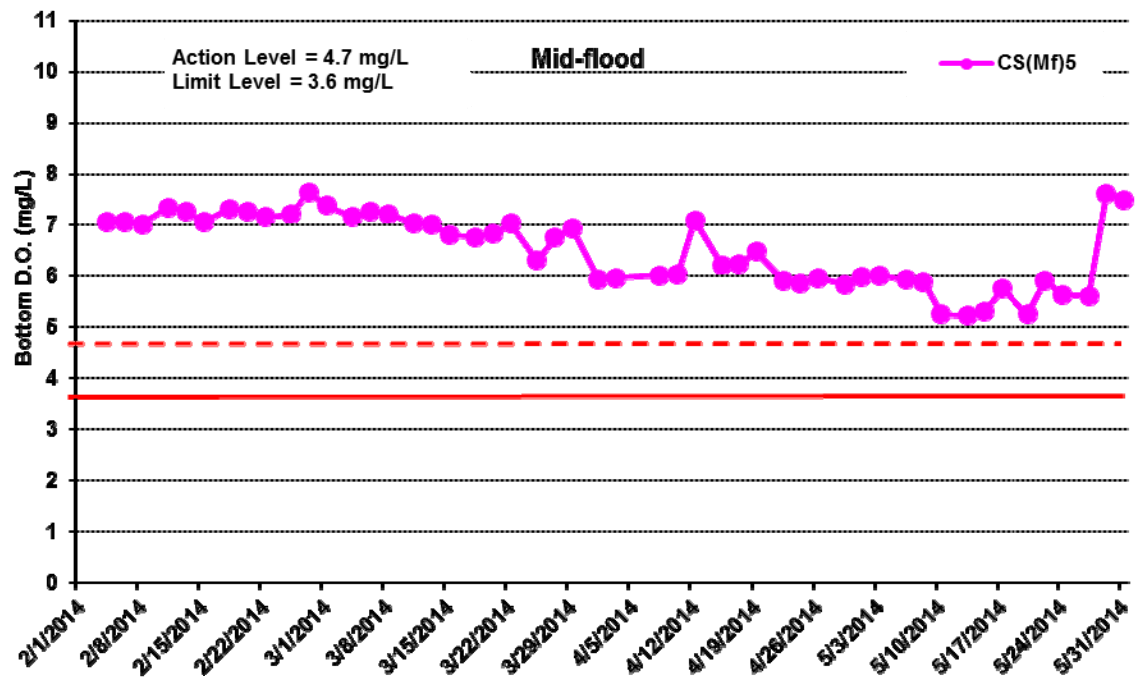
Figure H17 Impact Monitoring – Mean Level of Dissolved Oxygen (mg/L) in bottom waters during mid-flood tide between 1 February to 31 May 2014 at CS(Mf)3 and CS(Mf)5.

(Weather condition varied between sunny to rainy within the reporting period. Marine works within the reporting period include rockfill platform construction, marine piling platform installation and survey tower erection.)

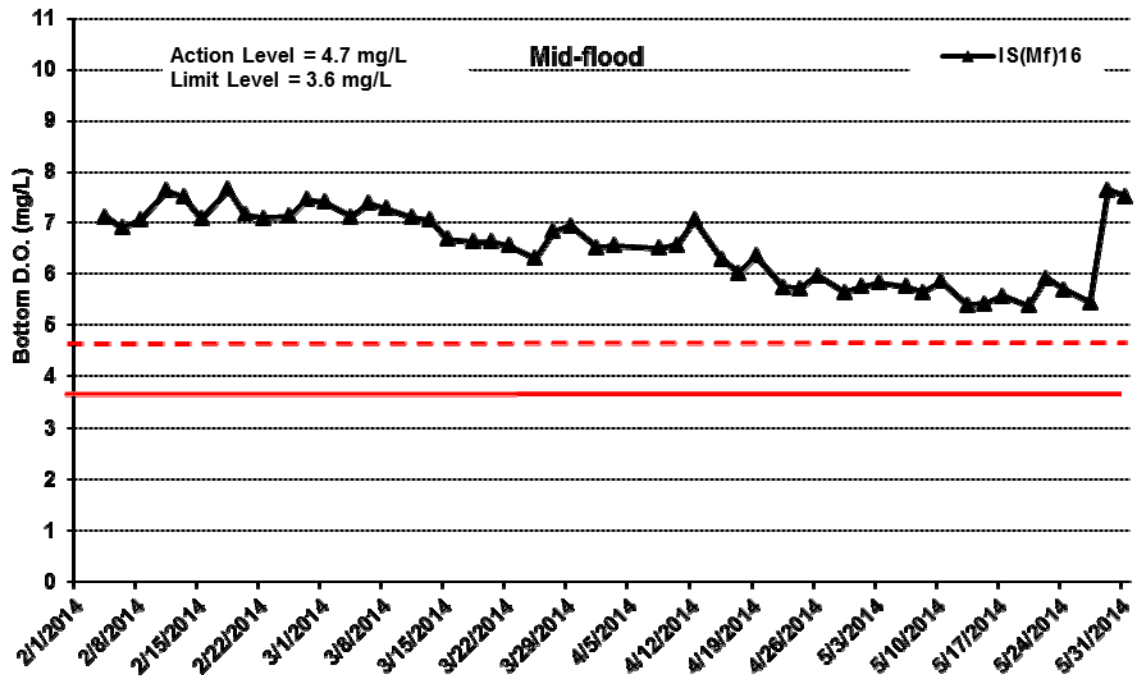
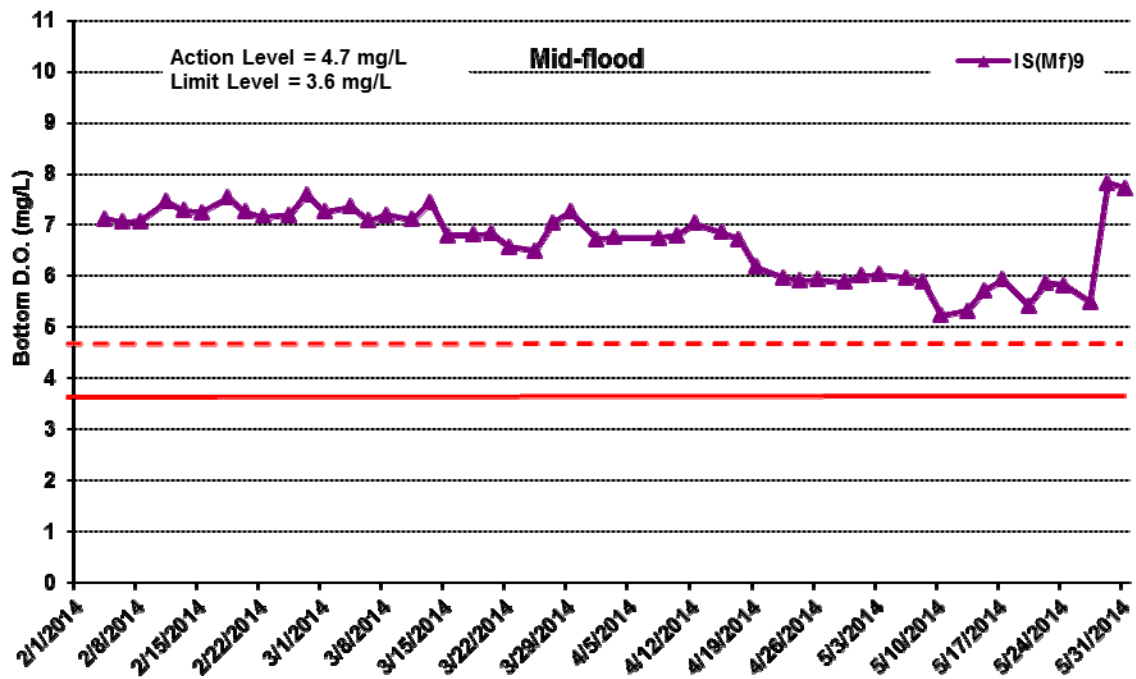
Figure H18 Impact Monitoring – Mean Level of Dissolved Oxygen (mg/L) in bottom waters during mid-flood tide between 1 February to 31 May 2014 at IS(Mf)16 and IS(Mf)9.

(Weather condition varied between sunny to rainy within the reporting period. Marine works within the reporting period include rockfill platform construction, marine piling platform installation and survey tower erection.)

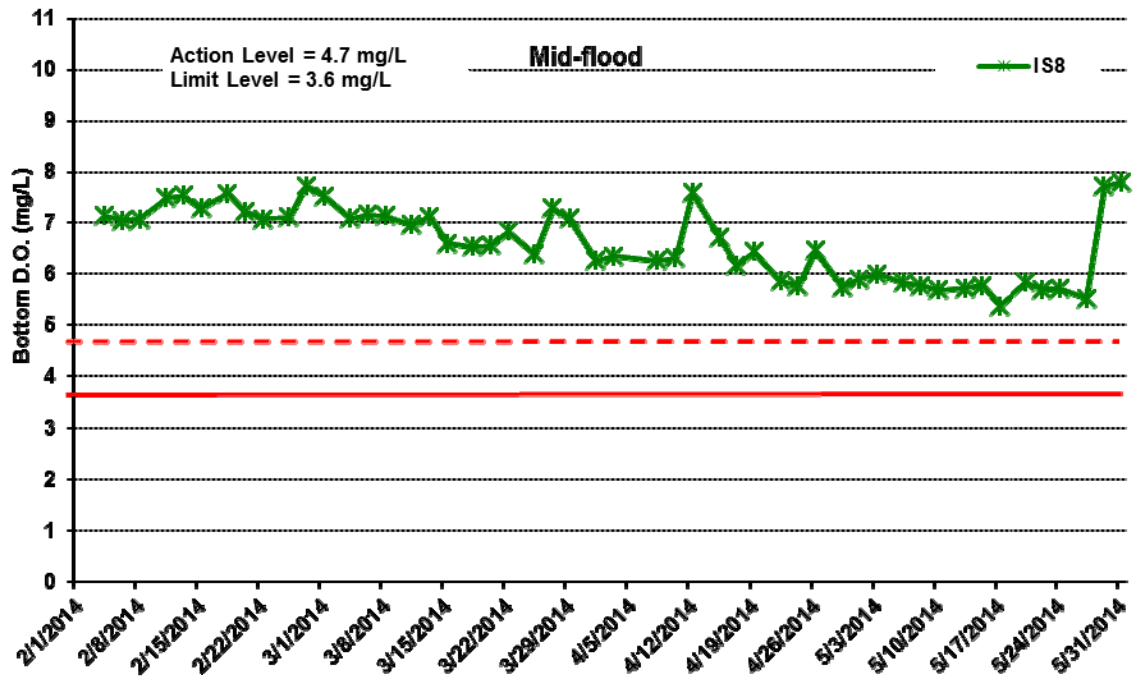
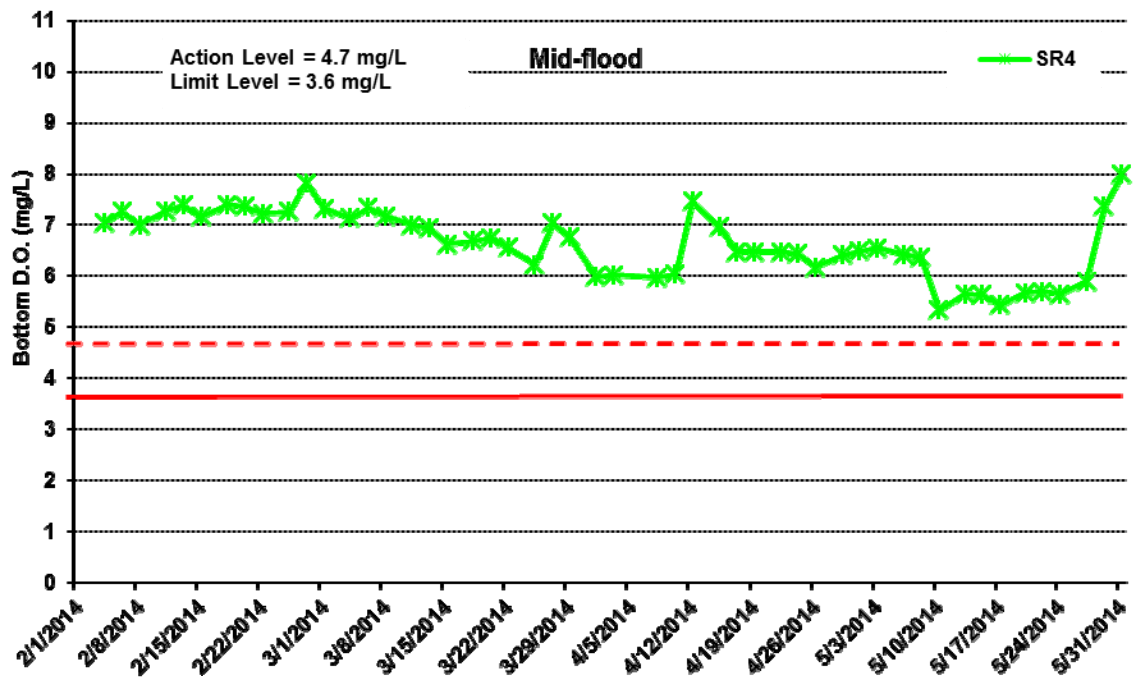
Figure H19 Impact Monitoring - Mean Level of Dissolved Oxygen (mg/L) in bottom waters during mid-flood tide between 1 February to 31 May 2014 at IS8 and SR4.

(Weather condition varied between sunny to rainy within the reporting period. Marine works within the reporting period include rockfill platform construction, marine piling platform installation and survey tower erection.)

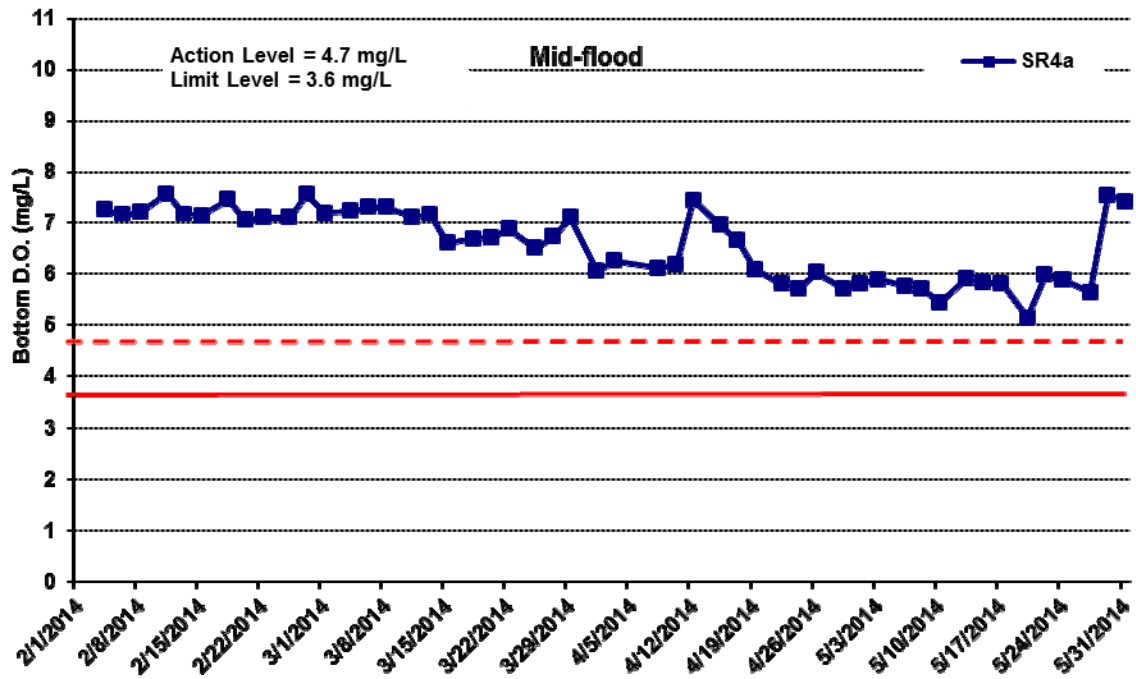
Figure H20 Impact Monitoring - Mean Level of Dissolved Oxygen (mg/L) in bottom waters during mid-flood tide between 1 February to 31 May 2014 at SR4a.

(Weather condition varied between sunny to rainy within the reporting period. Marine works within the reporting period include rockfill platform construction, marine piling platform installation and survey tower erection.)

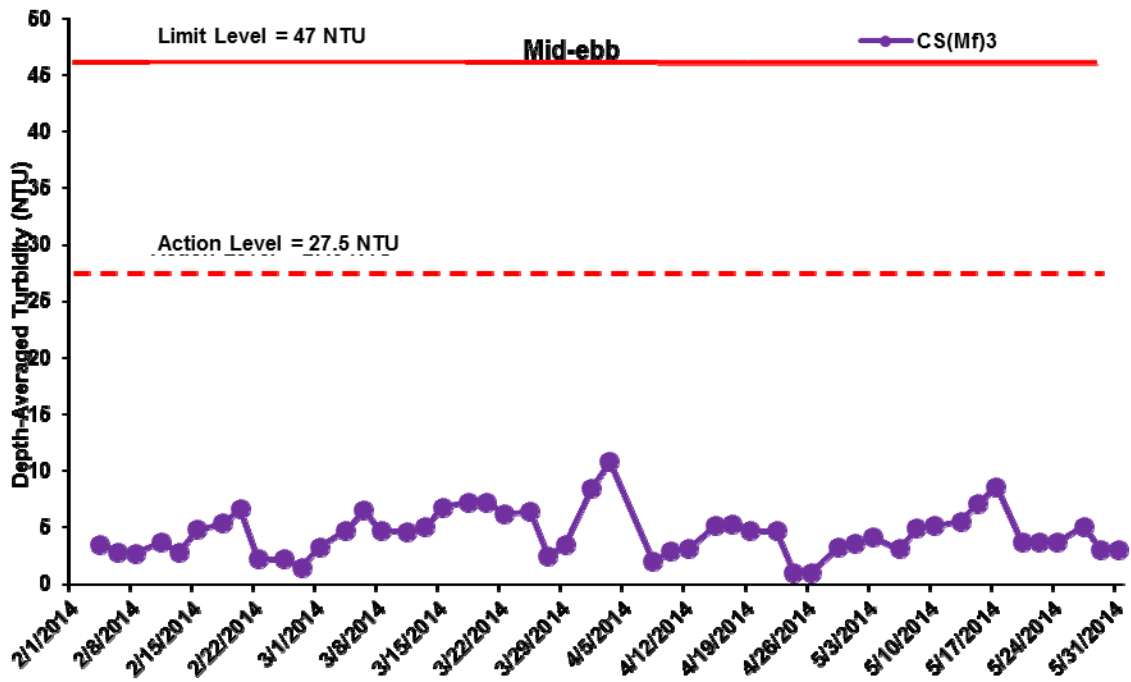
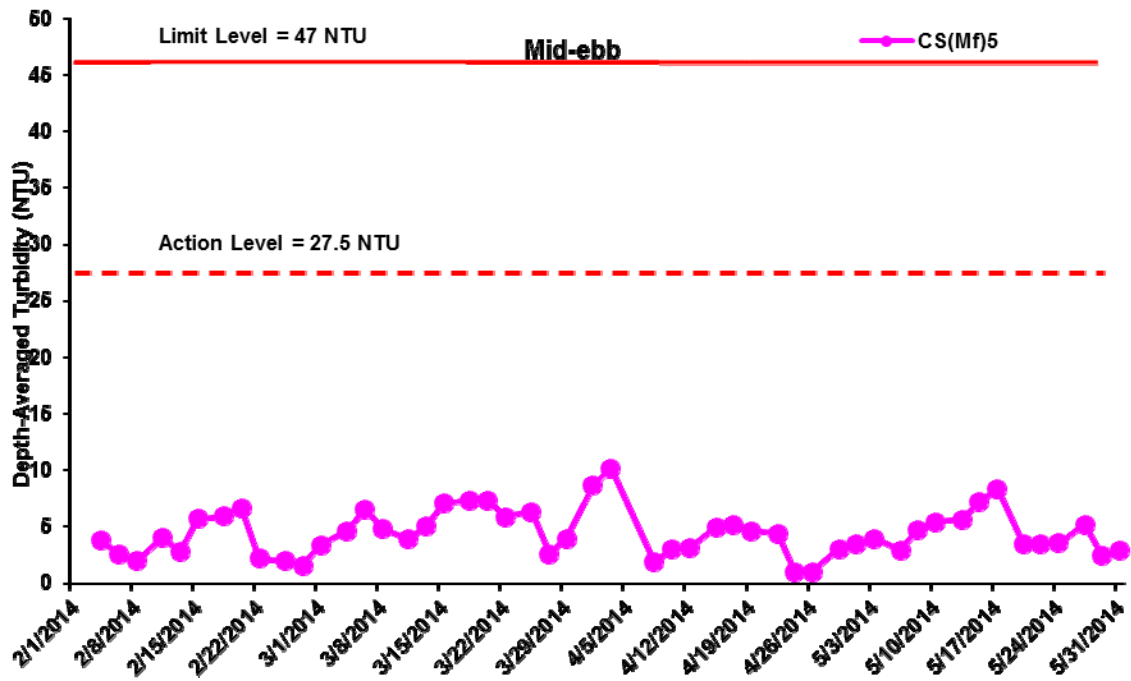
Figure H21 Impact Monitoring – Mean Level of depth-averaged Turbidity (NTU) during mid-ebb tide between 1 February to 31 May 2014 at CS(Mf)3 and CS(Mf)5.

(Weather condition varied between sunny to rainy within the reporting period. Marine works within the reporting period include rockfill platform construction, marine piling platform installation and survey tower erection.)

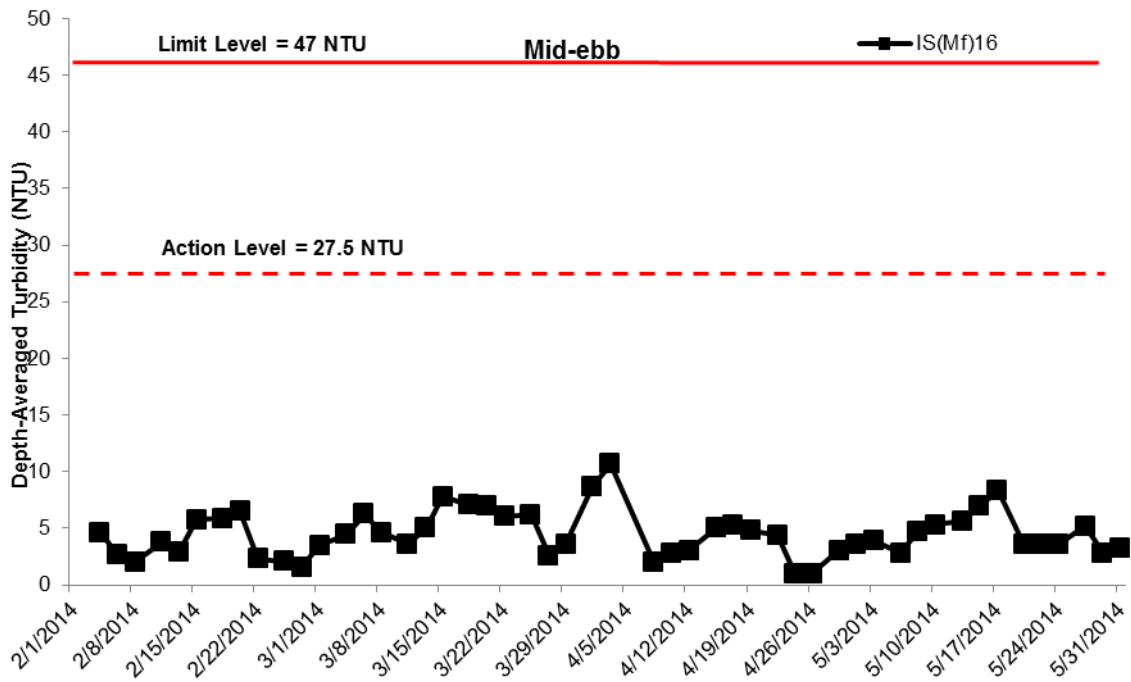
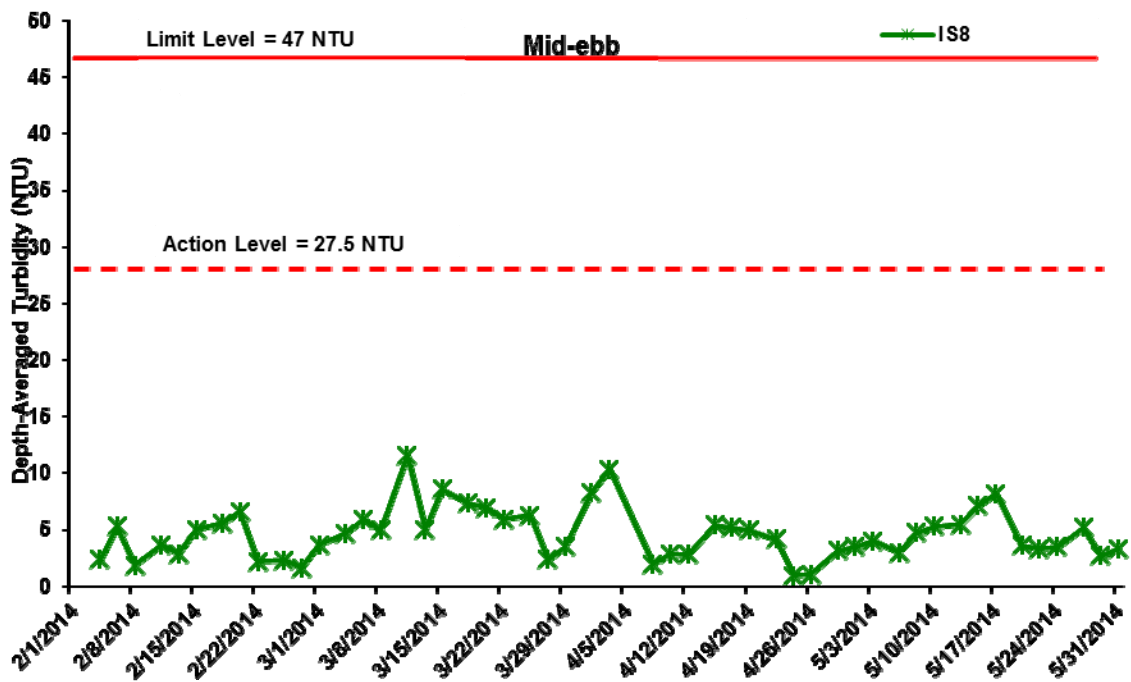
Figure H22 Impact Monitoring - Mean Level of depth-averaged Turbidity (NTU) during mid-ebb tide between 1 February to 31 May 2014 at IS(Mf)16 and IS(Mf)9.

(Weather condition varied between sunny to rainy within the reporting period. Marine works within the reporting period include rockfill platform construction, marine piling platform installation and survey tower erection.)

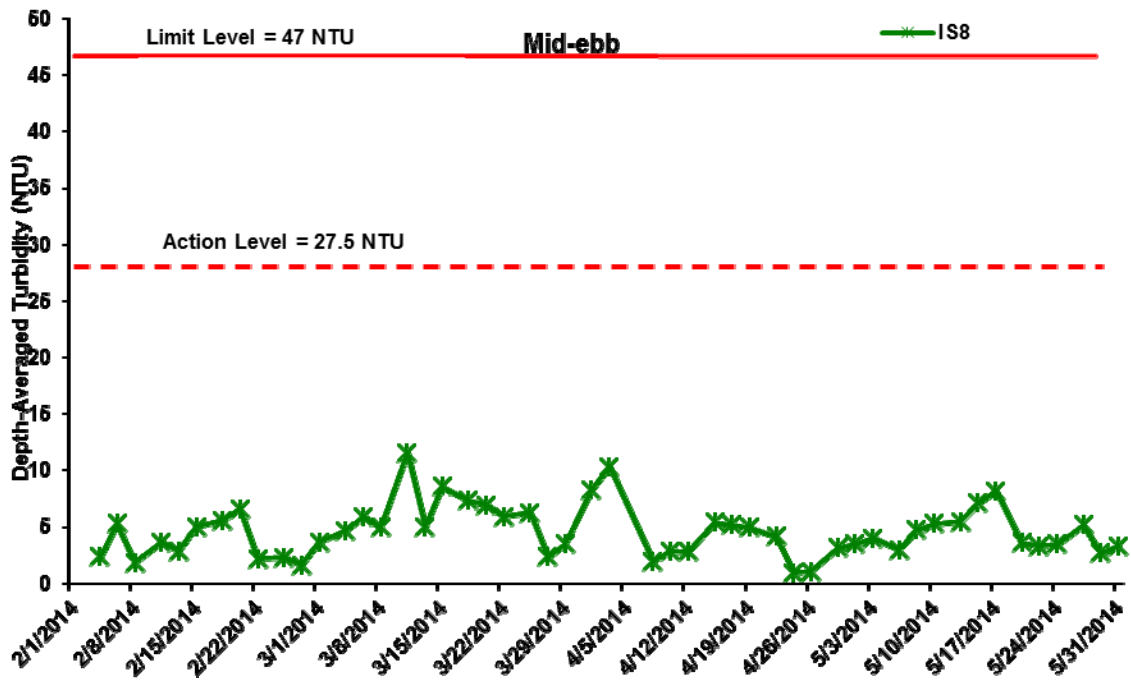
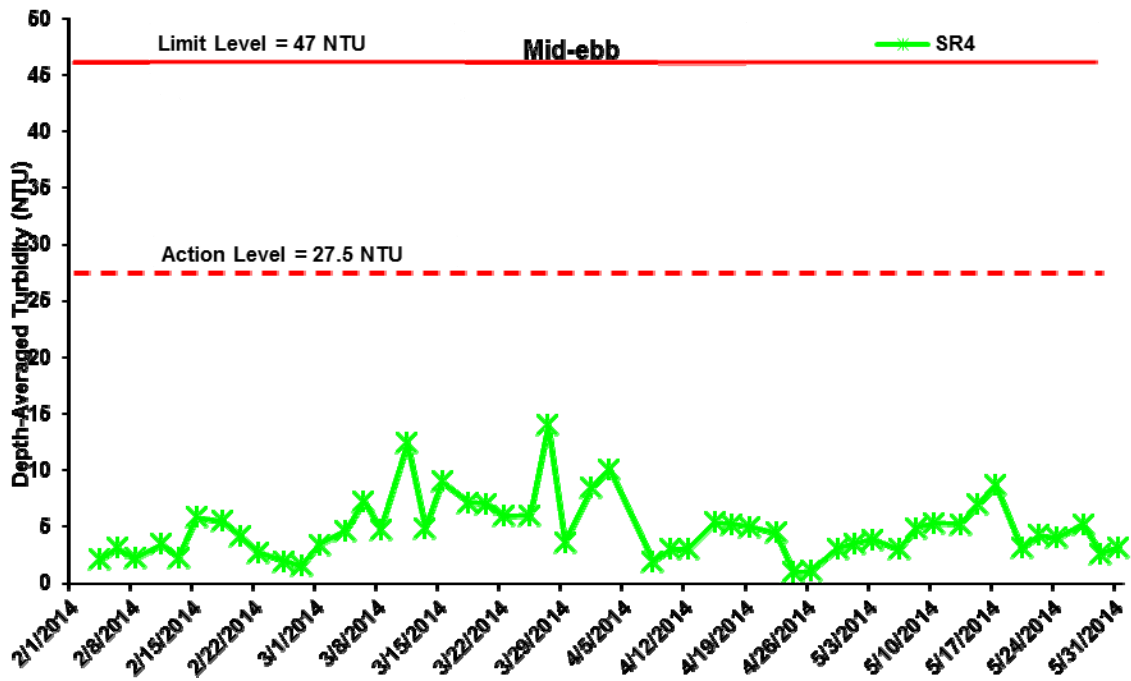
Figure H23 Impact Monitoring – Mean Level of depth-averaged Turbidity (NTU) during mid-ebb tide between 1 February to 31 May 2014 at IS8 and SR4.

(Weather condition varied between sunny to rainy within the reporting period. Marine works within the reporting period include rockfill platform construction, marine piling platform installation and survey tower erection.)

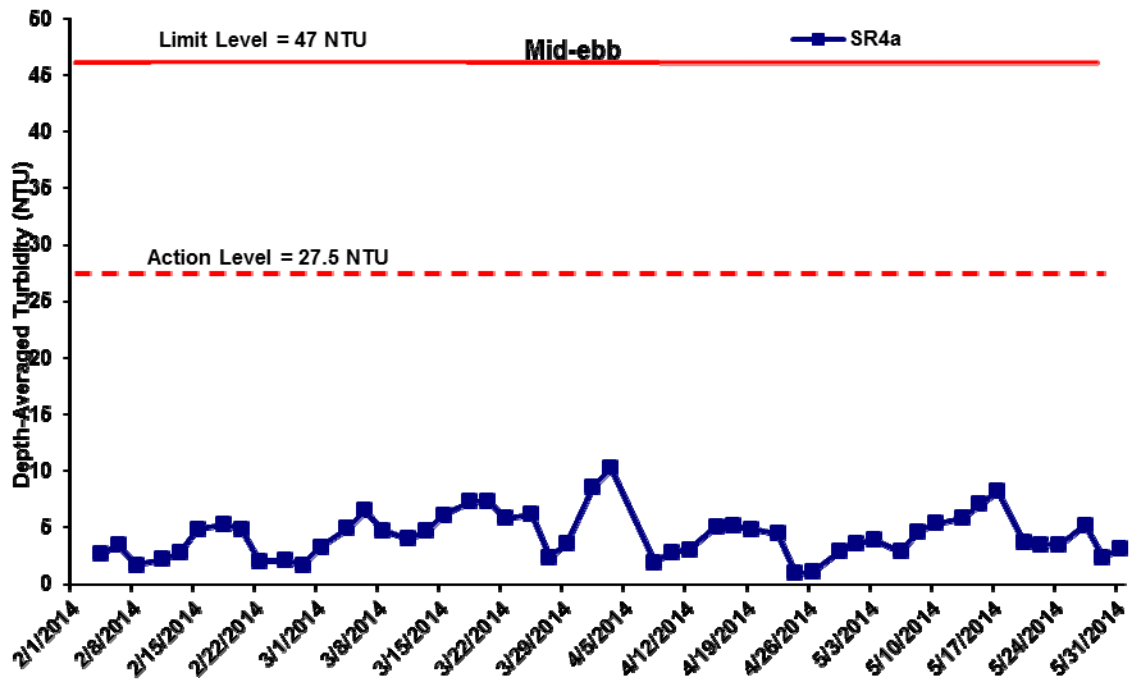
Figure H24 Impact Monitoring - Mean Level of depth-averaged Turbidity (NTU) during mid-ebb tide between 1 February to 31 May 2014 at SR4a.

(Weather condition varied between sunny to rainy within the reporting period. Marine works within the reporting period include rockfill platform construction, marine piling platform installation and survey tower erection.)

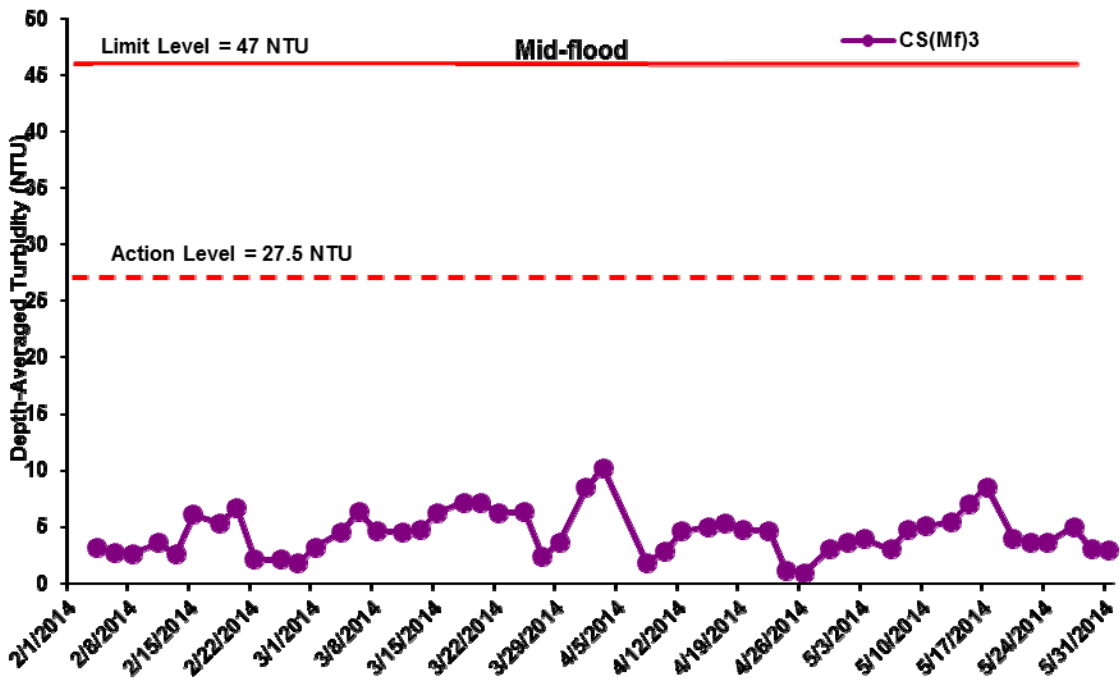
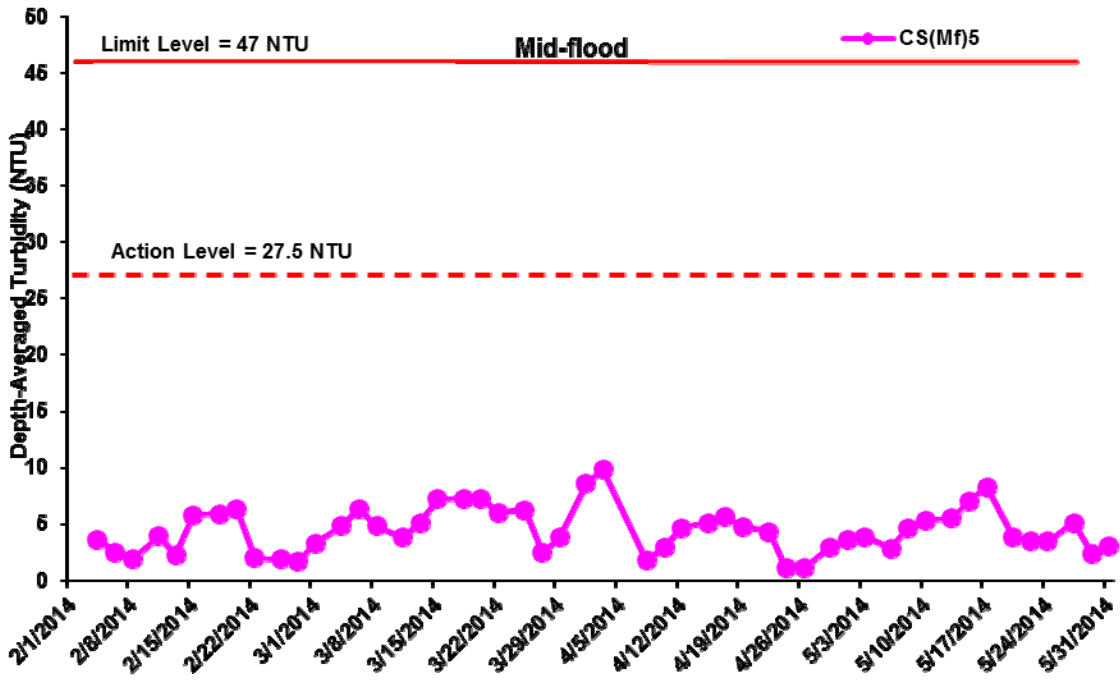
Figure H25 Impact Monitoring - Mean Level of depth-averaged Turbidity (NTU) during mid-flood tide between 1 February to 31 May 2014 at CS(Mf)3 and CS(Mf)5.

(Weather condition varied between sunny to rainy within the reporting period. Marine works within the reporting period include rockfill platform construction, marine piling platform installation and survey tower erection.)

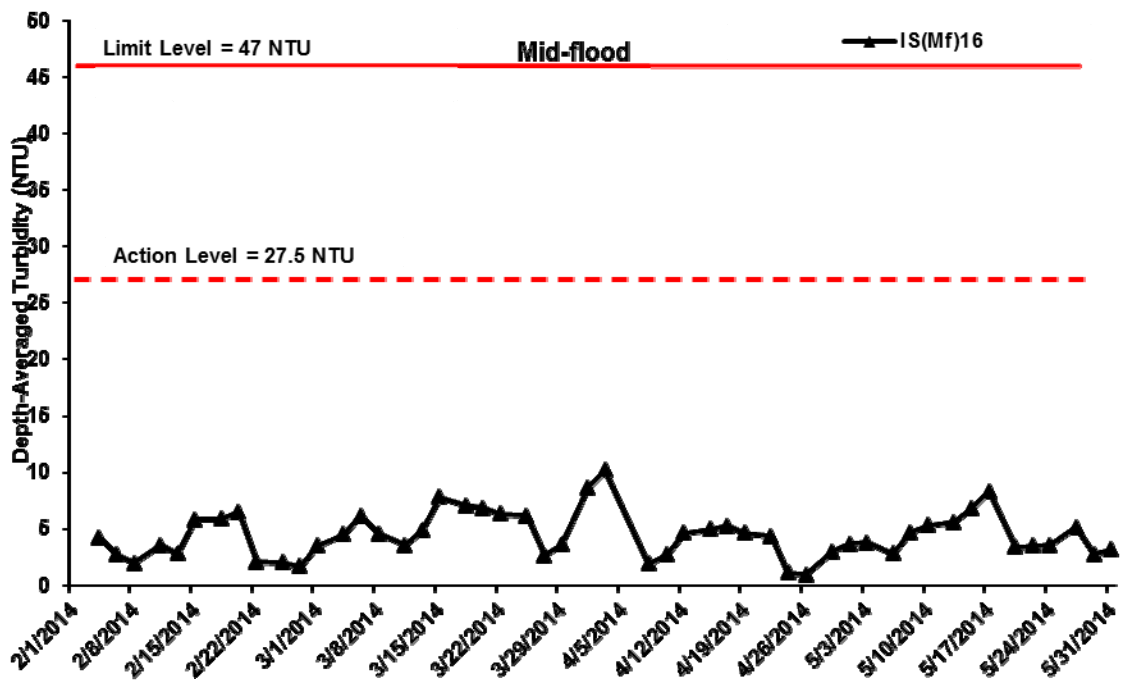
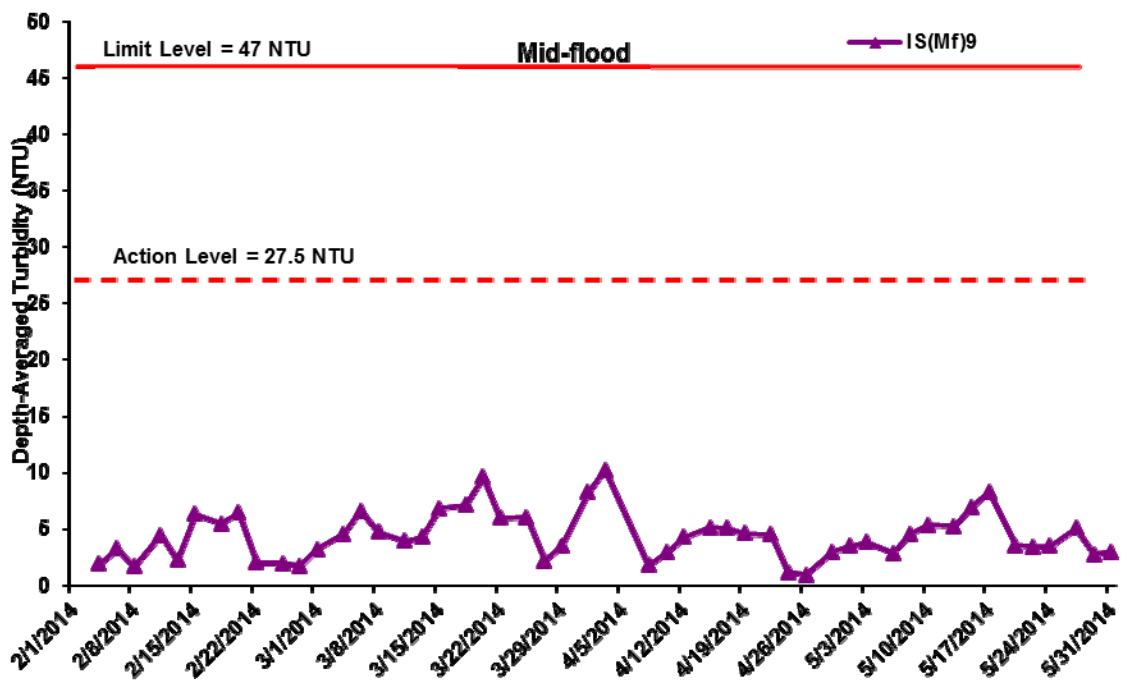
Figure H26 Impact Monitoring - Mean Level of depth-averaged Turbidity (NTU) during mid-flood tide between 1 February to 31 May 2014 at IS(Mf)16 and IS(Mf)9.

(Weather condition varied between sunny to rainy within the reporting period. Marine works within the reporting period include rockfill platform construction, marine piling platform installation and survey tower erection.)

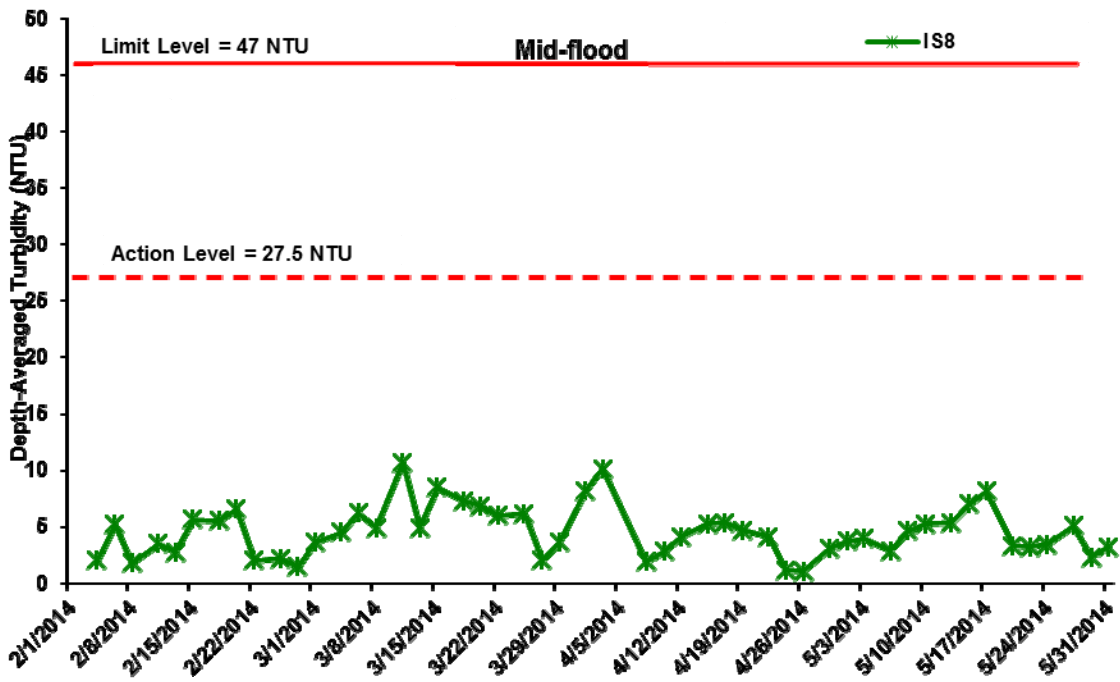
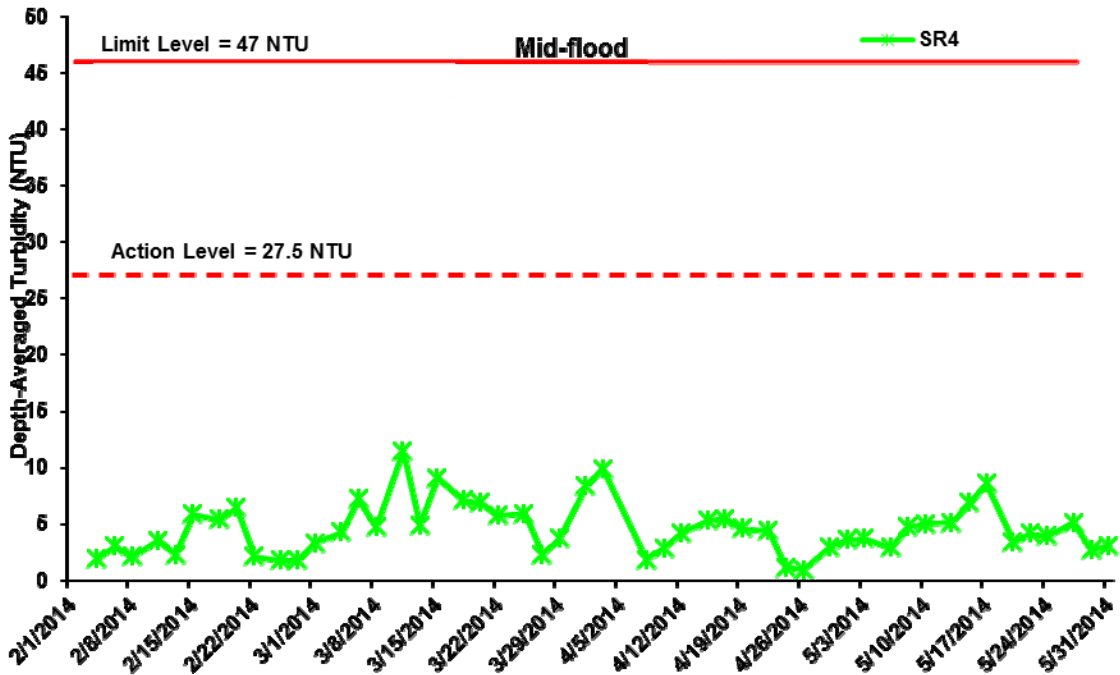
Figure H27 Impact Monitoring - Mean Level of depth-averaged Turbidity (NTU) during mid-flood tide between 1 February to 31 May 2014 at IS8 and SR4.

(Weather condition varied between sunny to rainy within the reporting period. Marine works within the reporting period include rockfill platform construction, marine piling platform installation and survey tower erection.)

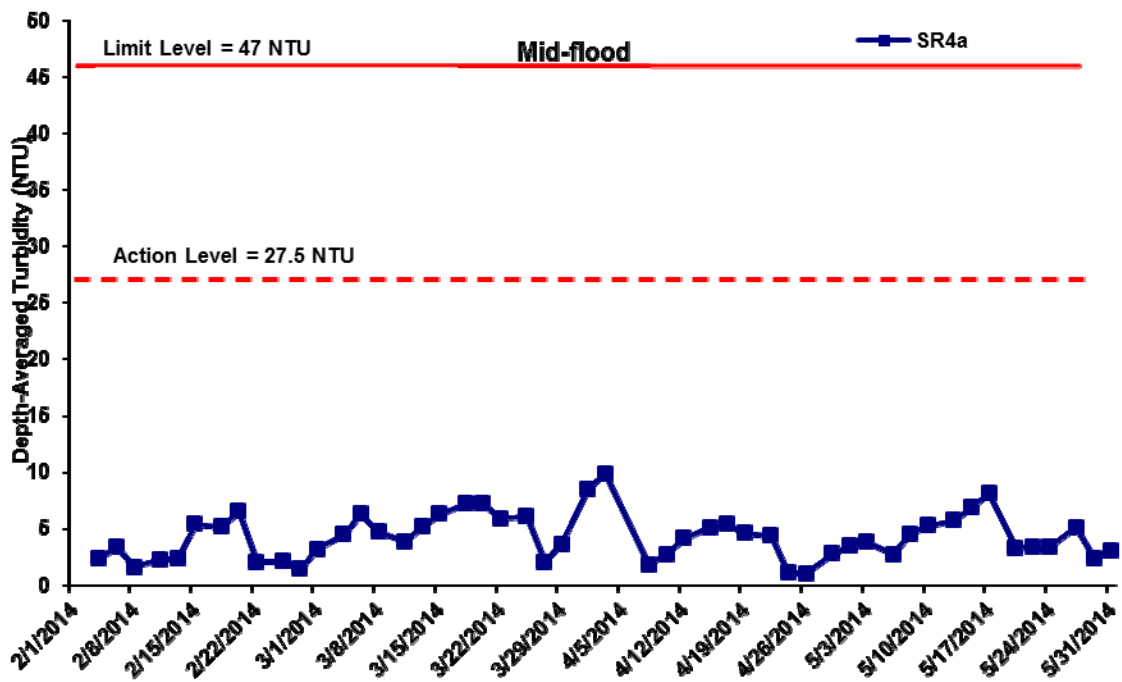
Figure H28 Impact Monitoring - Mean Level of depth-averaged Turbidity (NTU) during mid-flood tide between 1 February to 31 May 2014 at SR4a.

(Weather condition varied between sunny to rainy within the reporting period. Marine works within the reporting period include rockfill platform construction, marine piling platform installation and survey tower erection.)

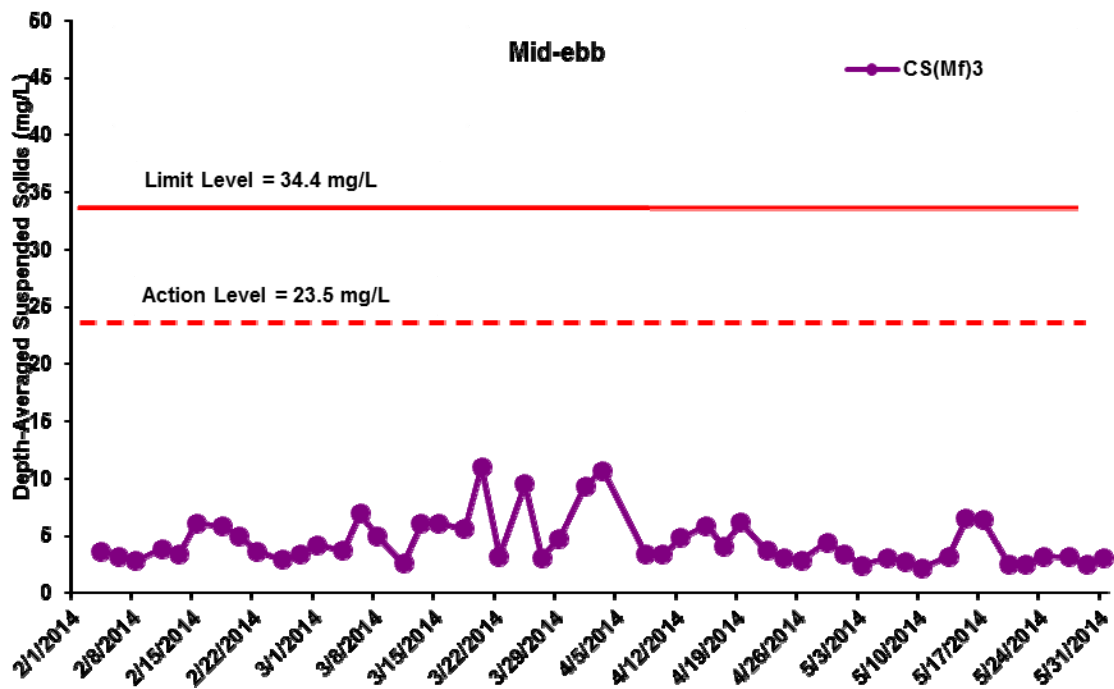
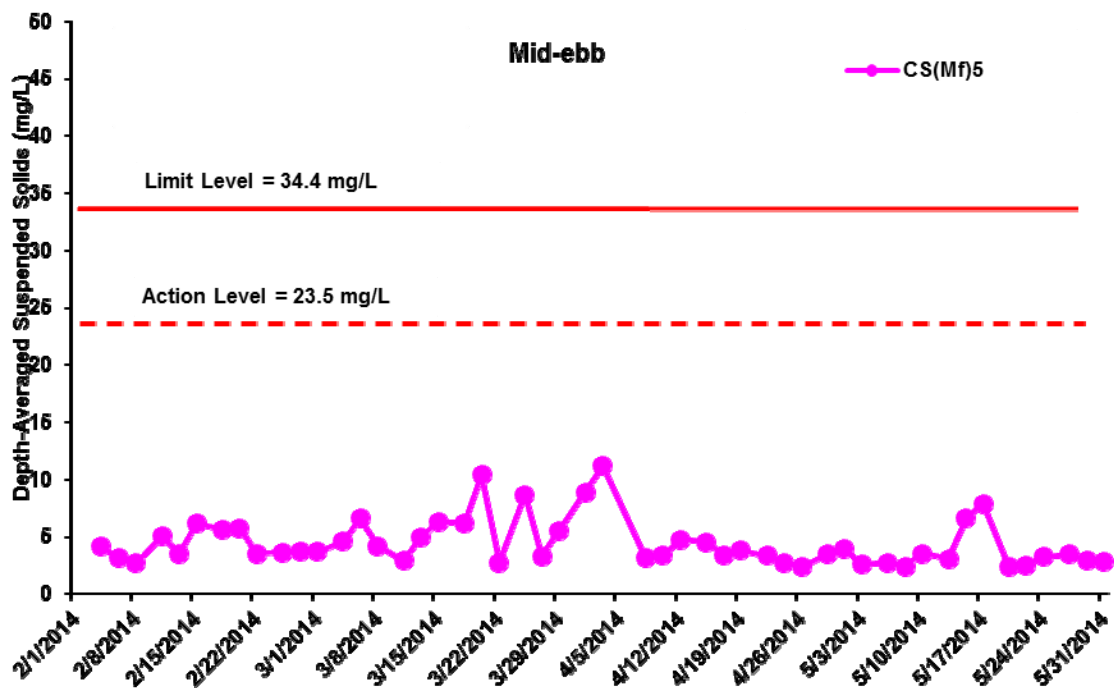
Figure H29 Impact Monitoring - Mean Level of depth-averaged Suspended Solids (mg/L) during mid-ebb tide between 1 February to 31 May 2014 at CS(Mf)3 and CS(Mf)5.

(Weather condition varied between sunny to rainy within the reporting period. Marine works within the reporting period include rockfill platform construction, marine piling platform installation and survey tower erection.)

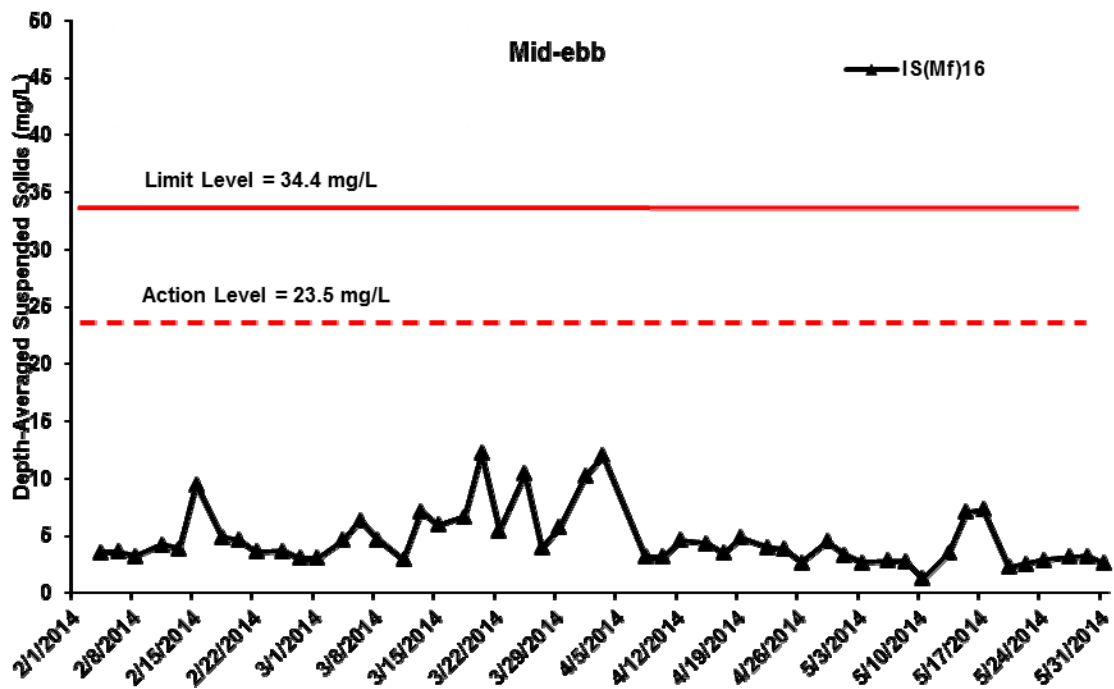
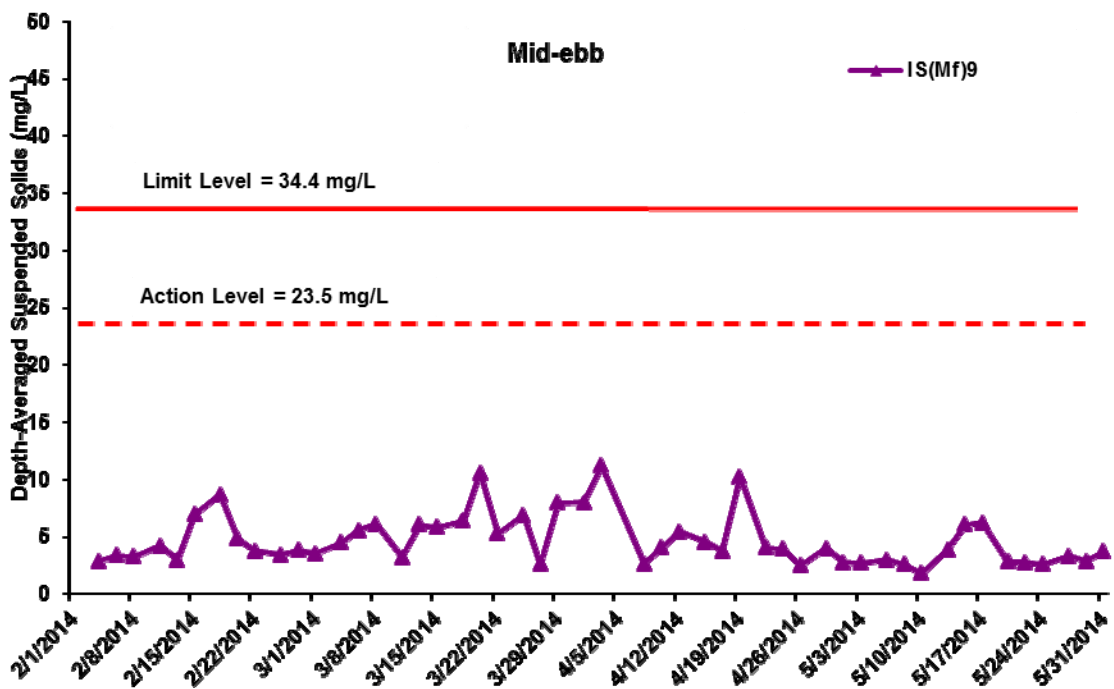
Figure H30 Impact Monitoring - Mean Level of depth-averaged Suspended Solids (mg/L) during mid-ebb tide between 1 February to 31 May 2014 at IS(Mf)16 and IS(Mf)9.

(Weather condition varied between sunny to rainy within the reporting period. Marine works within the reporting period include rockfill platform construction, marine piling platform installation and survey tower erection.)

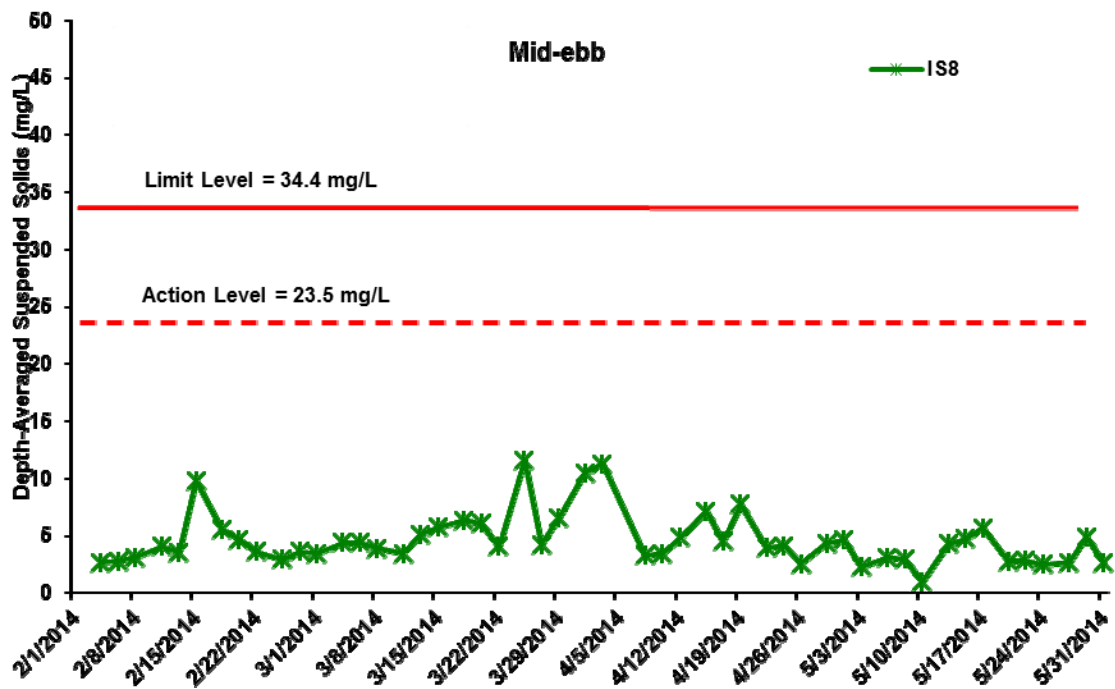
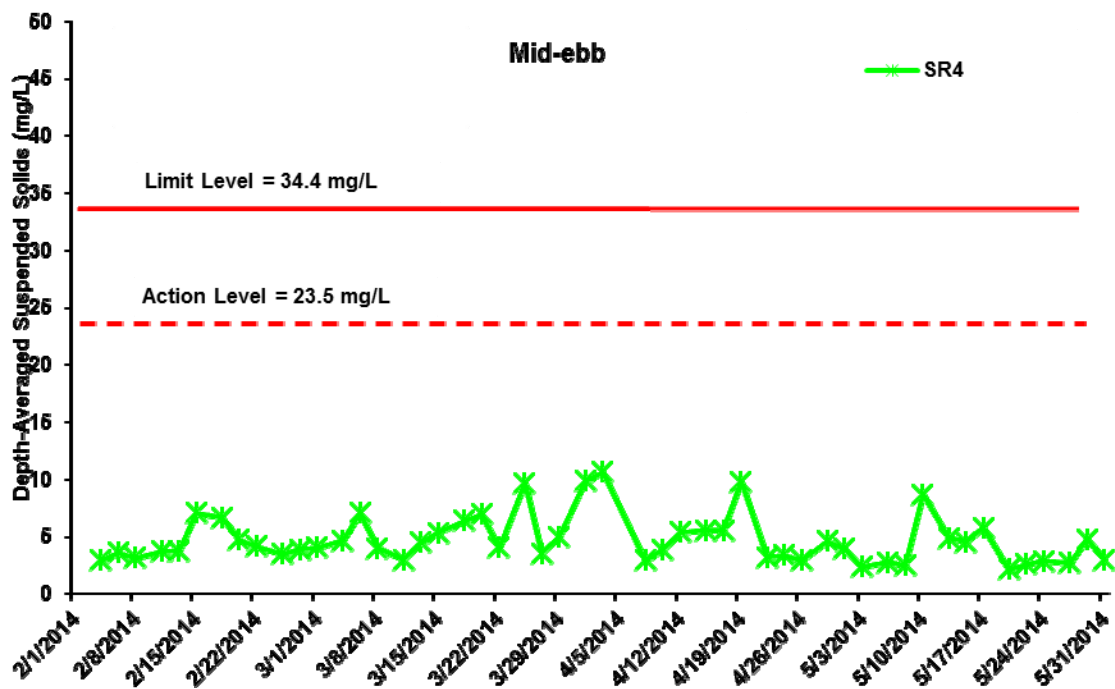
Figure H31 Impact Monitoring - Mean Level of depth-averaged Suspended Solids (mg/L) during mid-ebb tide between 1 February to 31 May 2014 at IS8 and SR4.

(Weather condition varied between sunny to rainy within the reporting period. Marine works within the reporting period include rockfill platform construction, marine piling platform installation and survey tower erection.)

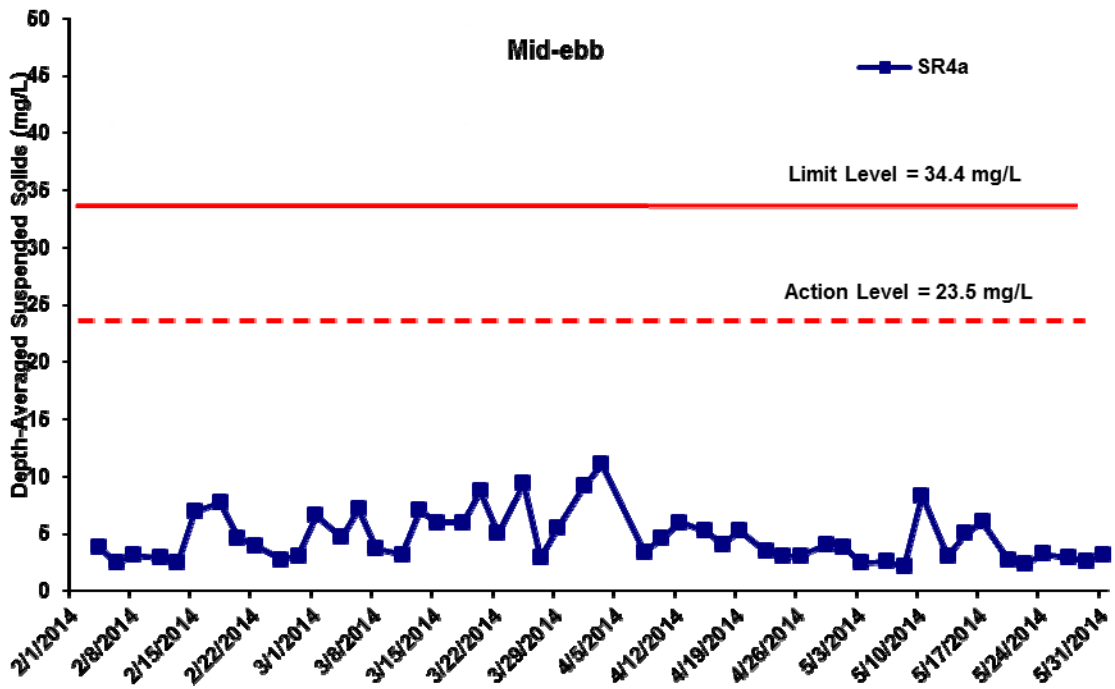
Figure H32 Impact Monitoring - Mean Level of depth-averaged Suspended Solids (mg/L) during mid-ebb tide between 1 February to 31 May 2014 at SR4a.

(Weather condition varied between sunny to rainy within the reporting period. Marine works within the reporting period include rockfill platform construction, marine piling platform installation and survey tower erection.)
