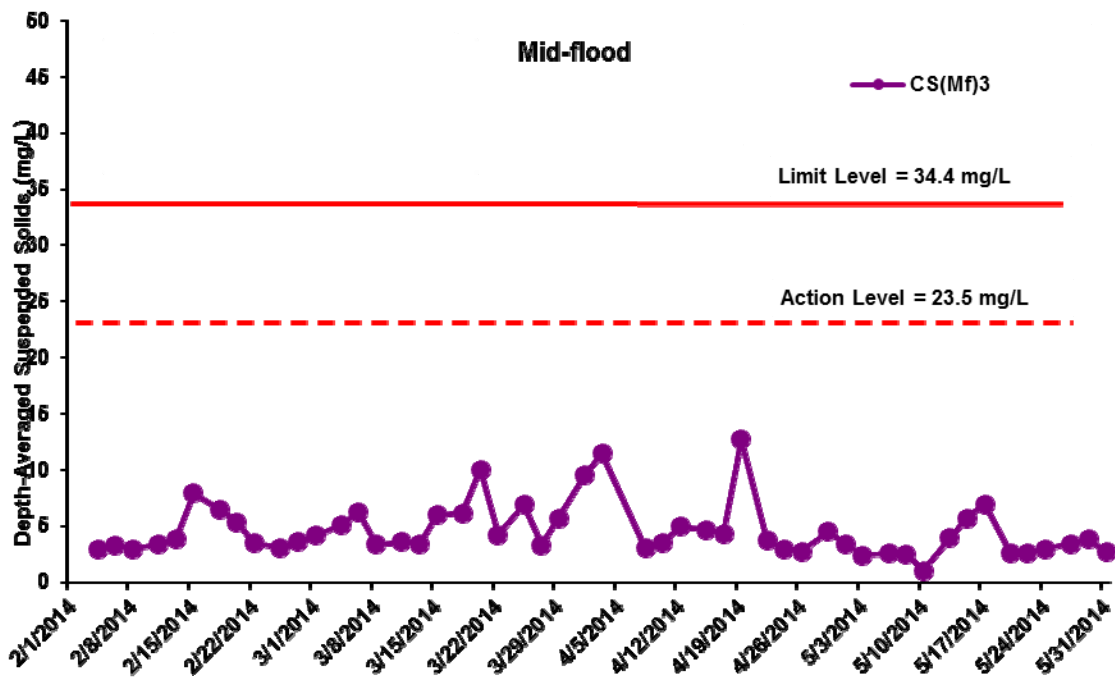
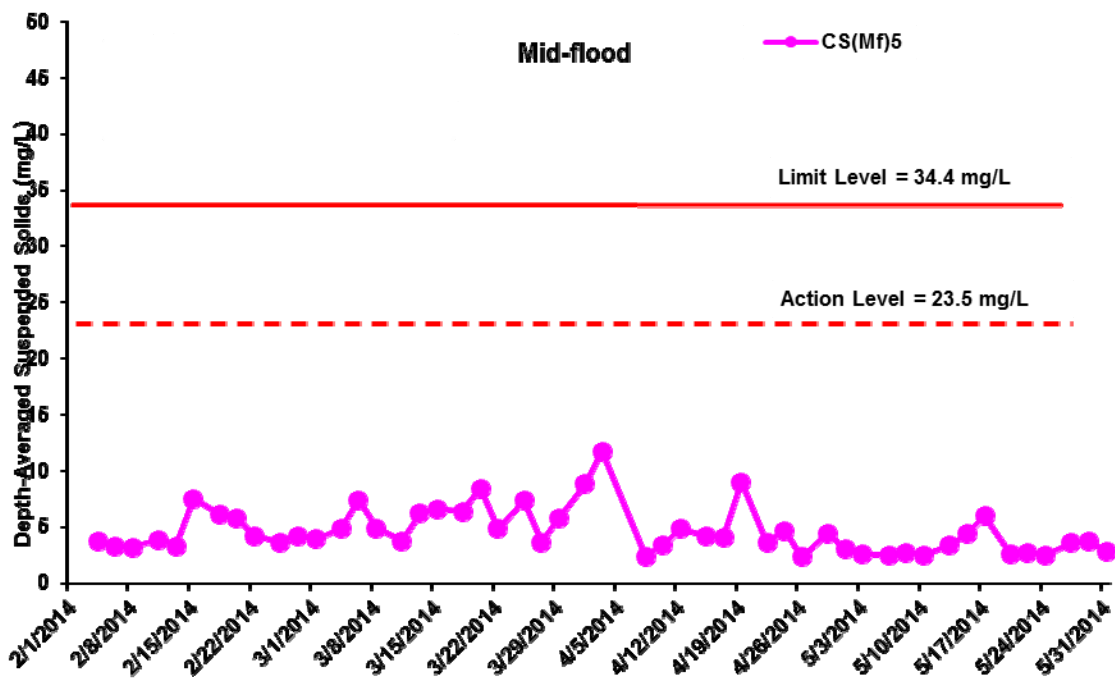
Figure H33 Impact Monitoring - Mean Level of depth-averaged Suspended Solids (mg/L) during mid-flood tide between 1 February to 31 May 2014 at CS(Mf)3 and CS(Mf)5.

(Weather condition varied between sunny to rainy within the reporting period. Marine works within the reporting period include rockfill platform construction, marine piling platform installation and survey tower erection.)

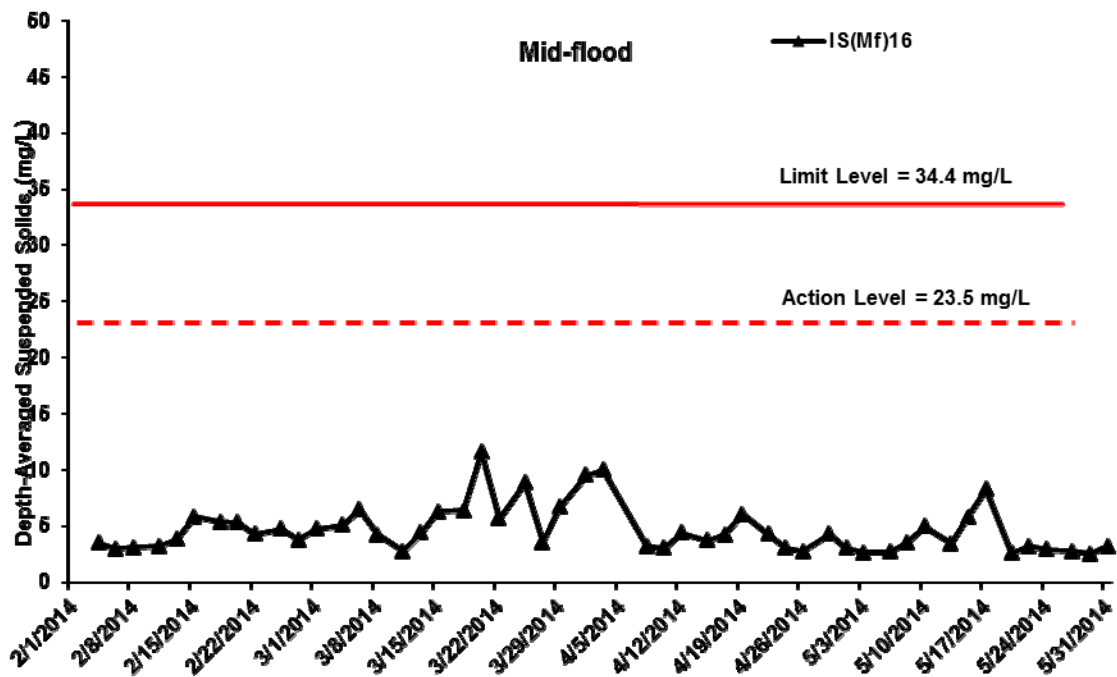
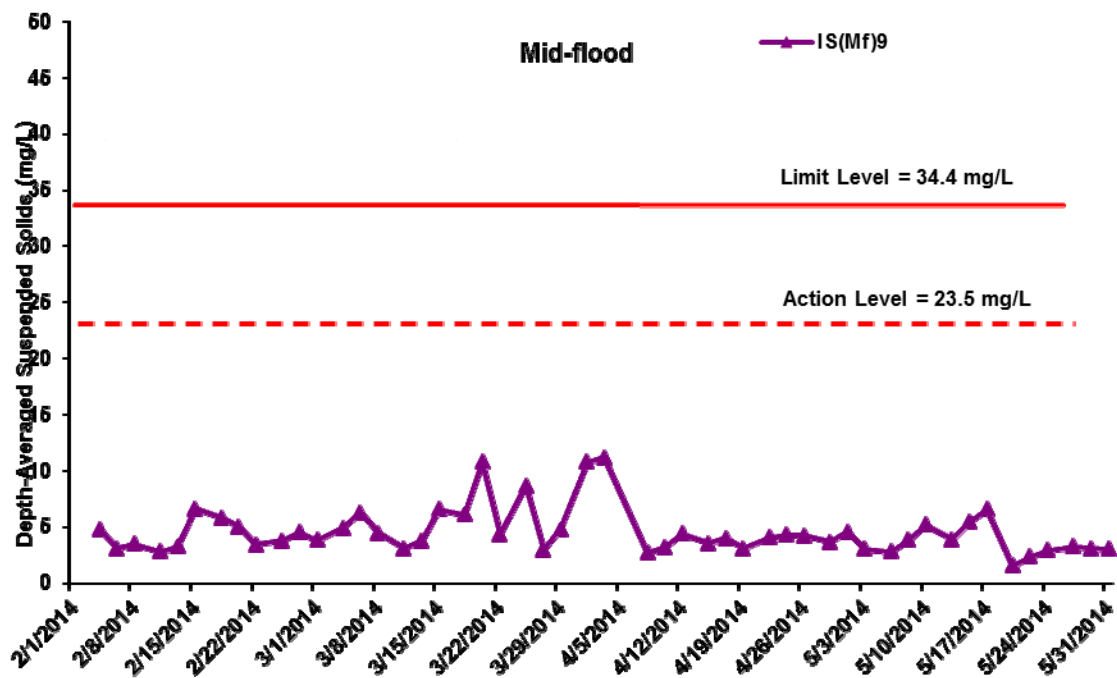
Figure H34 Impact Monitoring - Mean Level of depth-averaged Suspended Solids (mg/L) during mid-flood tide between 1 February to 31 May 2014 at IS(Mf)16 and IS(Mf)9 .

(Weather condition varied between sunny to rainy within the reporting period. Marine works within the reporting period include rockfill platform construction, marine piling platform installation and survey tower erection.)

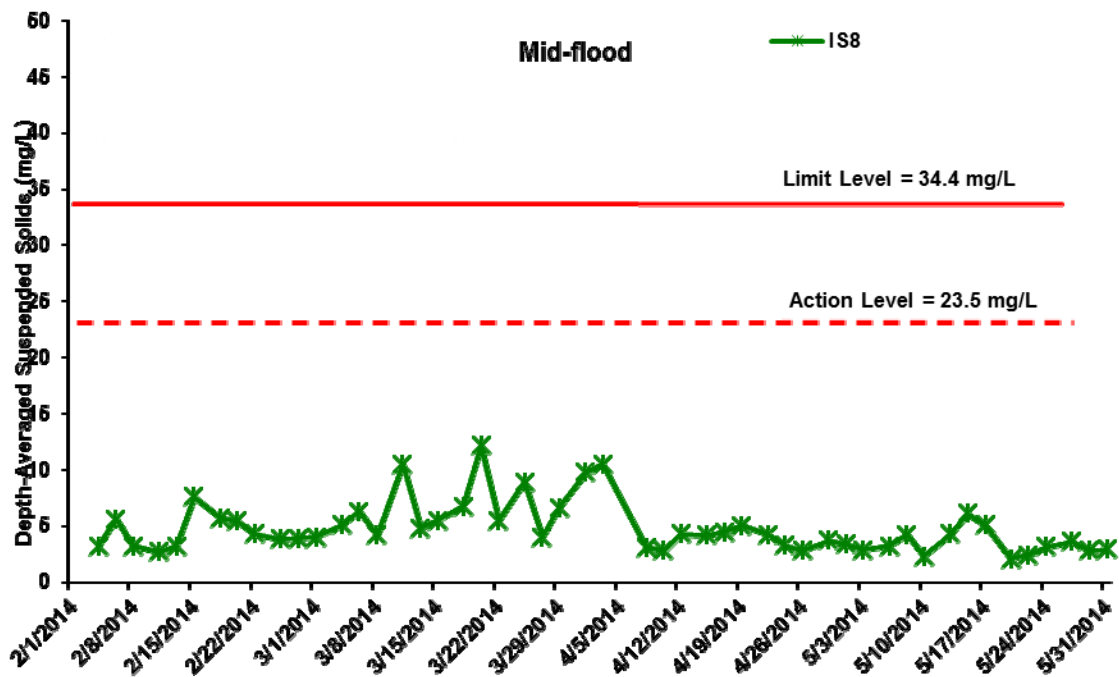
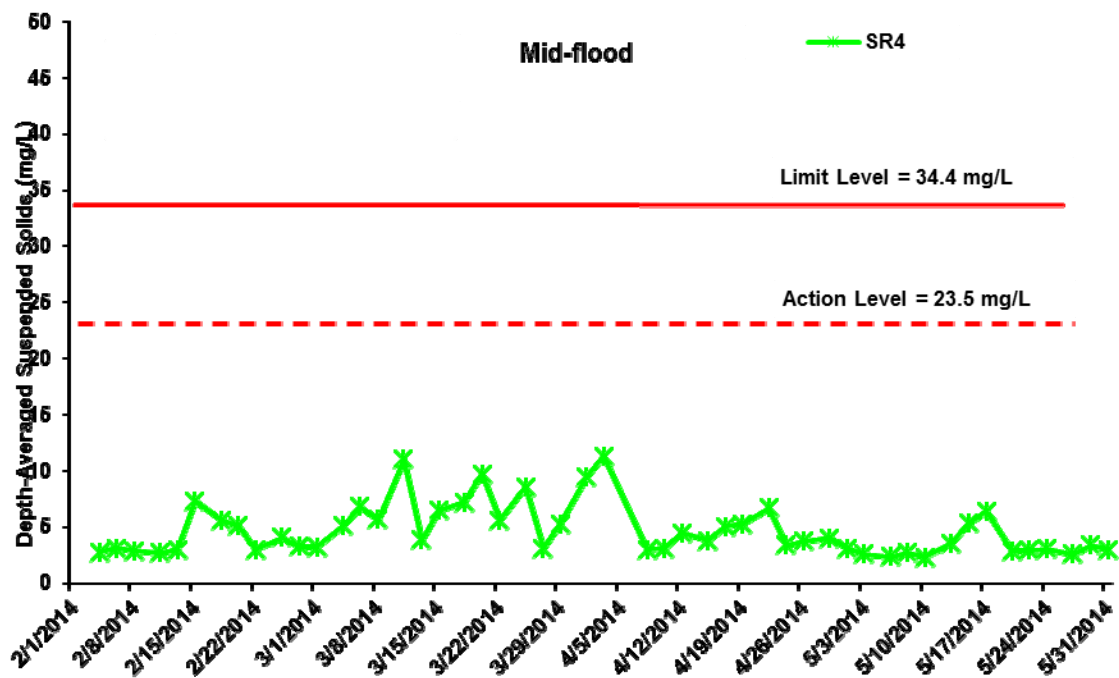
Figure H35 Impact Monitoring - Mean Level of depth-averaged Suspended Solids (mg/L) during mid-flood tide between 1 February to 31 May 2014 at IS8 and SR4.

(Weather condition varied between sunny to rainy within the reporting period. Marine works within the reporting period include rockfill platform construction, marine piling platform installation and survey tower erection.)

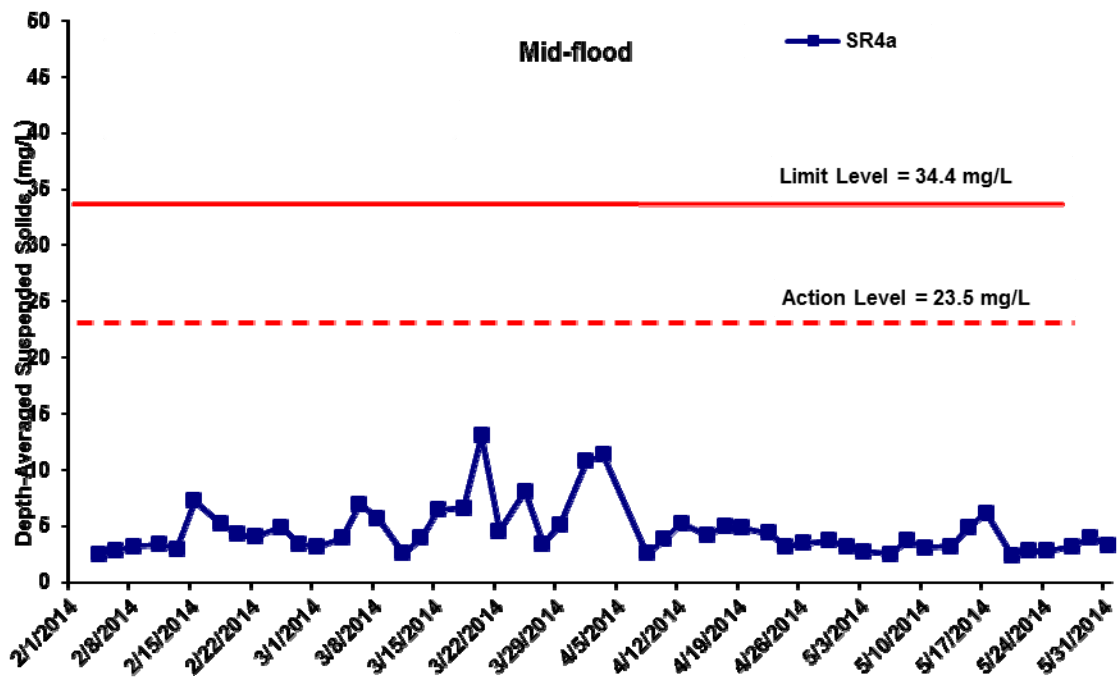
Figure H36 Impact Monitoring - Mean Level of depth-averaged Suspended Solids (mg/L) during mid-flood tide between 1 February to 31 May 2014 at SR4a.

(Weather condition varied between sunny to rainy within the reporting period. Marine works within the reporting period include rockfill platform construction, marine piling platform installation and survey tower erection.)
