Figure G1 Impact Monitoring – Mean Level of Dissolved Oxygen (mg/L) in surface waters between 1 May 2014 and 31 August 2014 at CS4. The weather conditions during the monitoring period varied mostly from sunny to cloudy. Major marine construction activities included: Dredging (5/1/2014 – 8/6/2014); Construction of Temporary Seawalls (5/1/2013 – 8/31/2014); Sheet Piling (5/1/2014 – 8/31/2014); Filling (5/1/2014 – 8/31/2014). No monitoring was conducted on 18 July 2014 due to adverse weather condition.

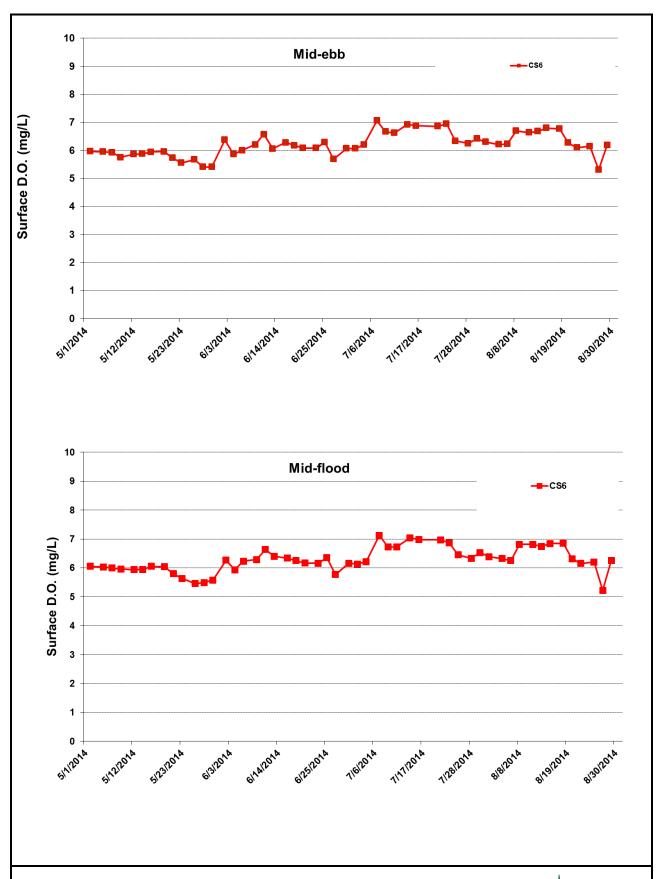
Figure G2 Impact Monitoring – Mean Level of Dissolved Oxygen (mg/L) in surface waters between 1 May 2014 and 31 August 2014 at CS6. The weather conditions during the monitoring period varied mostly from sunny to cloudy. Major marine construction activities included: Dredging (5/1/2014 – 8/6/2014); Construction of Temporary Seawalls (5/1/2013 – 8/31/2014); Sheet Piling (5/1/2014 – 8/31/2014); Filling (5/1/2014 – 8/31/2014). No monitoring was conducted on 18 July 2014 due to adverse weather condition.

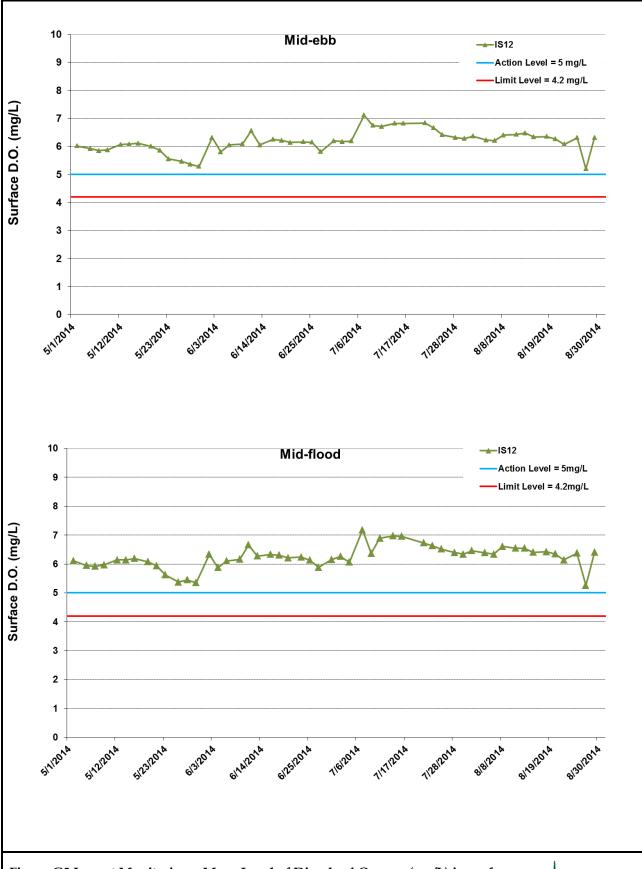
Figure G3 Impact Monitoring – Mean Level of Dissolved Oxygen (mg/L) in surface waters between 1 May 2014 and 31 August 2014 at IS12. The weather conditions during the monitoring period varied mostly from sunny to cloudy. Major marine construction activities included: Dredging (5/1/2014 – 8/6/2014); Construction of Temporary Seawalls (5/1/2013 – 8/31/2014); Sheet Piling (5/1/2014 – 8/31/2014); Filling (5/1/2014 – 8/31/2014). No monitoring was conducted on 18 July 2014 due to adverse weather condition.

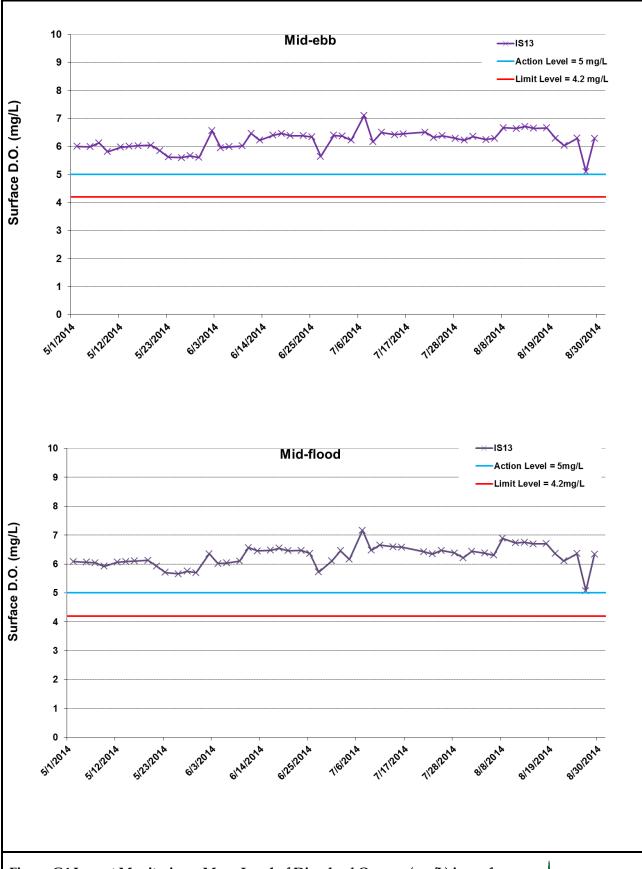
Figure G4 Impact Monitoring – Mean Level of Dissolved Oxygen (mg/L) in surface waters between 1 May 2014 and 31 August 2014 at IS13. The weather conditions during the monitoring period varied mostly from sunny to cloudy. Major marine construction activities included: Dredging (5/1/2014 – 8/6/2014); Construction of Temporary Seawalls (5/1/2013 – 8/31/2014); Sheet Piling (5/1/2014 – 8/31/2014); Filling (5/1/2014 – 8/31/2014). No monitoring was conducted on 18 July 2014 due to adverse weather condition.

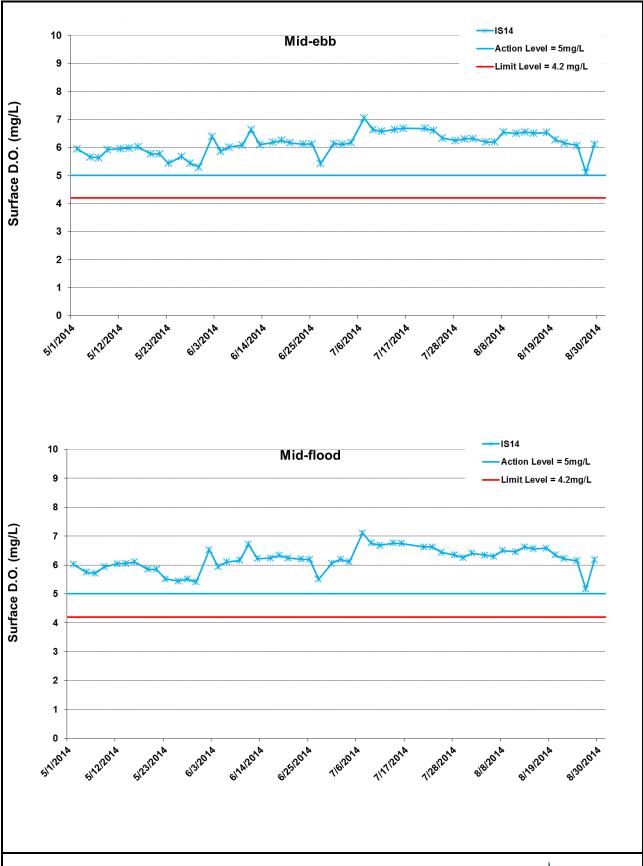
Figure G5 Impact Monitoring – Mean Level of Dissolved Oxygen (mg/L) in surface waters between 1 May 2014 and 31 August 2014 at IS14. The weather conditions during the monitoring period varied mostly from sunny to cloudy. Major marine construction activities included: Dredging (5/1/2014 – 8/6/2014); Construction of Temporary Seawalls (5/1/2013 – 8/31/2014); Sheet Piling (5/1/2014 – 8/31/2014); Filling (5/1/2014 – 8/31/2014). No monitoring was conducted on 18 July 2014 due to adverse weather condition.

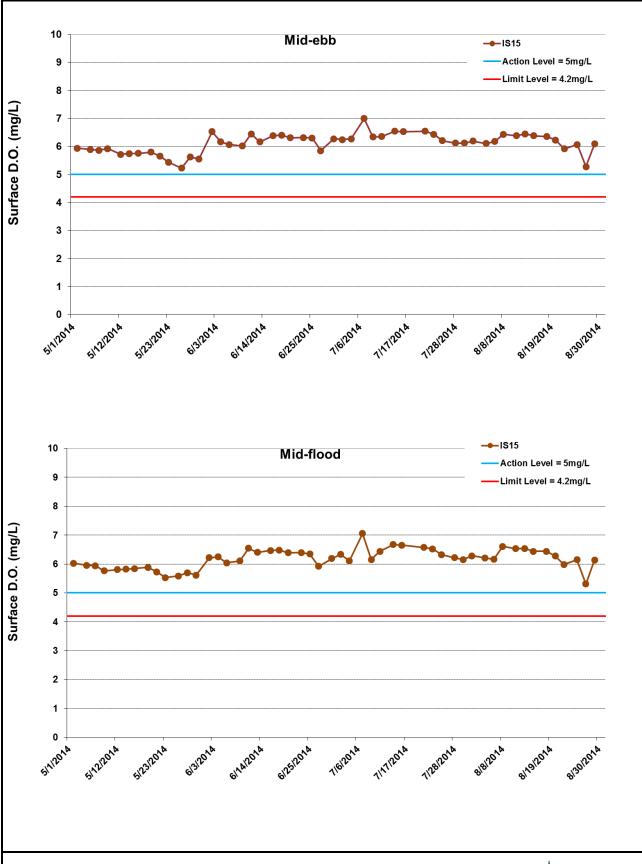
Figure G6 Impact Monitoring – Mean Level of Dissolved Oxygen (mg/L) in surface waters between 1 May 2014 and 31 August 2014 at IS15. The weather conditions during the monitoring period varied mostly from sunny to cloudy. Major marine construction activities included: Dredging (5/1/2014 – 8/6/2014); Construction of Temporary Seawalls (5/1/2013 – 8/31/2014); Sheet Piling (5/1/2014 – 8/31/2014); Filling (5/1/2014 – 8/31/2014). No monitoring was conducted on 18 July 2014 due to adverse weather condition.

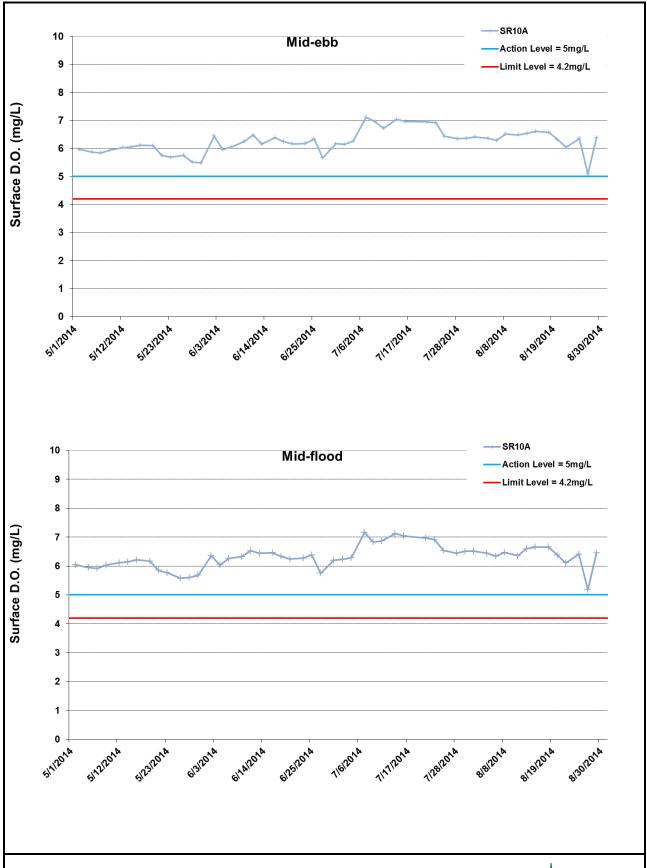
Figure G7 Impact Monitoring - Mean Level of Dissolved Oxygen (mg/L) in surface waters between 1 May 2014 and 31 August 2014 at SR10A. The weather conditions during the monitoring period varied mostly from sunny to cloudy. Major marine construction activities included: Dredging (5/1/2014 - 8/6/2014); Construction of Temporary Seawalls (5/1/2013 - 8/31/2014); Sheet Piling (5/1/2014 - 8/31/2014); Filling (5/1/2014 - 8/31/2014). No monitoring was conducted on 18 July 2014 due to adverse weather condition. *Ref:* 0212330\_Impact-

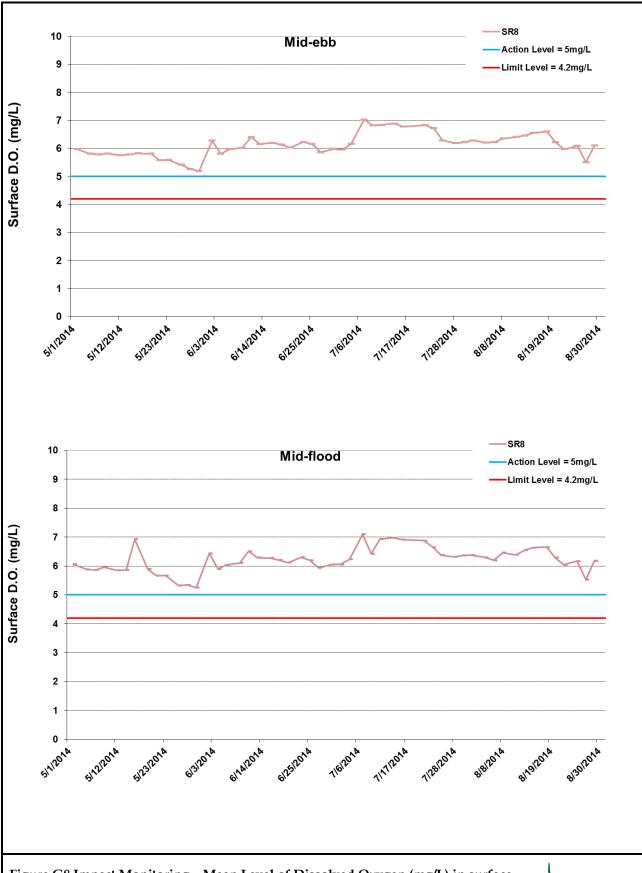
Figure G8 Impact Monitoring – Mean Level of Dissolved Oxygen (mg/L) in surface waters between 1 May 2014 and 31 August 2014 at SR8. The weather conditions during the monitoring period varied mostly from sunny to cloudy. Major marine construction activities included: Dredging (5/1/2014 – 8/6/2014); Construction of Temporary Seawalls (5/1/2013 – 8/31/2014); Sheet Piling (5/1/2014 – 8/31/2014); Filling (5/1/2014 – 8/31/2014). No monitoring was conducted on 18 July 2014 due to adverse weather condition.

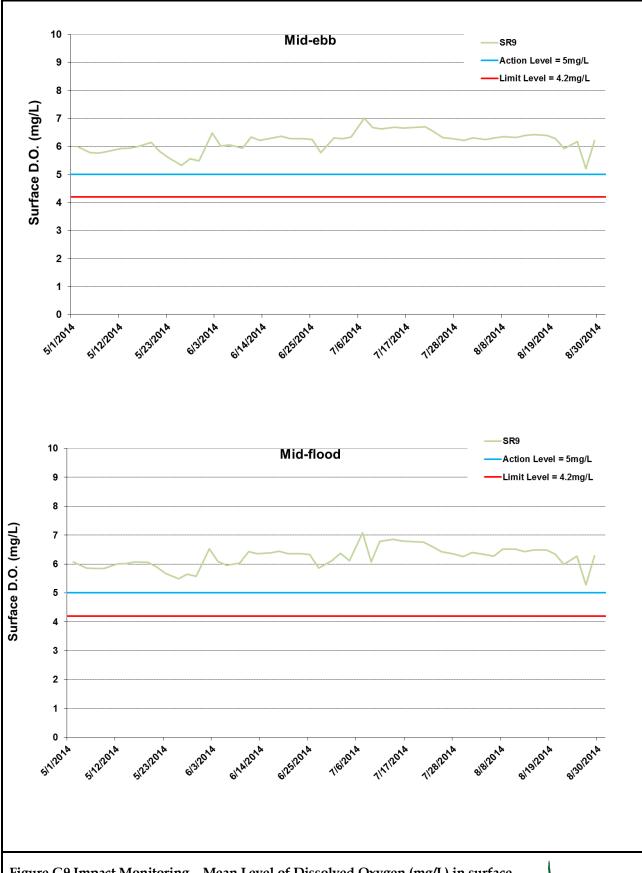
Figure G9 Impact Monitoring – Mean Level of Dissolved Oxygen (mg/L) in surface waters between 1 May 2014 and 31 August 2014 at SR9. The weather conditions during the monitoring period varied mostly from sunny to cloudy. Major marine construction activities included: Dredging (5/1/2014 – 8/6/2014); Construction of Temporary Seawalls (5/1/2013 – 8/31/2014); Sheet Piling (5/1/2014 – 8/31/2014); Filling (5/1/2014 – 8/31/2014). No monitoring was conducted on 18 July 2014 due to adverse weather condition.

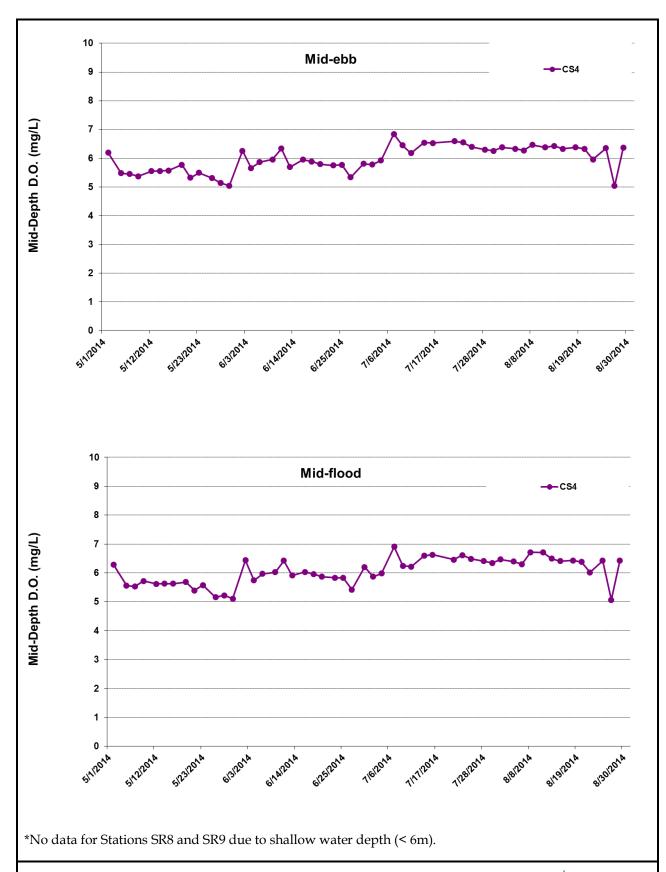
Figure G10 Impact Monitoring – Mean Level of Dissolved Oxygen (mg/L) in middepth waters between 1 May 2014 and 31 August 2014 at CS4. The weather conditions during the monitoring period varied mostly from sunny to cloudy. Major marine construction activities included: Dredging (5/1/2014 – 8/6/2014); Construction of Temporary Seawalls (5/1/2013 – 8/31/2014); Sheet Piling (5/1/2014 – 8/31/2014); Filling (5/1/2014 – 8/31/2014). No monitoring was conducted on 18 July 2014 due to adverse weather condition.

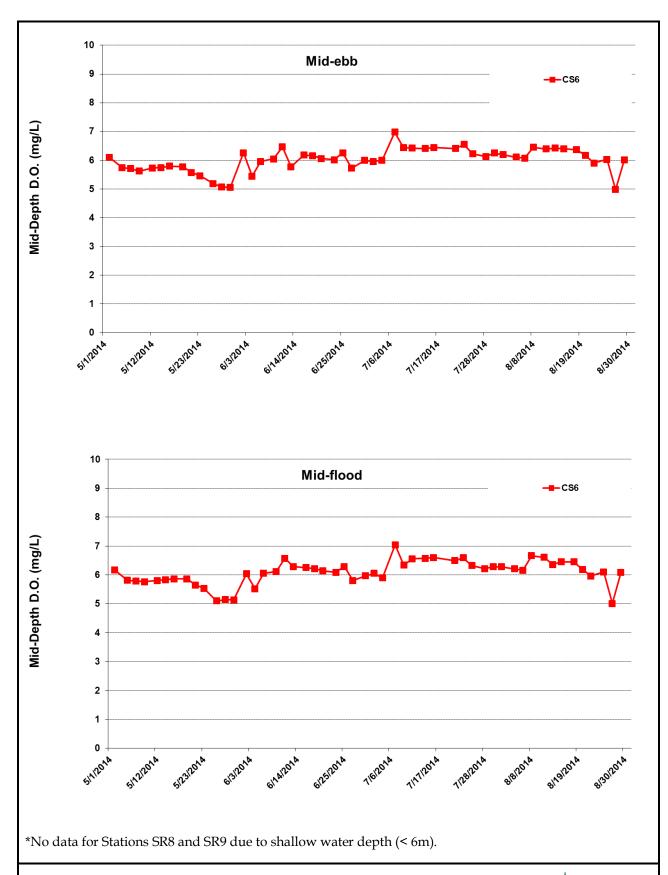
Figure G11 Impact Monitoring – Mean Level of Dissolved Oxygen (mg/L) in middepth waters between 1 May 2014 and 31 August 2014 at CS6. The weather conditions during the monitoring period varied mostly from sunny to cloudy. Major marine construction activities included: Dredging (5/1/2014 – 8/6/2014); Construction of Temporary Seawalls (5/1/2013 – 8/31/2014); Sheet Piling (5/1/2014 – 8/31/2014); Filling (5/1/2014 – 8/31/2014). No monitoring was conducted on 18 July 2014 due to adverse weather condition.

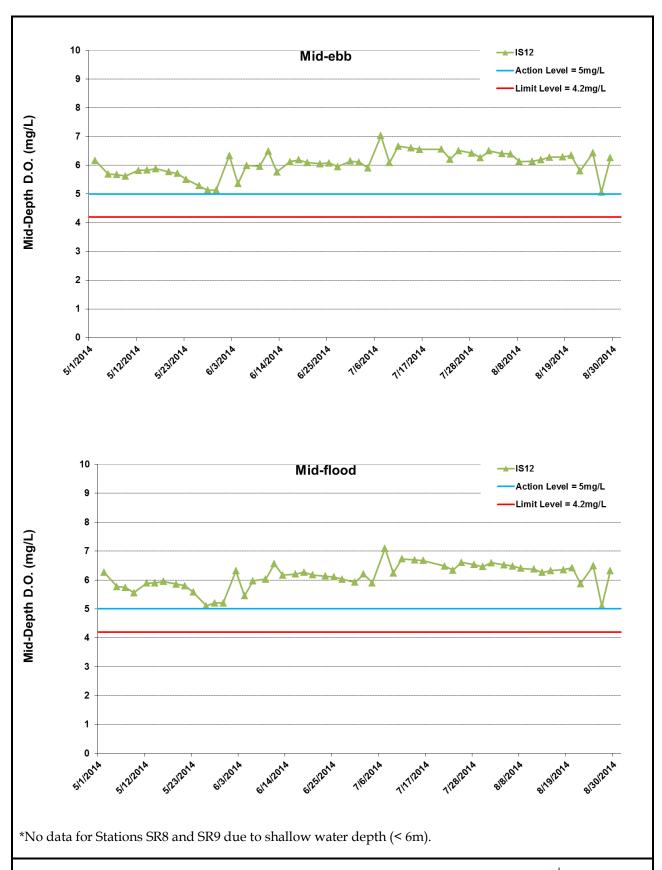
Figure G12 Impact Monitoring – Mean Level of Dissolved Oxygen (mg/L) in middepth waters between 1 May 2014 and 31 August 2014 at IS12. The weather conditions during the monitoring period varied mostly from sunny to cloudy. Major marine construction activities included: Dredging (5/1/2014 – 8/6/2014); Construction of Temporary Seawalls (5/1/2013 – 8/31/2014); Sheet Piling (5/1/2014 – 8/31/2014); Filling (5/1/2014 – 8/31/2014). No monitoring was conducted on 18 July 2014 due to adverse weather condition.

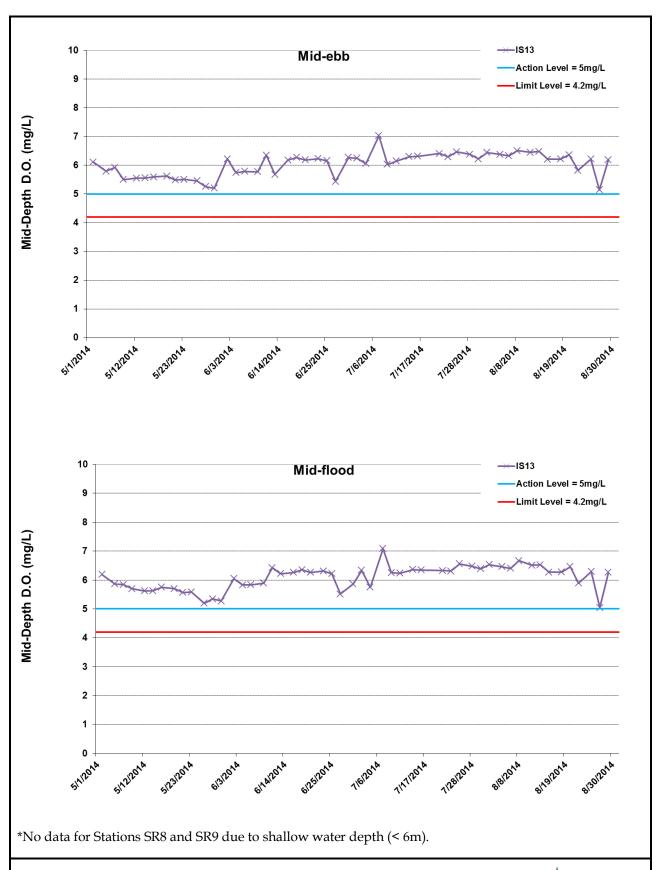
Figure G13 Impact Monitoring – Mean Level of Dissolved Oxygen (mg/L) in middepth waters between 1 May 2014 and 31 August 2014 at IS13. The weather conditions during the monitoring period varied mostly from sunny to cloudy. Major marine construction activities included: Dredging (5/1/2014 – 8/6/2014); Construction of Temporary Seawalls (5/1/2013 – 8/31/2014); Sheet Piling (5/1/2014 – 8/31/2014); Filling (5/1/2014 – 8/31/2014). No monitoring was conducted on 18 July 2014 due to adverse weather condition.

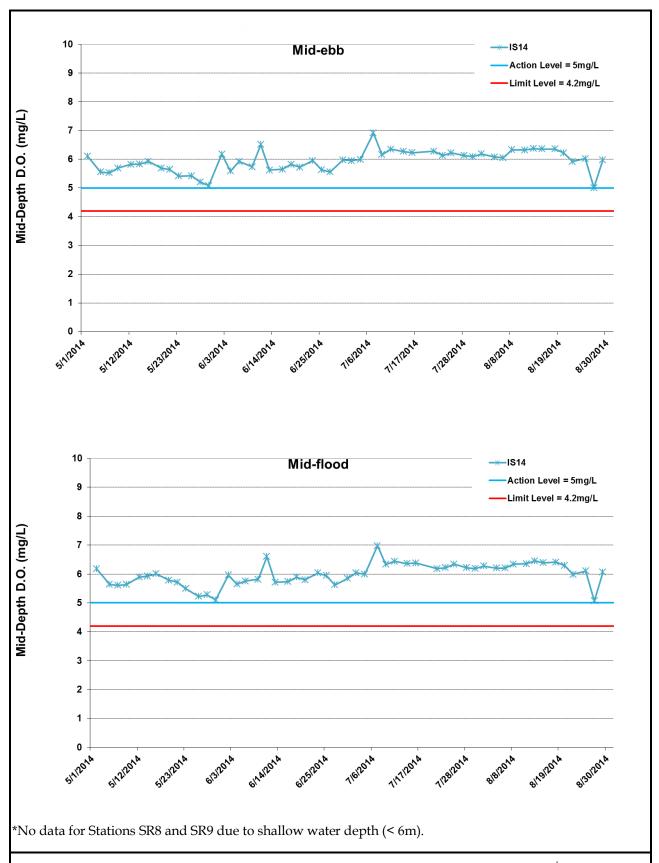
Figure G14 Impact Monitoring – Mean Level of Dissolved Oxygen (mg/L) in middepth waters between 1 May 2014 and 31 August 2014 at IS14. The weather conditions during the monitoring period varied mostly from sunny to cloudy. Major marine construction activities included: Dredging (5/1/2014 – 8/6/2014); Construction of Temporary Seawalls (5/1/2013 – 8/31/2014); Sheet Piling (5/1/2014 – 8/31/2014); Filling (5/1/2014 – 8/31/2014). No monitoring was conducted on 18 July 2014 due to adverse weather condition.

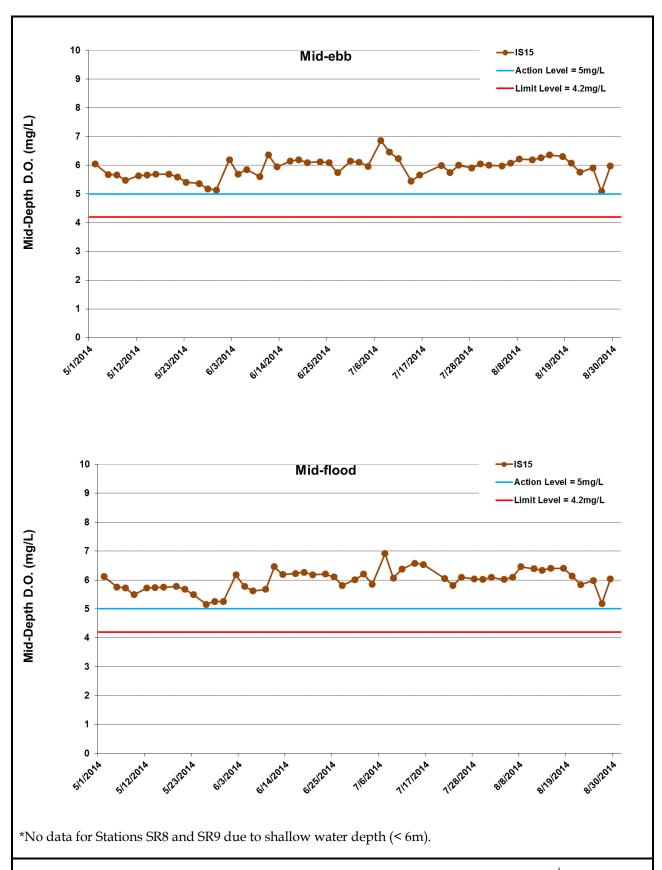
Figure G15 Impact Monitoring – Mean Level of Dissolved Oxygen (mg/L) in middepth waters between 1 May 2014 and 31 August 2014 at IS15. The weather conditions during the monitoring period varied mostly from sunny to cloudy. Major marine construction activities included: Dredging (5/1/2014 – 8/6/2014); Construction of Temporary Seawalls (5/1/2013 – 8/31/2014); Sheet Piling (5/1/2014 – 8/31/2014); Filling (5/1/2014 – 8/31/2014). No monitoring was conducted on 18 July 2014 due to adverse weather condition.

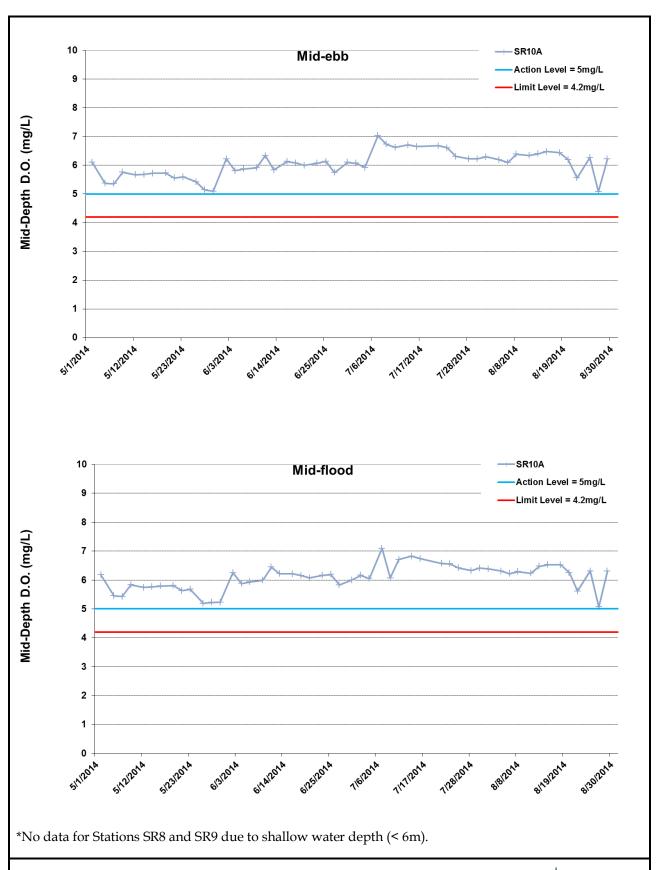
Figure G16 Impact Monitoring – Mean Level of Dissolved Oxygen (mg/L) in middepth waters between 1 May 2014 and 31 August 2014 at SR10A. The weather conditions during the monitoring period varied mostly from sunny to cloudy. Major marine construction activities included: Dredging (5/1/2014 – 8/6/2014); Construction of Temporary Seawalls (5/1/2013 – 8/31/2014); Sheet Piling (5/1/2014 – 8/31/2014); Filling (5/1/2014 – 8/31/2014). No monitoring was conducted on 18 July 2014 due to adverse weather condition.

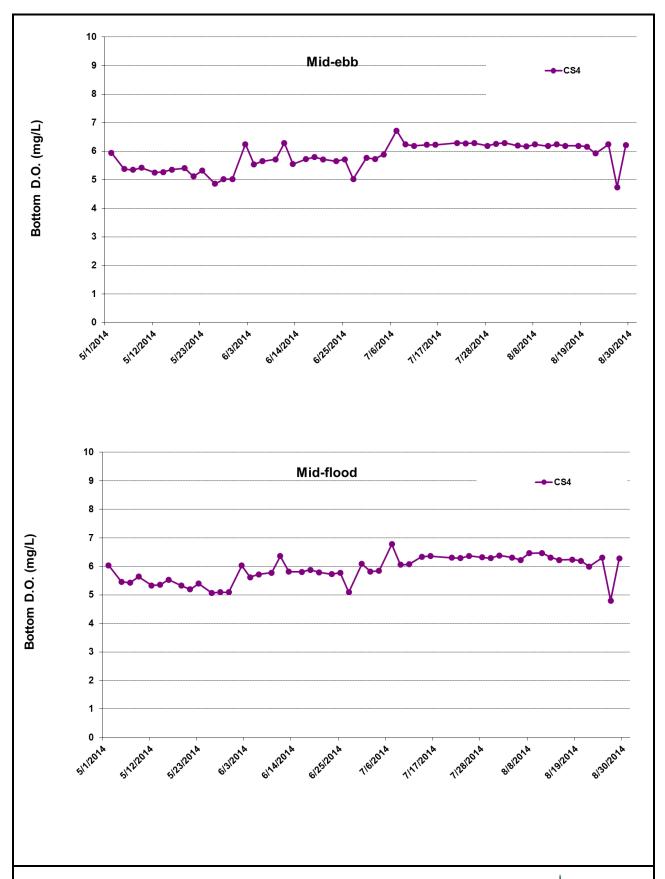
Figure G17 Impact Monitoring – Mean Level of Dissolved Oxygen (mg/L) in bottom water between 1 May 2014 and 31 August 2014 at CS4. The weather conditions during the monitoring period varied mostly from sunny to cloudy. Major marine construction activities included: Dredging (5/1/2014 – 8/6/2014); Construction of Temporary Seawalls (5/1/2013 – 8/31/2014); Sheet Piling (5/1/2014 – 8/31/2014); Filling (5/1/2014 – 8/31/2014). No monitoring was conducted on 18 July 2014 due to adverse weather condition.

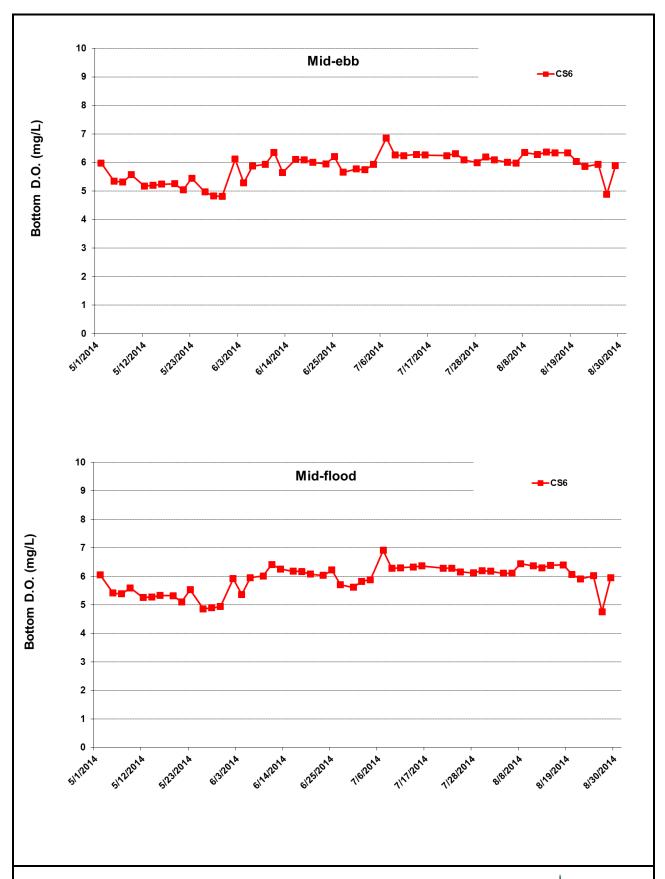
Figure G18 Impact Monitoring – Mean Level of Dissolved Oxygen (mg/L) in bottom water between 1 May 2014 and 31 August 2014 at CS6. The weather conditions during the monitoring period varied mostly from sunny to cloudy. Major marine construction activities included: Dredging (5/1/2014 – 8/6/2014); Construction of Temporary Seawalls (5/1/2013 – 8/31/2014); Sheet Piling (5/1/2014 – 8/31/2014); Filling (5/1/2014 – 8/31/2014). No monitoring was conducted on 18 July 2014 due to adverse weather condition.

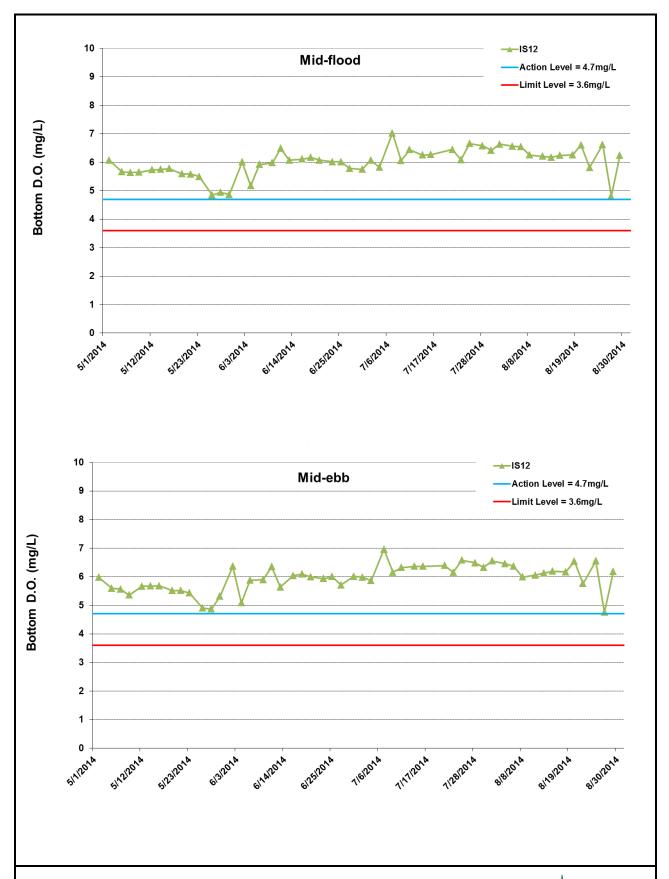
Figure G19 Impact Monitoring – Mean Level of Dissolved Oxygen (mg/L) in bottom water between 1 May 2014 and 31 August 2014 at IS12. The weather conditions during the monitoring period varied mostly from sunny to cloudy. Major marine construction activities included: Dredging (5/1/2014 – 8/6/2014); Construction of Temporary Seawalls (5/1/2013 – 8/31/2014); Sheet Piling (5/1/2014 – 8/31/2014); Filling (5/1/2014 – 8/31/2014). No monitoring was conducted on 18 July 2014 due to adverse weather condition.

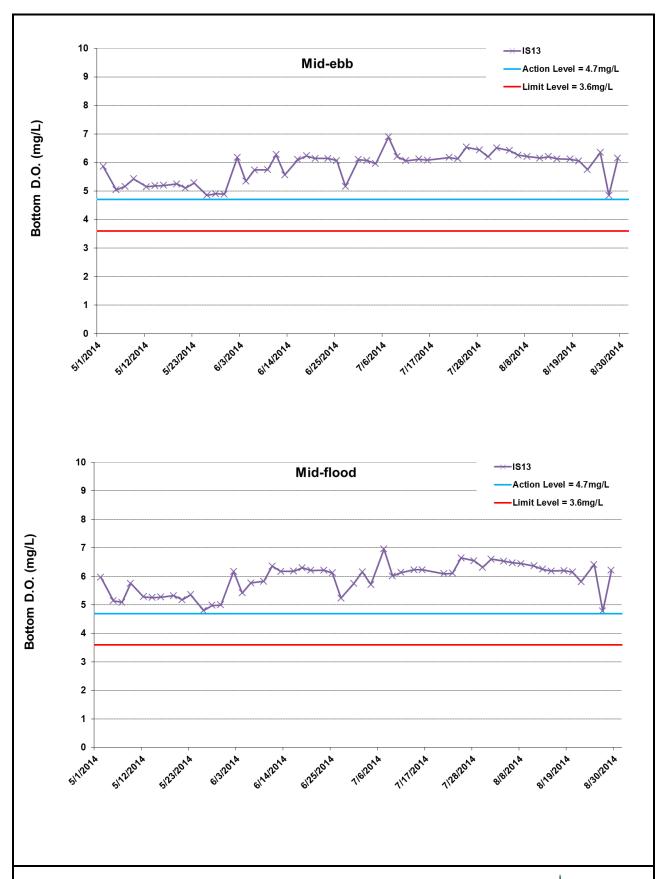
Figure G20 Impact Monitoring – Mean Level of Dissolved Oxygen (mg/L) in bottom water between 1 May 2014 and 31 August 2014 at IS13. The weather conditions during the monitoring period varied mostly from sunny to cloudy. Major marine construction activities included: Dredging (5/1/2014 – 8/6/2014); Construction of Temporary Seawalls (5/1/2013 – 8/31/2014); Sheet Piling (5/1/2014 – 8/31/2014); Filling (5/1/2014 – 8/31/2014). No monitoring was conducted on 18 July 2014 due to adverse weather condition.

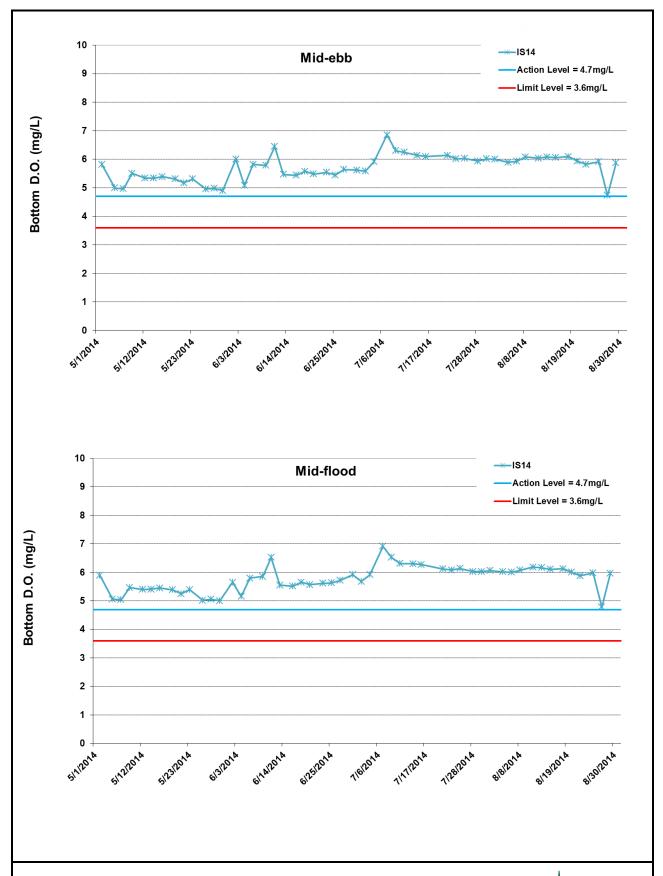
Figure G21 Impact Monitoring – Mean Level of Dissolved Oxygen (mg/L) in bottom water between 1 May 2014 and 31 August 2014 at IS14. The weather conditions during the monitoring period varied mostly from sunny to cloudy. Major marine construction activities included: Dredging (5/1/2014 – 8/6/2014); Construction of Temporary Seawalls (5/1/2013 – 8/31/2014); Sheet Piling (5/1/2014 – 8/31/2014); Filling (5/1/2014 – 8/31/2014). No monitoring was conducted on 18 July 2014 due to adverse weather condition.

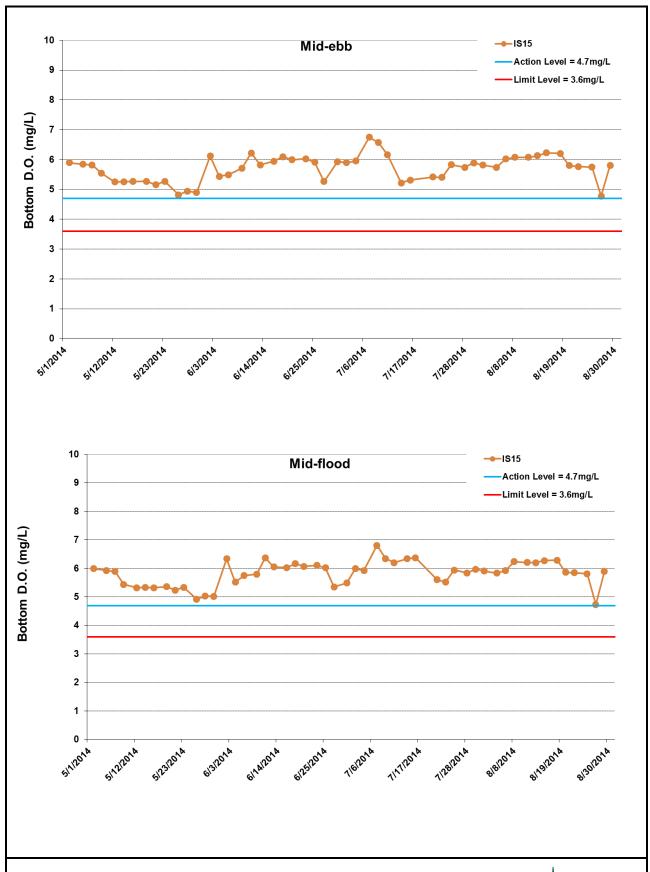
Figure G22 Impact Monitoring – Mean Level of Dissolved Oxygen (mg/L) in bottom water between 1 May 2014 and 31 August 2014 at IS15. The weather conditions during the monitoring period varied mostly from sunny to cloudy. Major marine construction activities included: Dredging (5/1/2014 – 8/6/2014); Construction of Temporary Seawalls (5/1/2013 – 8/31/2014); Sheet Piling (5/1/2014 – 8/31/2014); Filling (5/1/2014 – 8/31/2014). No monitoring was conducted on 18 July 2014 due to adverse weather condition.

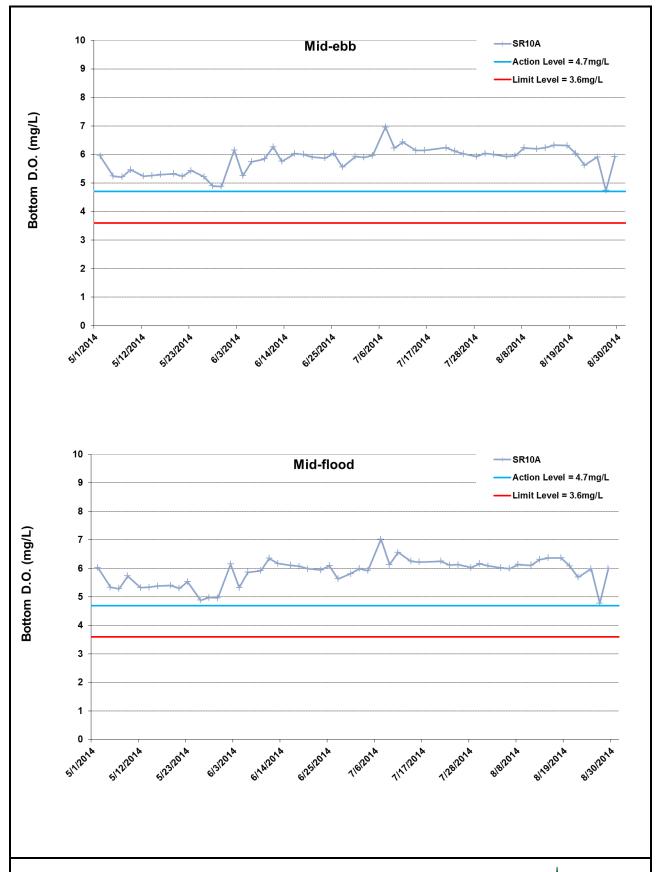
Figure G23 Impact Monitoring – Mean Level of Dissolved Oxygen (mg/L) in bottom water between 1 May 2014 and 31 August 2014 at SR10A. The weather conditions during the monitoring period varied mostly from sunny to cloudy. Major marine construction activities included: Dredging (5/1/2014 – 8/6/2014); Construction of Temporary Seawalls (5/1/2013 – 8/31/2014); Sheet Piling (5/1/2014 – 8/31/2014); Filling (5/1/2014 – 8/31/2014). No monitoring was conducted on 18 July 2014 due to adverse weather condition.

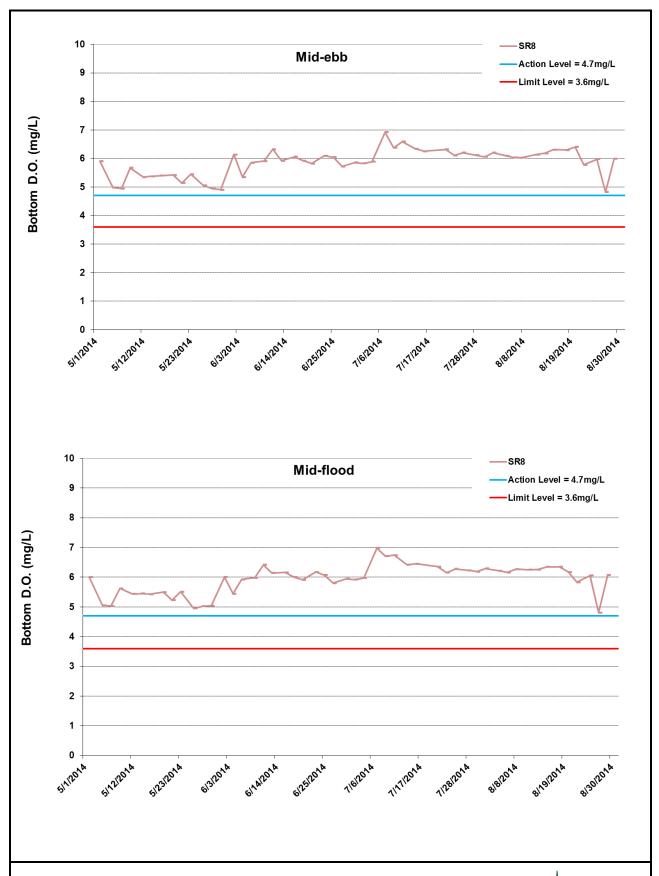
Figure G24 Impact Monitoring – Mean Level of Dissolved Oxygen (mg/L) in bottom water between 1 May 2014 and 31 August 2014 at SR8. The weather conditions during the monitoring period varied mostly from sunny to cloudy. Major marine construction activities included: Dredging (5/1/2014 – 8/6/2014); Construction of Temporary Seawalls (5/1/2013 – 8/31/2014); Sheet Piling (5/1/2014 – 8/31/2014); Filling (5/1/2014 – 8/31/2014). No monitoring was conducted on 18 July 2014 due to adverse weather condition.

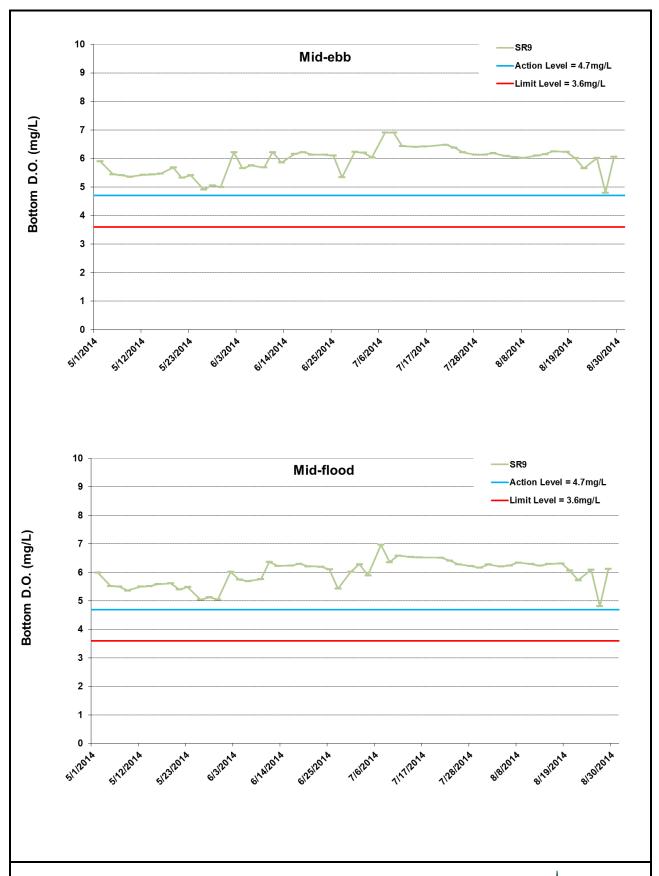
Figure G25 Impact Monitoring – Mean Level of Dissolved Oxygen (mg/L) in bottom water between 1 May 2014 and 31 August 2014 at SR9. The weather conditions during the monitoring period varied mostly from sunny to cloudy. Major marine construction activities included: Dredging (5/1/2014 – 8/6/2014); Construction of Temporary Seawalls (5/1/2013 – 8/31/2014); Sheet Piling (5/1/2014 – 8/31/2014); Filling (5/1/2014 – 8/31/2014). No monitoring was conducted on 18 July 2014 due to adverse weather condition.

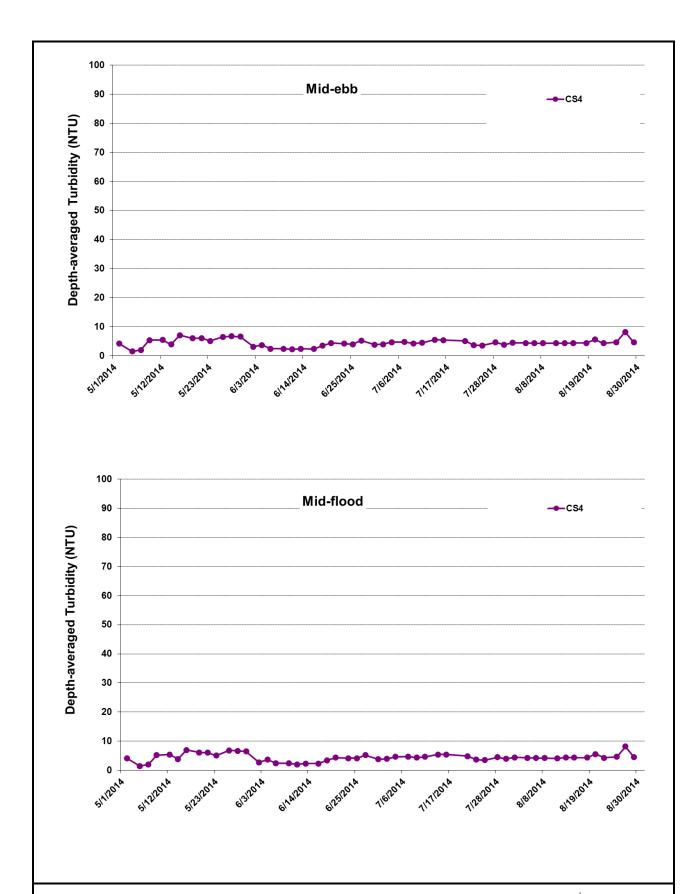
Figure G26 Impact Monitoring – Mean Depth-averaged Level of Turbidity (NTU) between 1 May 2014 and 31 August 2014 at CS4. The weather conditions during the monitoring period varied mostly from sunny to cloudy. Major marine construction activities included: Dredging (5/1/2014 – 8/6/2014); Construction of Temporary Seawalls (5/1/2013 – 8/31/2014); Sheet Piling (5/1/2014 – 8/31/2014); Filling (5/1/2014 – 8/31/2014). No monitoring was conducted on 18 July 2014 due to adverse weather condition.

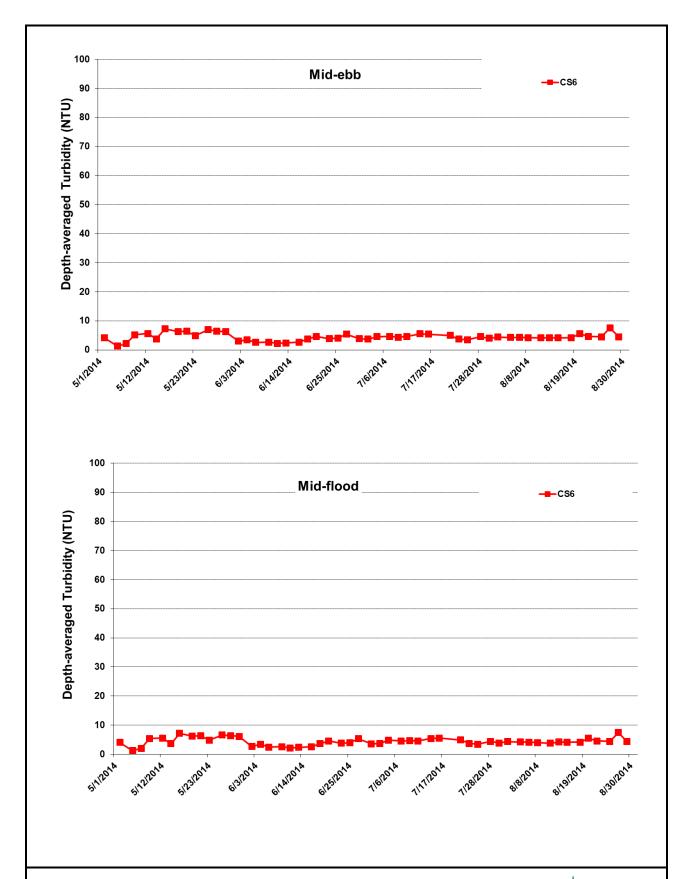
Figure G27 Impact Monitoring – Mean Depth-averaged Level of Turbidity (NTU) between 1 May 2014 and 31 August 2014 at CS6. The weather conditions during the monitoring period varied mostly from sunny to cloudy. Major marine construction activities included: Dredging (5/1/2014 – 8/6/2014); Construction of Temporary Seawalls (5/1/2013 – 8/31/2014); Sheet Piling (5/1/2014 – 8/31/2014); Filling (5/1/2014 – 8/31/2014). No monitoring was conducted on 18 July 2014 due to adverse weather condition.

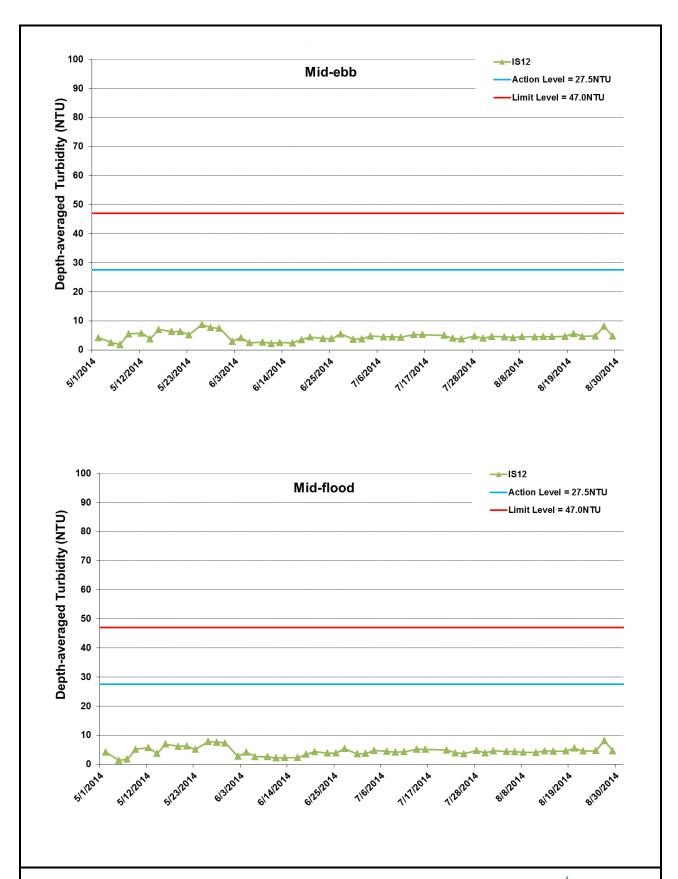
Figure G28 Impact Monitoring – Mean Depth-averaged Level of Turbidity (NTU) between 1 May 2014 and 31 August 2014 at IS12. The weather conditions during the monitoring period varied mostly from sunny to cloudy. Major marine construction activities included: Dredging (5/1/2014 – 8/6/2014); Construction of Temporary Seawalls (5/1/2013 – 8/31/2014); Sheet Piling (5/1/2014 – 8/31/2014); Filling (5/1/2014 – 8/31/2014). No monitoring was conducted on 18 July 2014 due to adverse weather condition.

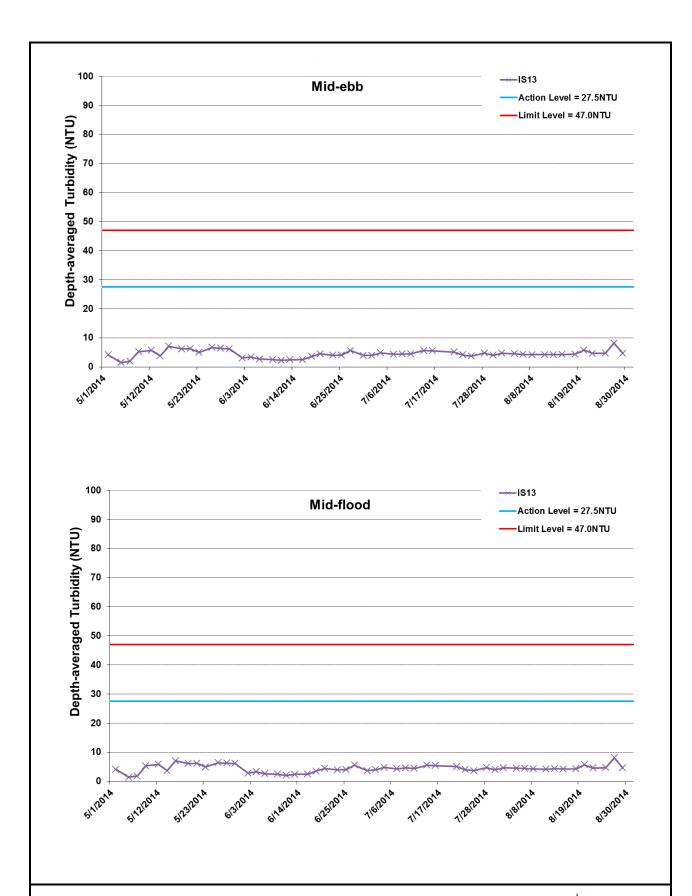
Figure G29 Impact Monitoring – Mean Depth-averaged Level of Turbidity (NTU) between 1 May 2014 and 31 August 2014 at IS13. The weather conditions during the monitoring period varied mostly from sunny to cloudy. Major marine construction activities included: Dredging (5/1/2014 – 8/6/2014); Construction of Temporary Seawalls (5/1/2013 – 8/31/2014); Sheet Piling (5/1/2014 – 8/31/2014); Filling (5/1/2014 – 8/31/2014). No monitoring was conducted on 18 July 2014 due to adverse weather condition.

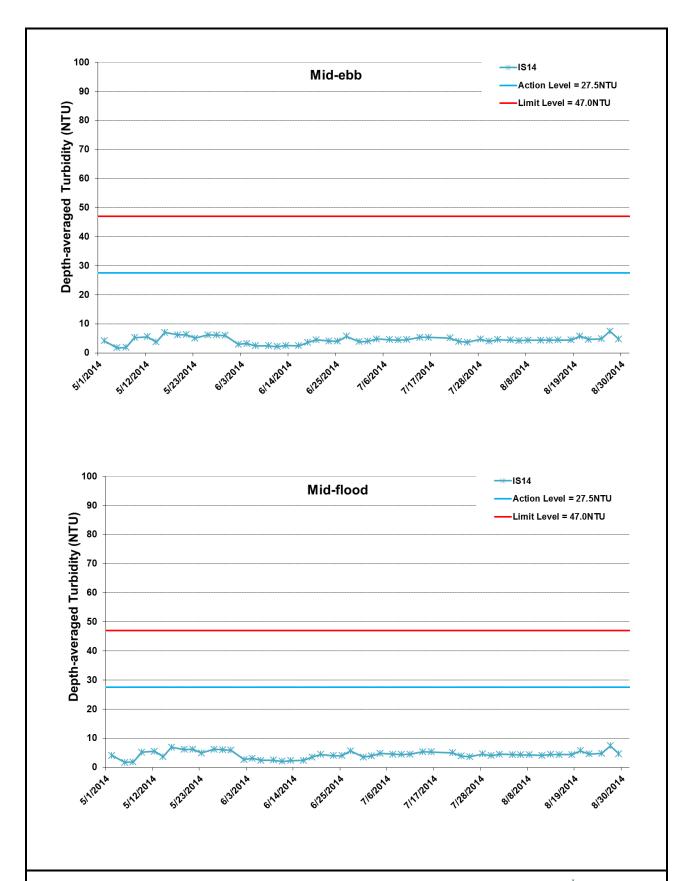
Figure G30 Impact Monitoring – Mean Depth-averaged Level of Turbidity (NTU) between 1 May 2014 and 31 August 2014 at IS14. The weather conditions during the monitoring period varied mostly from sunny to cloudy. Major marine construction activities included: Dredging (5/1/2014 – 8/6/2014); Construction of Temporary Seawalls (5/1/2013 – 8/31/2014); Sheet Piling (5/1/2014 – 8/31/2014); Filling (5/1/2014 – 8/31/2014). No monitoring was conducted on 18 July 2014 due to adverse weather condition.

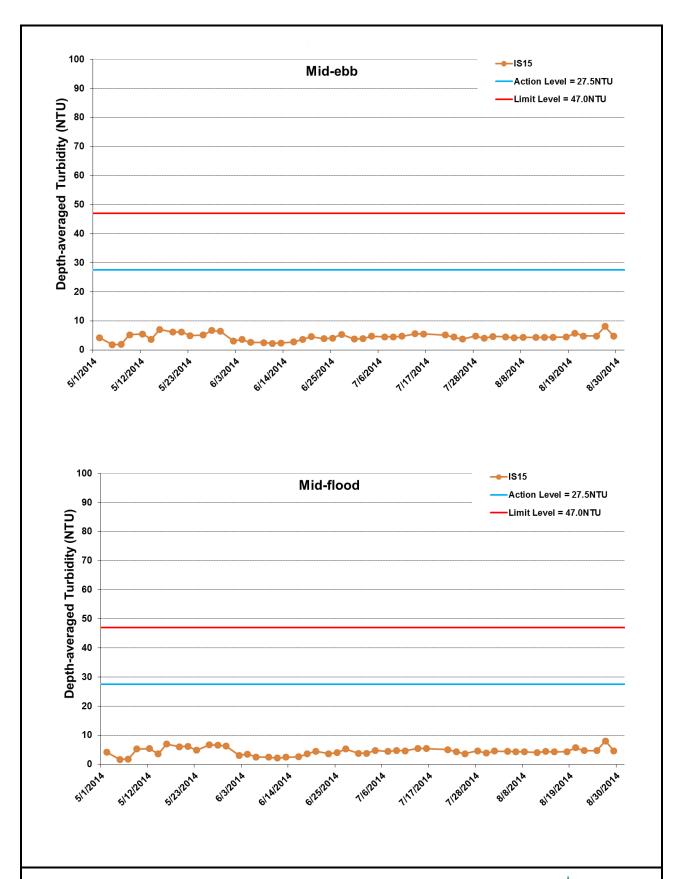
Figure G31 Impact Monitoring – Mean Depth-averaged Level of Turbidity (NTU) between 1 May 2014 and 31 August 2014 at IS15. The weather conditions during the monitoring period varied mostly from sunny to cloudy. Major marine construction activities included: Dredging (5/1/2014 – 8/6/2014); Construction of Temporary Seawalls (5/1/2013 – 8/31/2014); Sheet Piling (5/1/2014 – 8/31/2014); Filling (5/1/2014 – 8/31/2014). No monitoring was conducted on 18 July 2014 due to adverse weather condition.

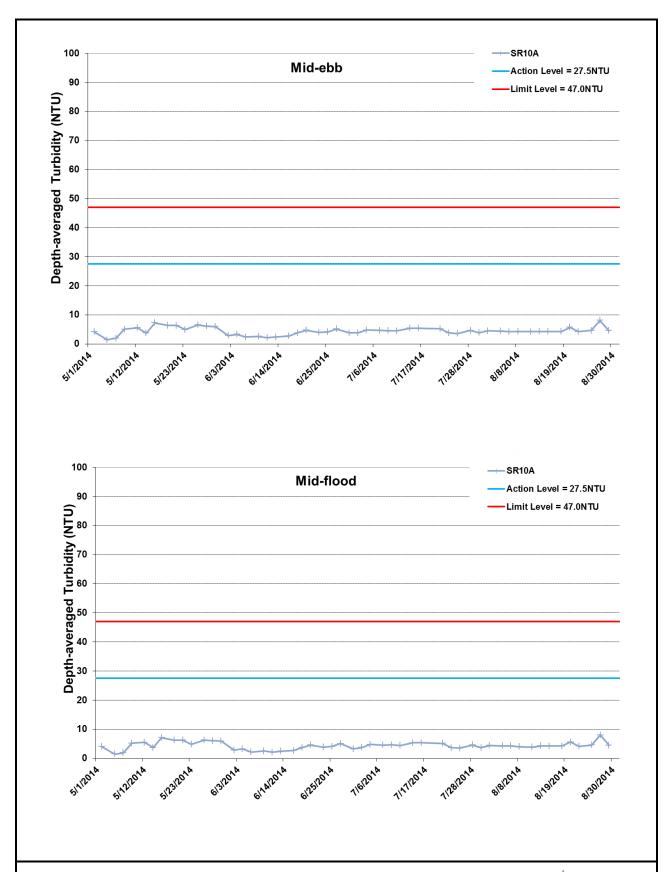
Figure G32 Impact Monitoring – Mean Depth-averaged Level of Turbidity (NTU) between 1 May 2014 and 31 August 2014 at SR10A. The weather conditions during the monitoring period varied mostly from sunny to cloudy. Major marine construction activities included: Dredging (5/1/2014 – 8/6/2014); Construction of Temporary Seawalls (5/1/2013 – 8/31/2014); Sheet Piling (5/1/2014 – 8/31/2014); Filling (5/1/2014 – 8/31/2014). No monitoring was conducted on 18 July 2014 due to adverse weather condition.
