Figure G1 Impact Monitoring – Mean Level of Dissolved Oxygen (mg/L) in surface waters between 1 May 2014 and 31 August 2014 at CS4. The weather conditions during the monitoring period varied mostly from sunny to cloudy. Major marine construction activities included: Dredging (5/1/2014 – 8/6/2014); Construction of Temporary Seawalls (5/1/2013 – 8/31/2014); Sheet Piling (5/1/2014 – 8/31/2014); Filling (5/1/2014 – 8/31/2014). No monitoring was conducted on 18 July 2014 due to adverse weather condition.

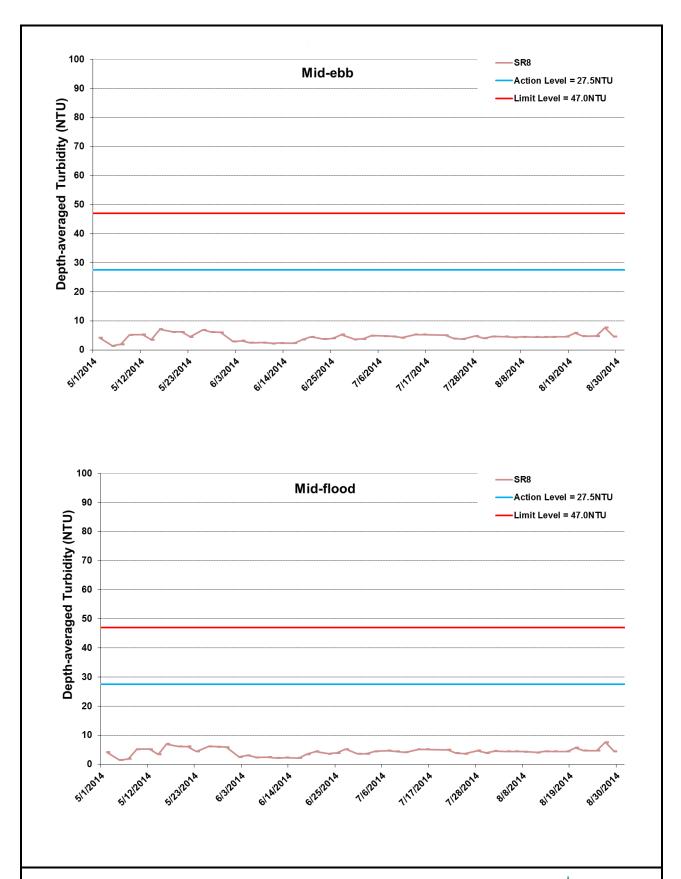
Figure G33 Impact Monitoring – Mean Depth-averaged Level of Turbidity (NTU) between 1 May 2014 and 31 August 2014 at SR8. The weather conditions during the monitoring period varied mostly from sunny to cloudy. Major marine construction activities included: Dredging (5/1/2014 – 8/6/2014); Construction of Temporary Seawalls (5/1/2013 – 8/31/2014); Sheet Piling (5/1/2014 – 8/31/2014); Filling (5/1/2014 – 8/31/2014). No monitoring was conducted on 18 July 2014 due to adverse weather condition.

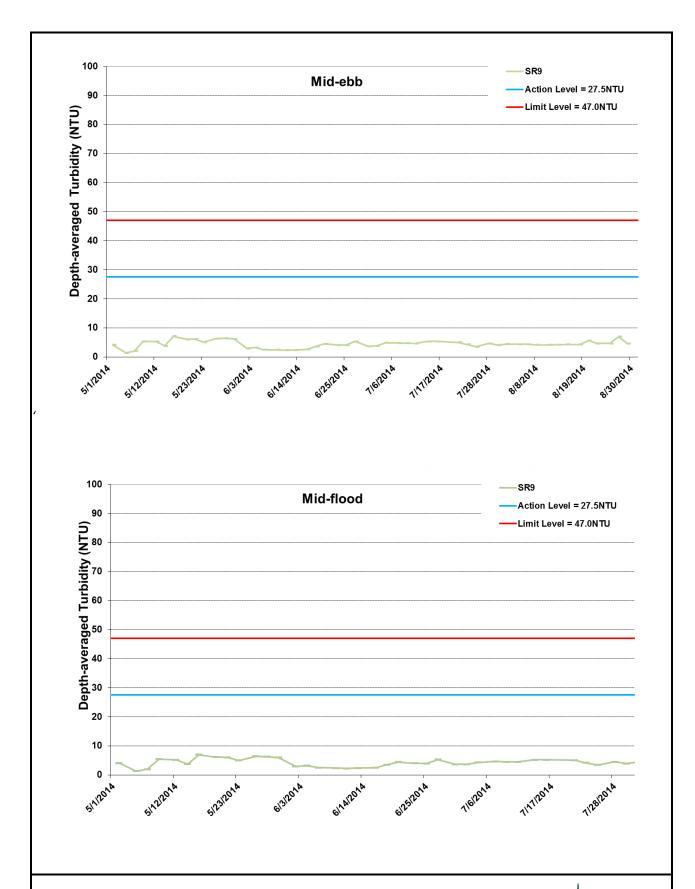
Figure G34 Impact Monitoring – Mean Depth-averaged Level of Turbidity (NTU) between 1 May 2014 and 31 August 2014 at SR9. The weather conditions during the monitoring period varied mostly from sunny to cloudy. Major marine construction activities included: Dredging (5/1/2014 – 8/6/2014); Construction of Temporary Seawalls (5/1/2013 – 8/31/2014); Sheet Piling (5/1/2014 – 8/31/2014); Filling (5/1/2014 – 8/31/2014). No monitoring was conducted on 18 July 2014 due to adverse weather condition.

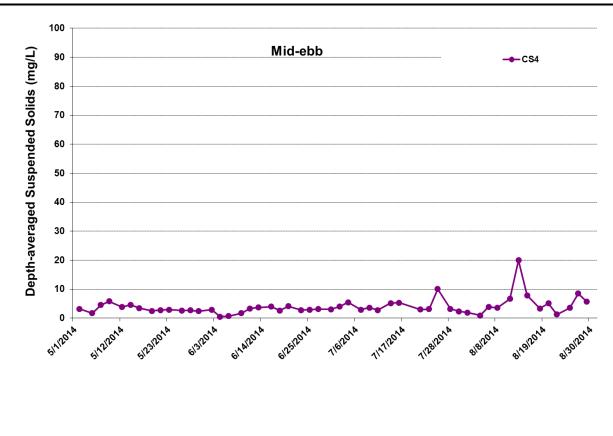
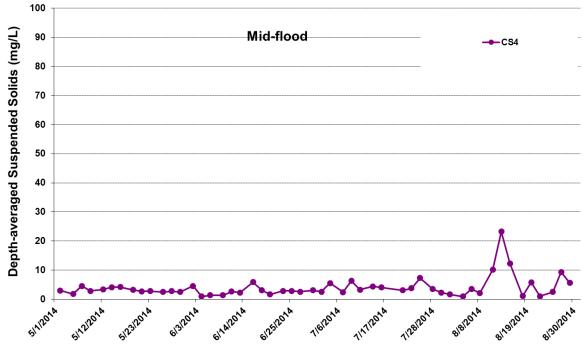
Figure G35 Impact Monitoring – Mean Depth-averaged Level of Suspended Solids (mg/L) between 1 May 2014 and 31 August 2014 at CS4. The weather conditions during the monitoring period varied mostly from sunny to cloudy. Major marine construction activities included: Dredging (5/1/2014 – 8/6/2014); Construction of Temporary Seawalls (5/1/2013 – 8/31/2014); Sheet Piling (5/1/2014 – 8/31/2014); Filling (5/1/2014 – 8/31/2014). No monitoring was conducted on 18 July 2014 due to adverse weather condition.

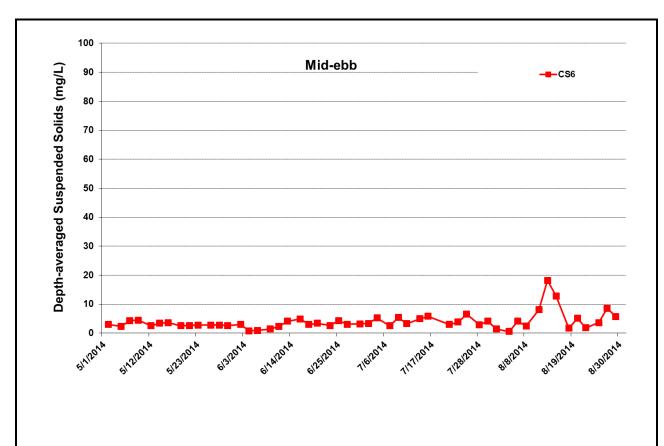
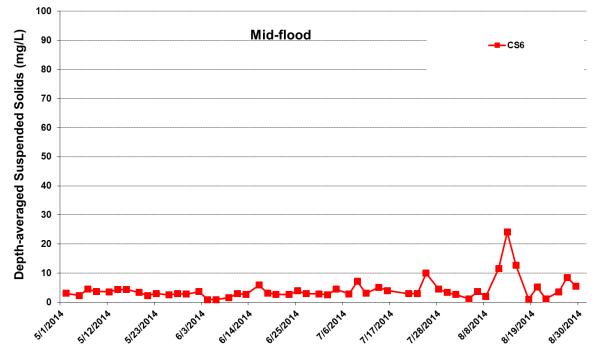
Figure G36 Impact Monitoring – Mean Depth-averaged Level of Suspended Solids (mg/L) between 1 May 2014 and 31 August 2014 at CS6. The weather conditions during the monitoring period varied mostly from sunny to cloudy. Major marine construction activities included: Dredging (5/1/2014 – 8/6/2014); Construction of Temporary Seawalls (5/1/2013 – 8/31/2014); Sheet Piling (5/1/2014 – 8/31/2014); Filling (5/1/2014 – 8/31/2014). No monitoring was conducted on 18 July 2014 due to adverse weather condition.

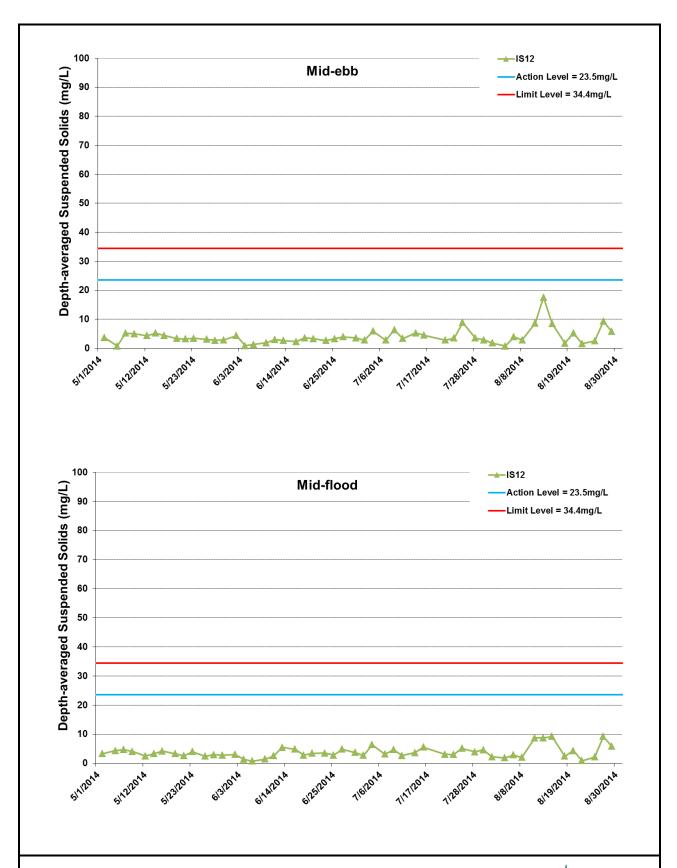
Figure G37 Impact Monitoring – Mean Depth-averaged Level of Suspended Solids (mg/L) between 1 May 2014 and 31 August 2014 at IS12. The weather conditions during the monitoring period varied mostly from sunny to cloudy. Major marine construction activities included: Dredging (5/1/2014 – 8/6/2014); Construction of Temporary Seawalls (5/1/2013 – 8/31/2014); Sheet Piling (5/1/2014 – 8/31/2014); Filling (5/1/2014 – 8/31/2014). No monitoring was conducted on 18 July 2014 due to adverse weather condition.

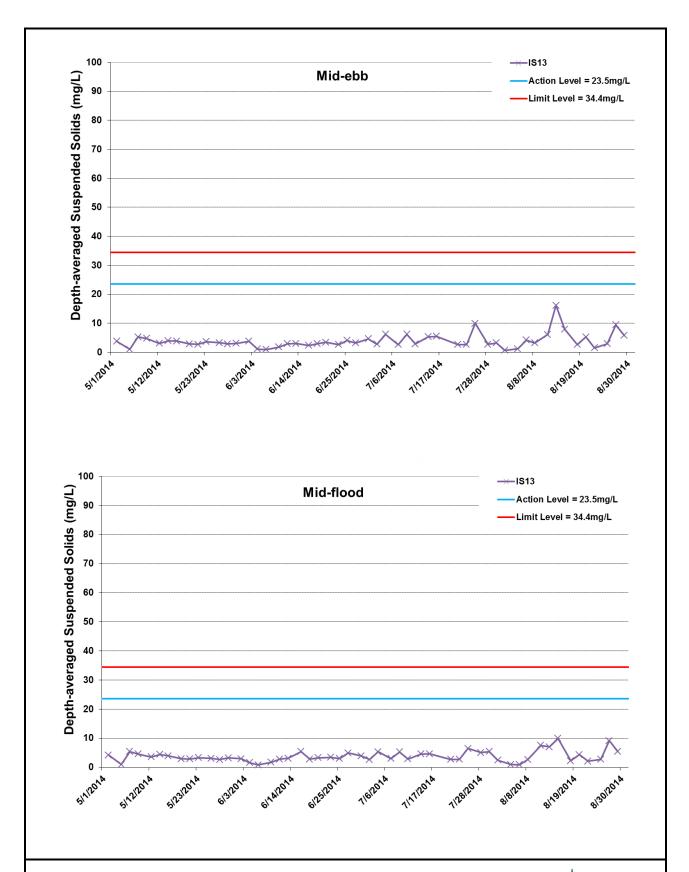
Figure G38 Impact Monitoring – Mean Depth-averaged Level of Suspended Solids (mg/L) between 1 May 2014 and 31 August 2014 at IS13. The weather conditions during the monitoring period varied mostly from sunny to cloudy. Major marine construction activities included: Dredging (5/1/2014 – 8/6/2014); Construction of Temporary Seawalls (5/1/2013 – 8/31/2014); Sheet Piling (5/1/2014 – 8/31/2014); Filling (5/1/2014 – 8/31/2014). No monitoring was conducted on 18 July 2014 due to adverse weather condition.

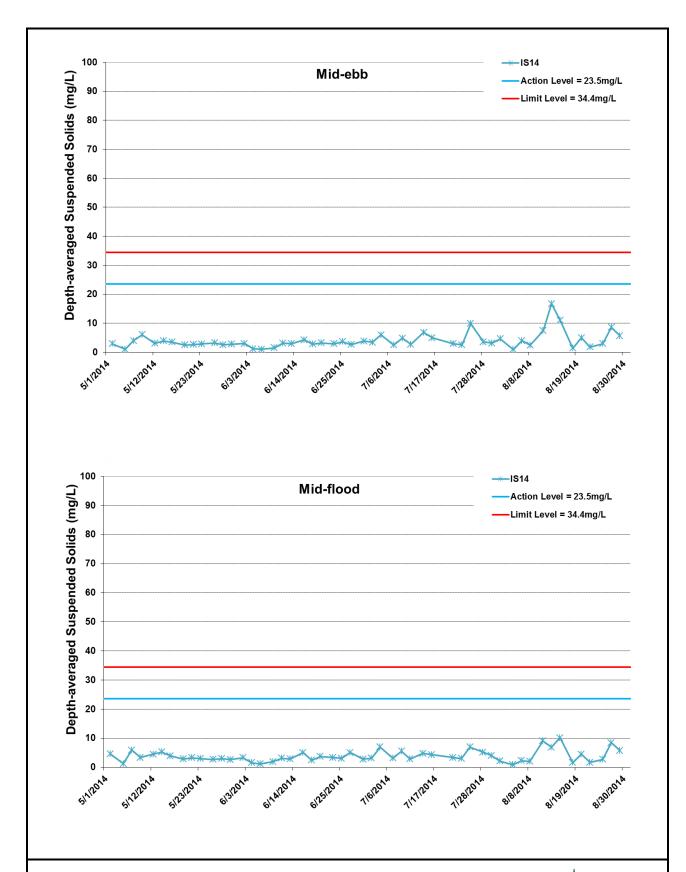
Figure G39 Impact Monitoring – Mean Depth-averaged Level of Suspended Solids (mg/L) between 1 May 2014 and 31 August 2014 at IS14. The weather conditions during the monitoring period varied mostly from sunny to cloudy. Major marine construction activities included: Dredging (5/1/2014 – 8/6/2014); Construction of Temporary Seawalls (5/1/2013 – 8/31/2014); Sheet Piling (5/1/2014 – 8/31/2014); Filling (5/1/2014 – 8/31/2014). No monitoring was conducted on 18 July 2014 due to adverse weather condition.

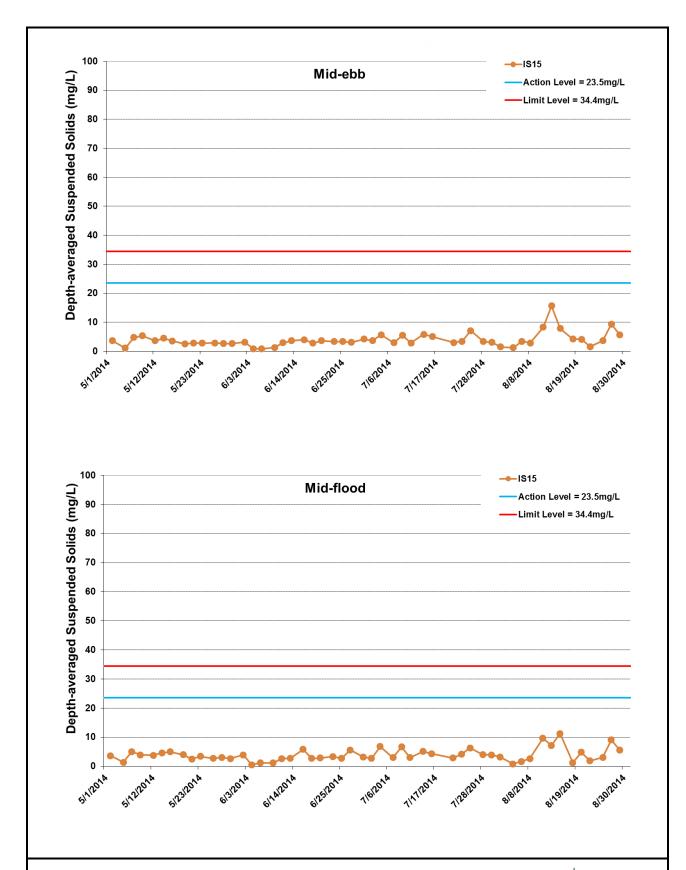
Figure G40 Impact Monitoring – Mean Depth-averaged Level of Suspended Solids (mg/L) between 1 May 2014 and 31 August 2014 at IS15. The weather conditions during the monitoring period varied mostly from sunny to cloudy. Major marine construction activities included: Dredging (5/1/2014 – 8/6/2014); Construction of Temporary Seawalls (5/1/2013 – 8/31/2014); Sheet Piling (5/1/2014 – 8/31/2014); Filling (5/1/2014 – 8/31/2014). No monitoring was conducted on 18 July 2014 due to adverse weather condition.

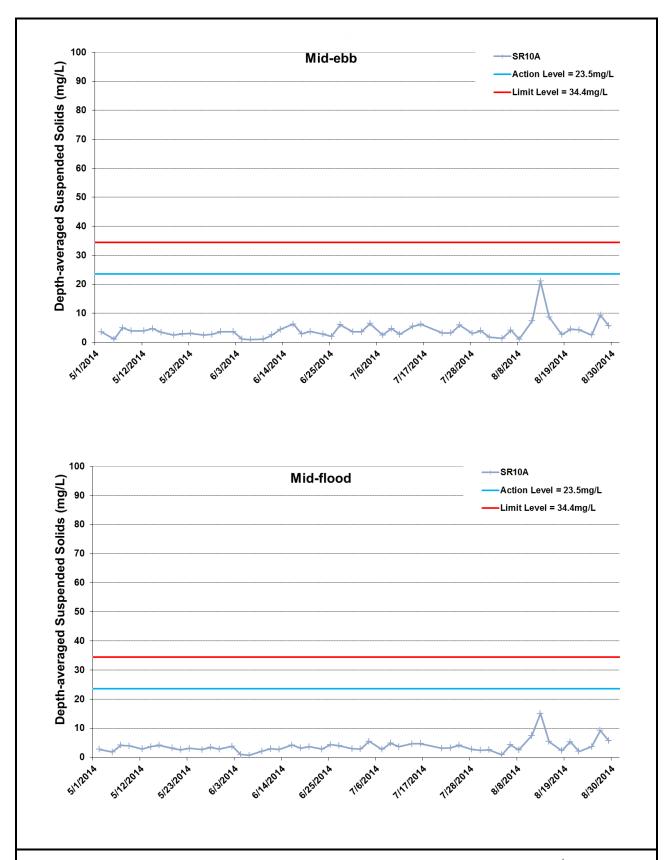
Figure G41 Impact Monitoring – Mean Depth-averaged Level of Suspended Solids (mg/L) between 1 May 2014 and 31 August 2014 at SR10A. The weather conditions during the monitoring period varied mostly from sunny to cloudy. Major marine construction activities included: Dredging (5/1/2014 – 8/6/2014); Construction of Temporary Seawalls (5/1/2013 – 8/31/2014); Sheet Piling (5/1/2014 – 8/31/2014); Filling (5/1/2014 – 8/31/2014). No monitoring was conducted on 18 July 2014 due to adverse weather condition.

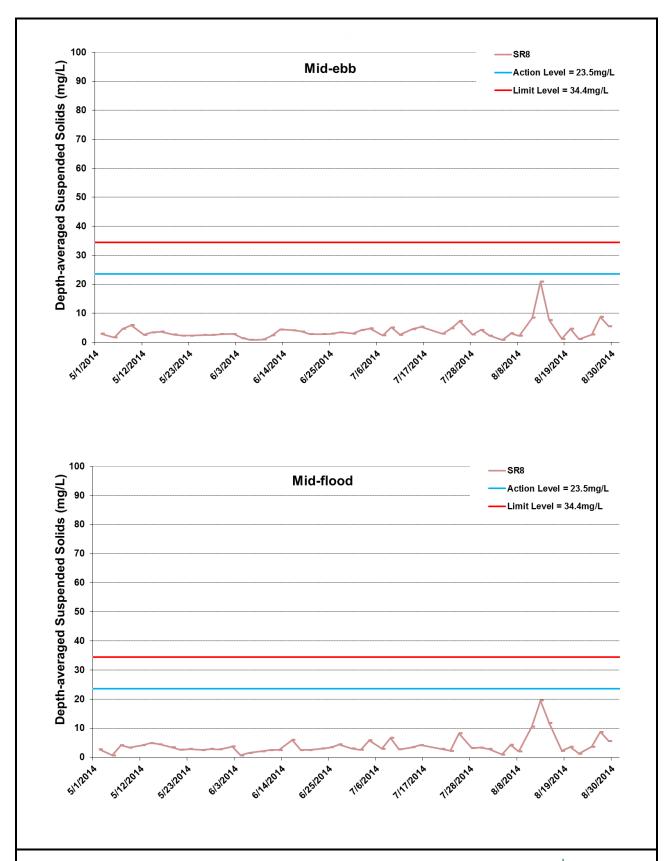
Figure G42 Impact Monitoring – Mean Depth-averaged Level of Suspended Solids (mg/L) between 1 May 2014 and 31 August 2014 at SR8. The weather conditions during the monitoring period varied mostly from sunny to cloudy. Major marine construction activities included: Dredging (5/1/2014 – 8/6/2014); Construction of Temporary Seawalls (5/1/2013 – 8/31/2014); Sheet Piling (5/1/2014 – 8/31/2014); Filling (5/1/2014 – 8/31/2014). No monitoring was conducted on 18 July 2014 due to adverse weather condition.

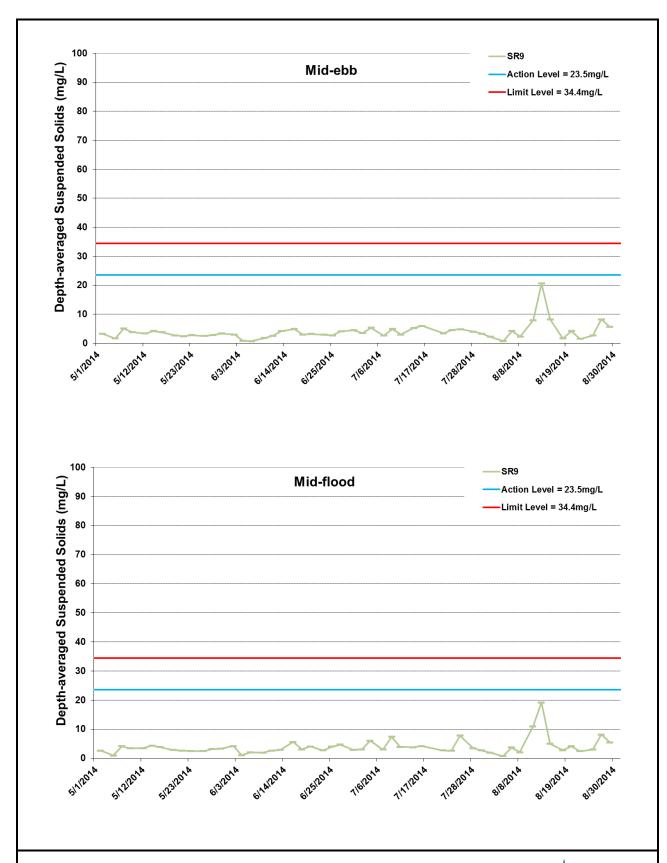
Figure G43 Impact Monitoring – Mean Depth-averaged Level of Suspended Solids (mg/L) between 1 May 2014 and 31 August 2014 at SR9. The weather conditions during the monitoring period varied mostly from sunny to cloudy. Major marine construction activities included: Dredging (5/1/2014 – 8/6/2014); Construction of Temporary Seawalls (5/1/2013 – 8/31/2014); Sheet Piling (5/1/2014 – 8/31/2014); Filling (5/1/2014 – 8/31/2014). No monitoring was conducted on 18 July 2014 due to adverse weather condition.
