AUES JOB No.: TCS00715/14

TUEN MUN - CHEK LAP KOK LINK
CONTRACT NO. HY/2013/12 –
NORTHERN CONNECTION TOLL PLAZA AND
ASSOCIATED WORKS

2nd QUARTERLY ENVIRONMENTAL MONITORING &
AUDIT SUMMARY REPORT –
(February to April 2015)

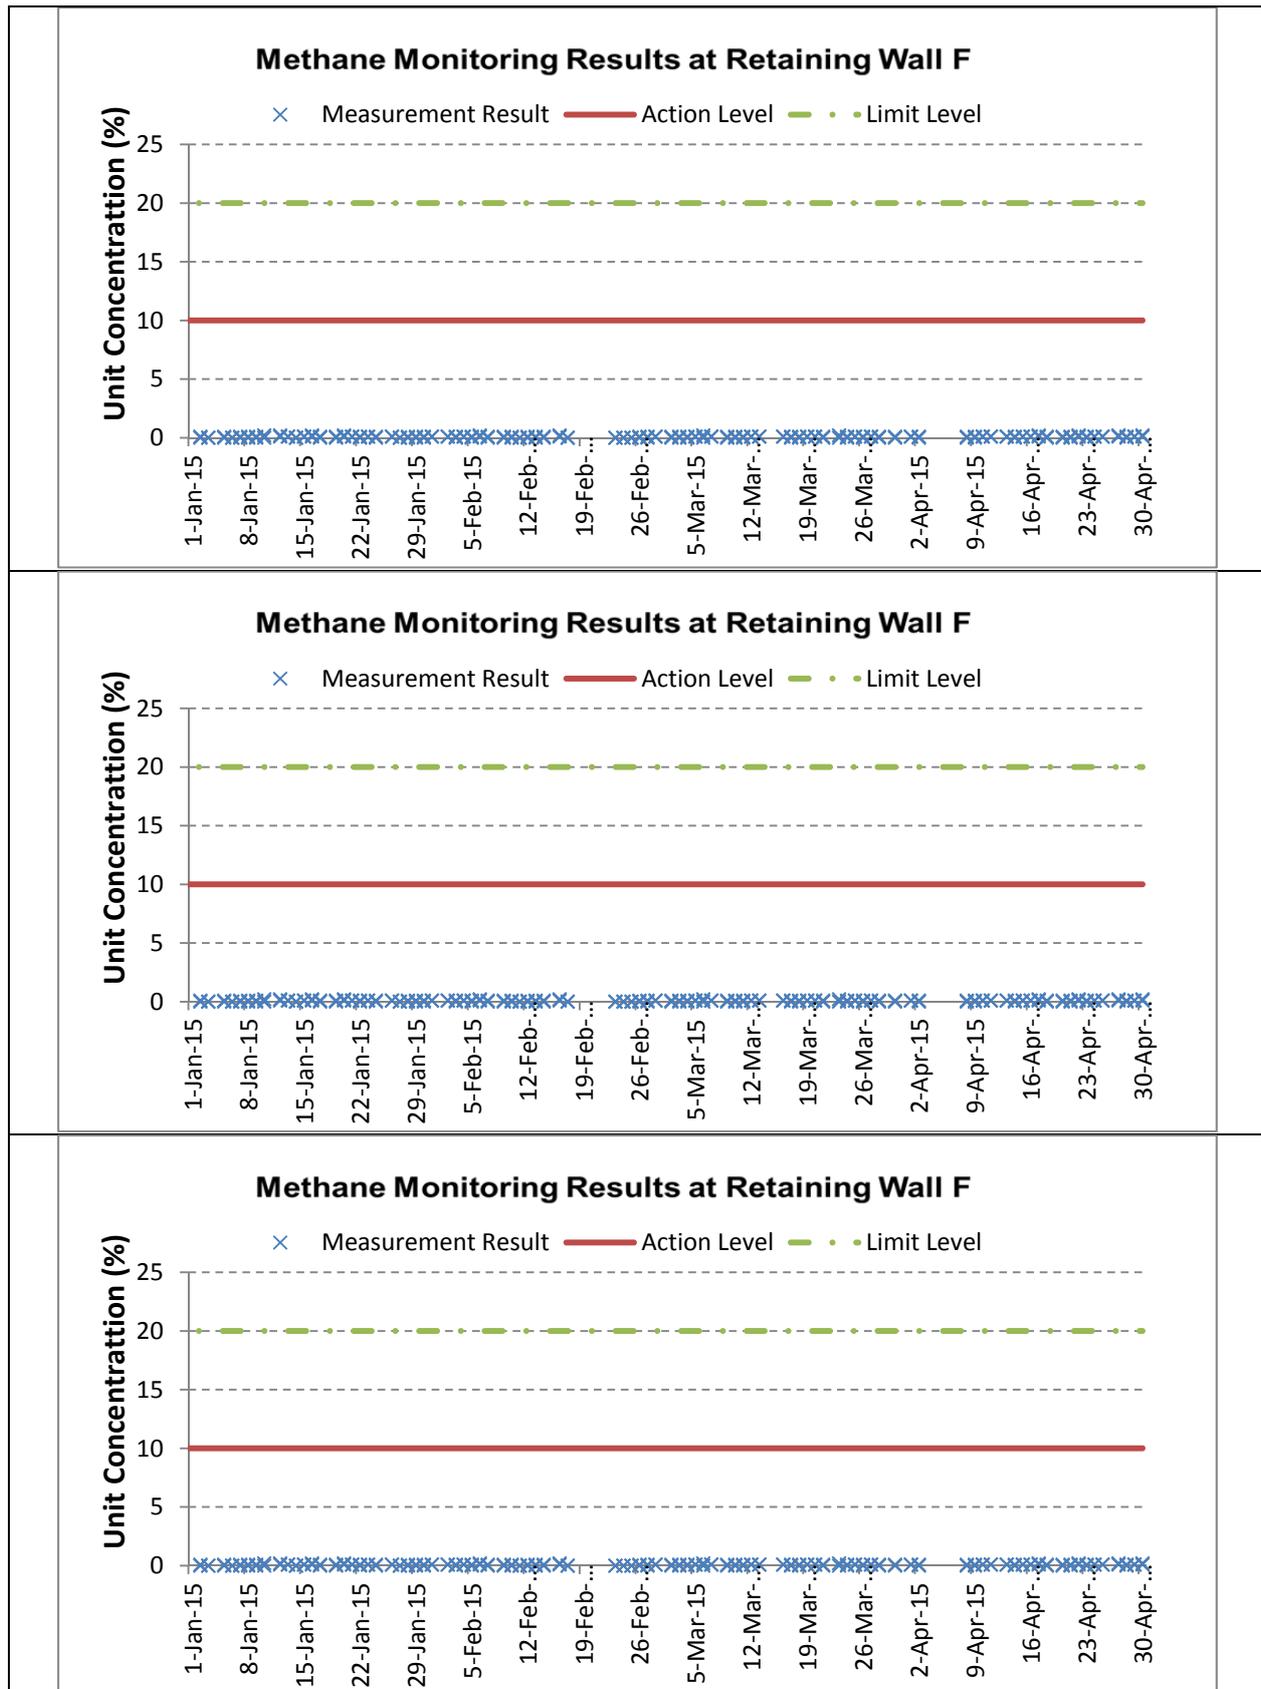
During 1 January to 30 April 2015, major construction activity was construction of retaining wall F and the specified works included excavation, rock breaking, blinding, formworking, steel-fixing and concreting. The weather condition varied from sunny to rainy. The monitoring data was provided by the Contractor followed to their QA/QC control.

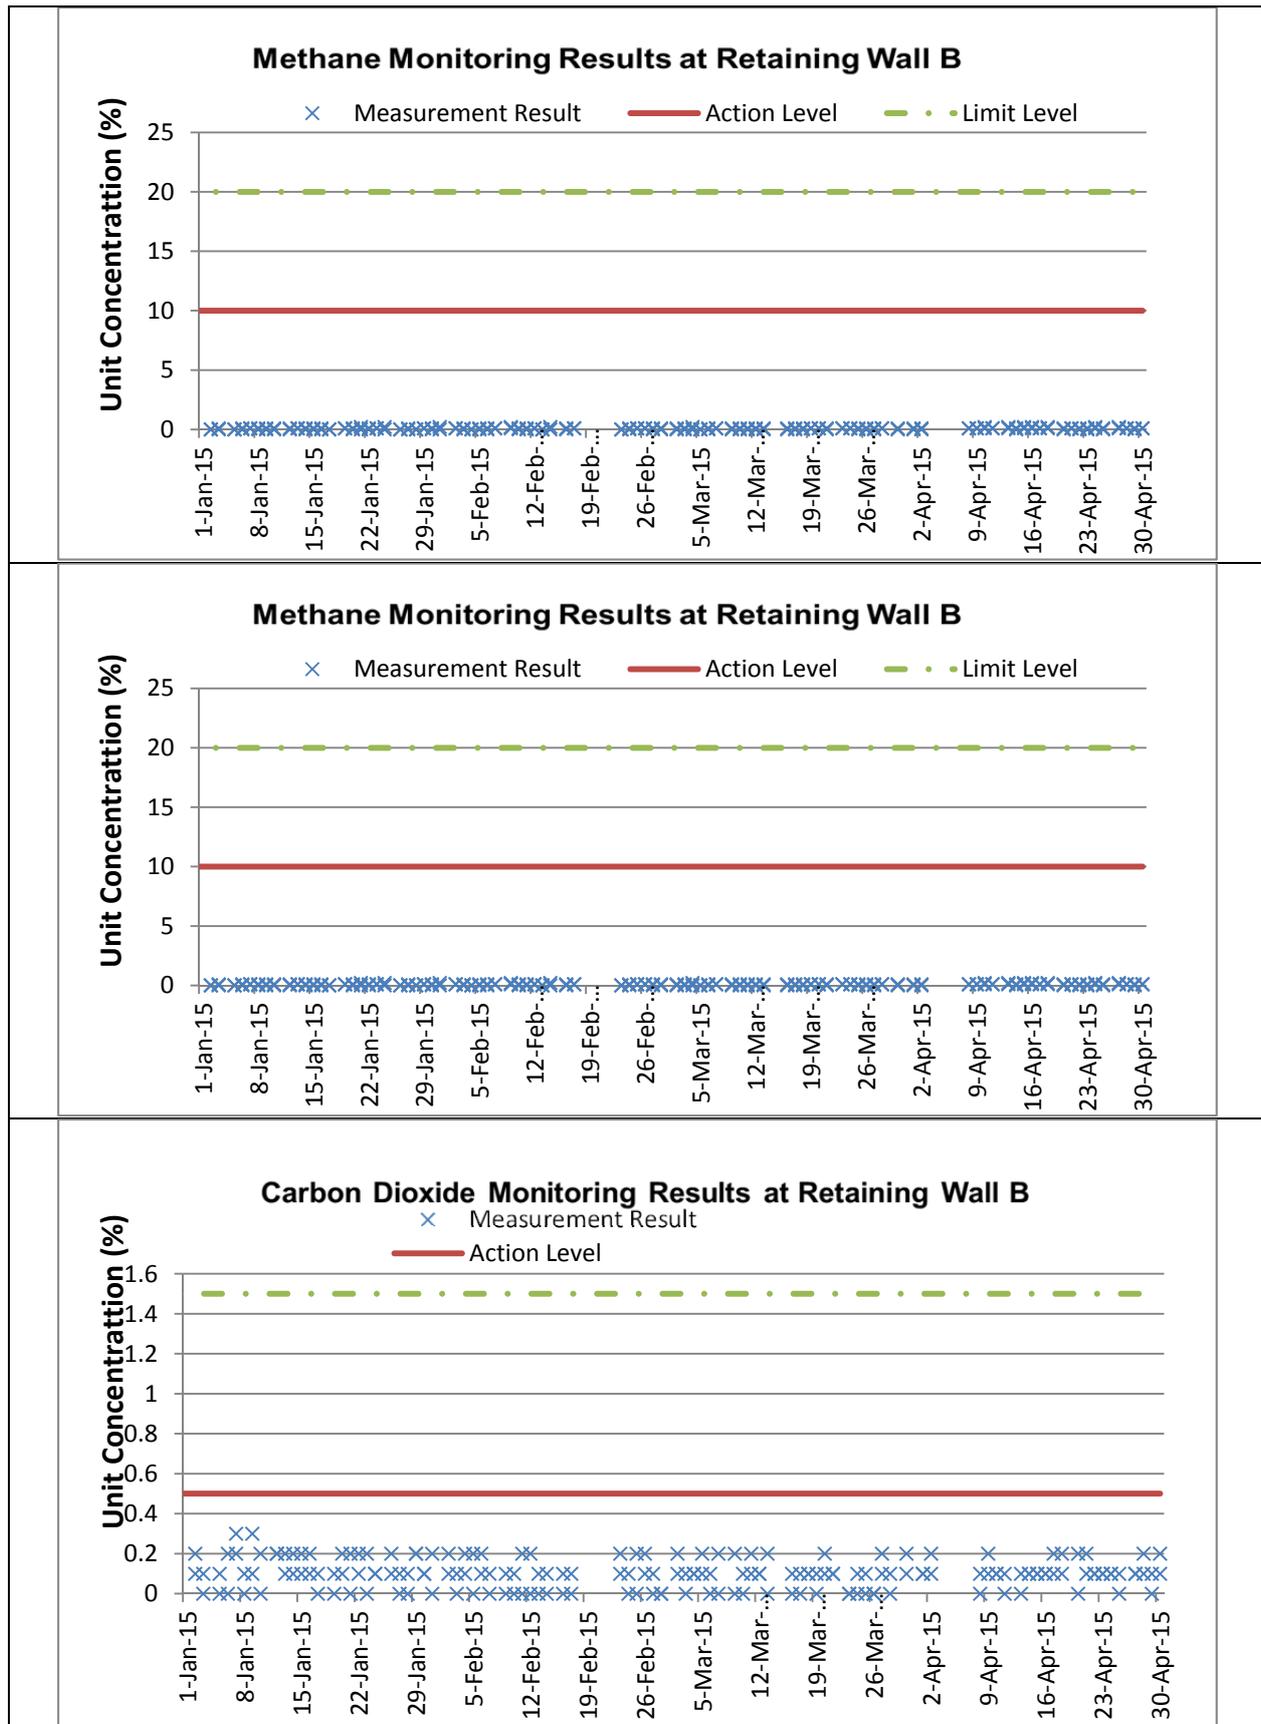
During 1 January to 30 April 2015, major construction activity was construction of retaining wall B and the specified works included excavation, rock breaking, blinding, formworking, steel-fixing and concreting. The weather condition varied from sunny to rainy. The monitoring data was provided by the Contractor followed to their QA/QC control.
